Narrative Appraisal Report

Pierce County Rural Library District Property
6302 Wildaire Road SW
Lakewood, WA
(Parcel No. 503000-2991)

Condition Assessment Report for Lakewood Library and Tillicum Library

**LAKWOOD LIBRARY
ROOF EVALUATION
MARCH 10, 2022**

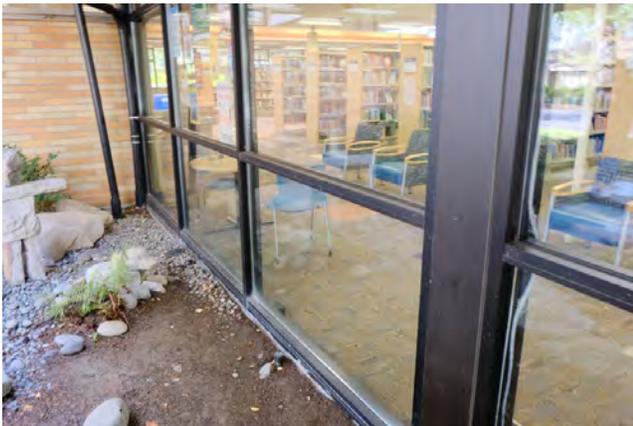
Windows near entry with failed glazing seals

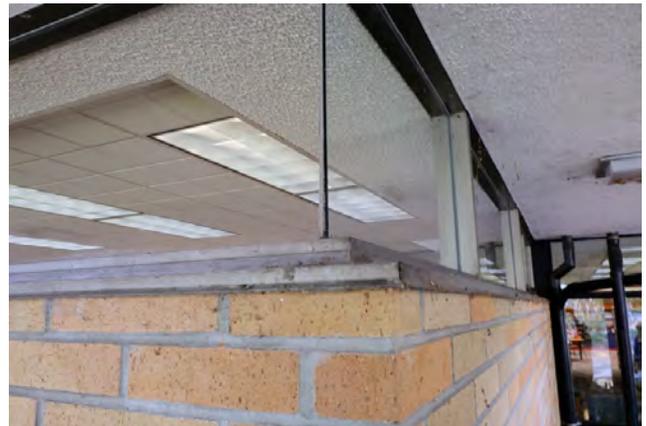
Single pane windows with failed seal at corner joint

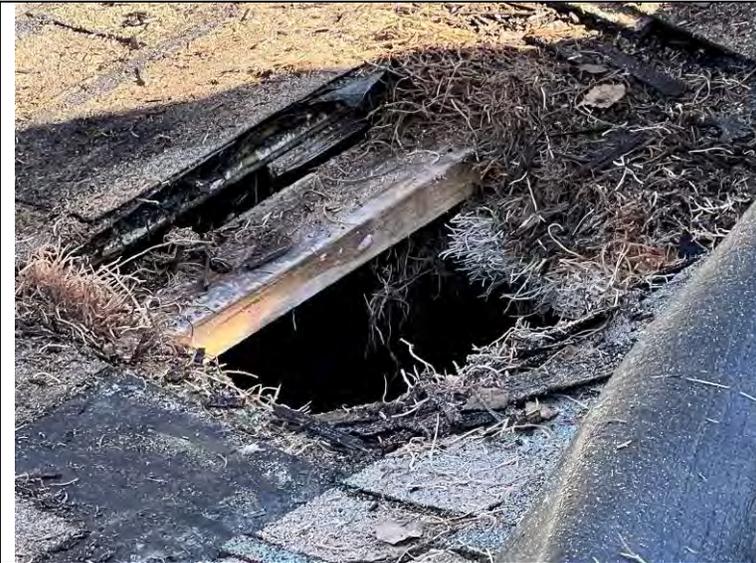
Photograph 19: Closer view of test opening #4 showing the deteriorated cementitious wood fiber substrate board.

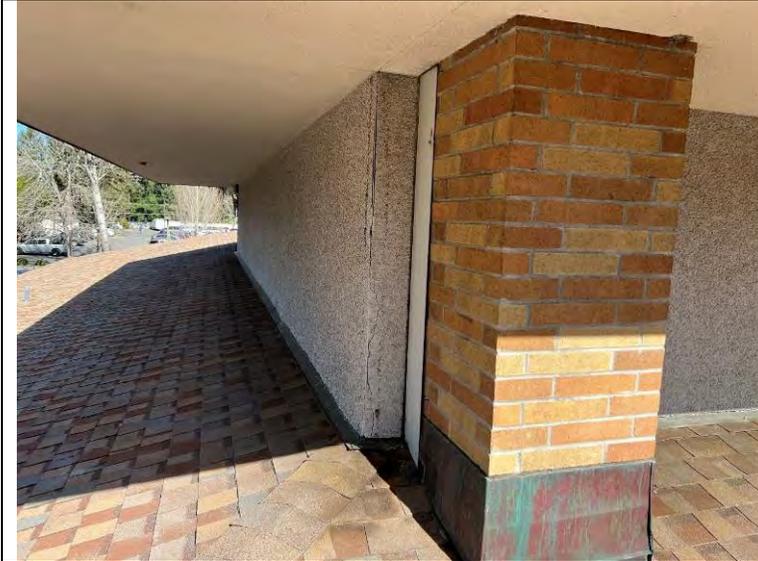
Photograph 35: Cracked marblecrete at a rising wall corner transition.

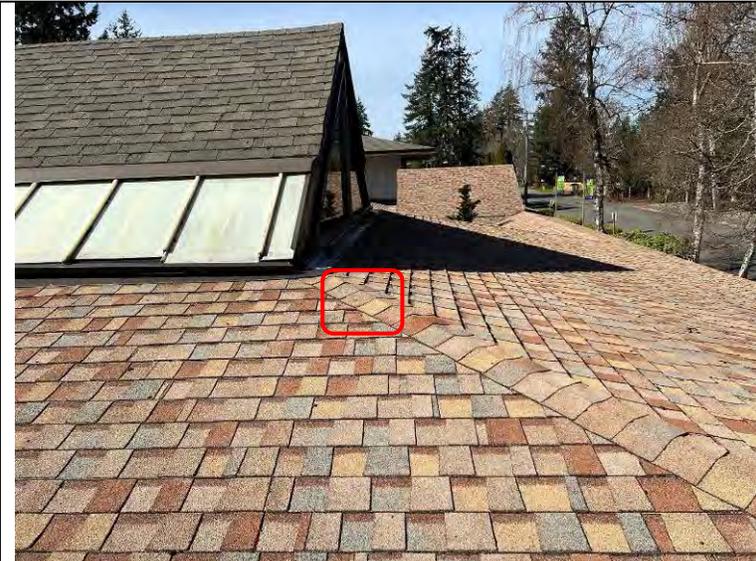
Photograph 46: Hip condition, roofed with hip shingles.

Note the backed-out nails (highlighted).

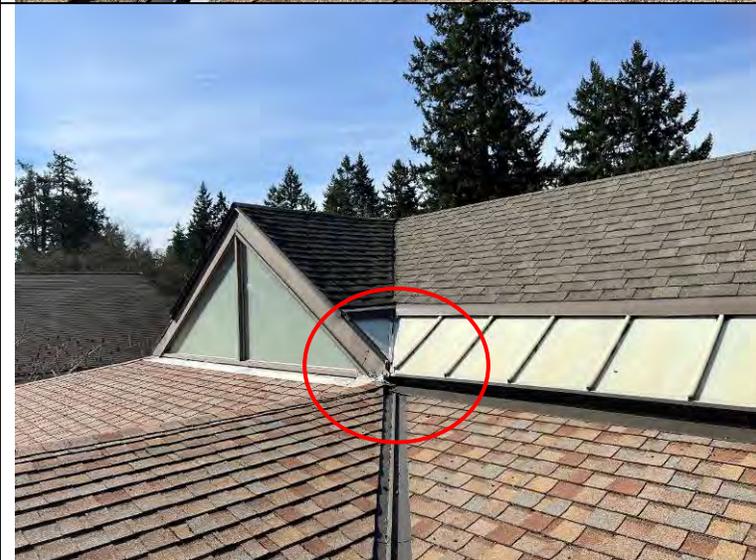
Photograph 51: Overview of a leak location temporarily sealed by Wayne's Roofing.

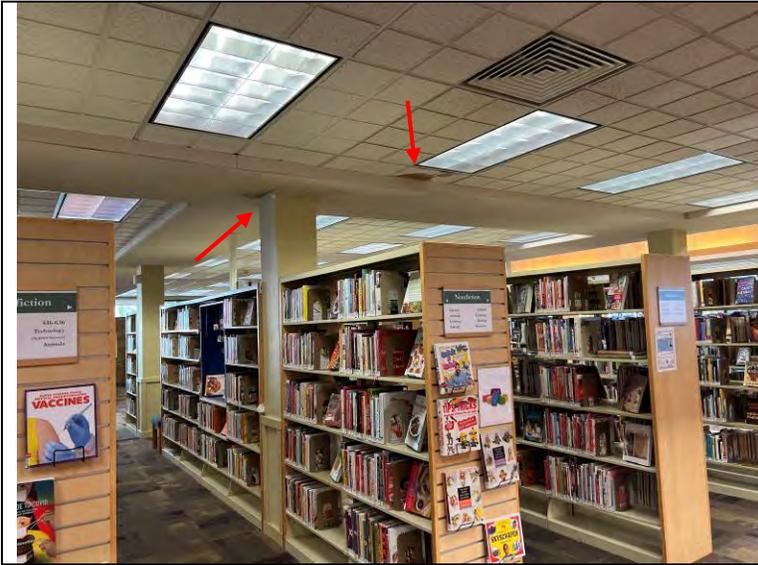
Photograph 79: Approximate area beneath the roof cement patch shown in Photographs 77 and 78.
