**Lakewood Pierce
County Library building
condition assessment,
roof evaluation, and
structural engineering
reports**

LWD Building Analysis – Executive Summary

Condition Assessment Report for Lakewood Library and Tillicum Library

**LAKESWOOD LIBRARY
ROOF EVALUATION
MARCH 10, 2022**

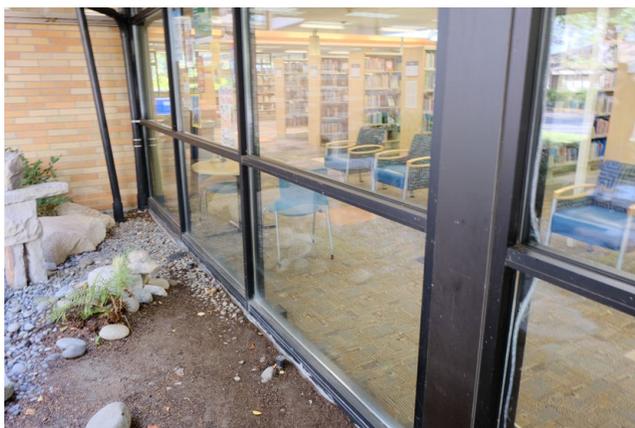
Windows near entry with failed glazing seals

**Windows are original, single pane and insulated units in wood frames.
All are in poor condition and/or do not meet current energy code requirements.
All wondows should be replaced with new.**

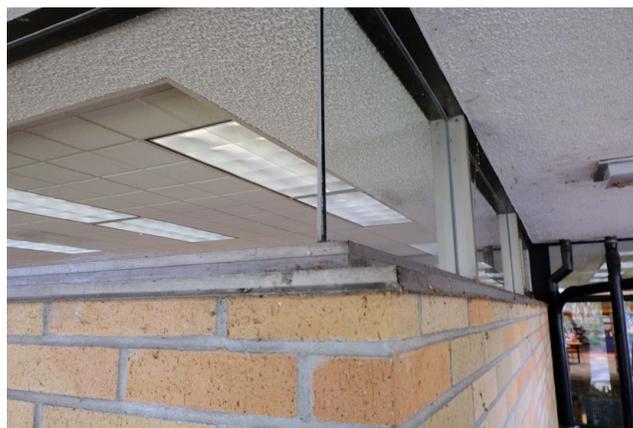
Single pane windows with failed seal at corner joint

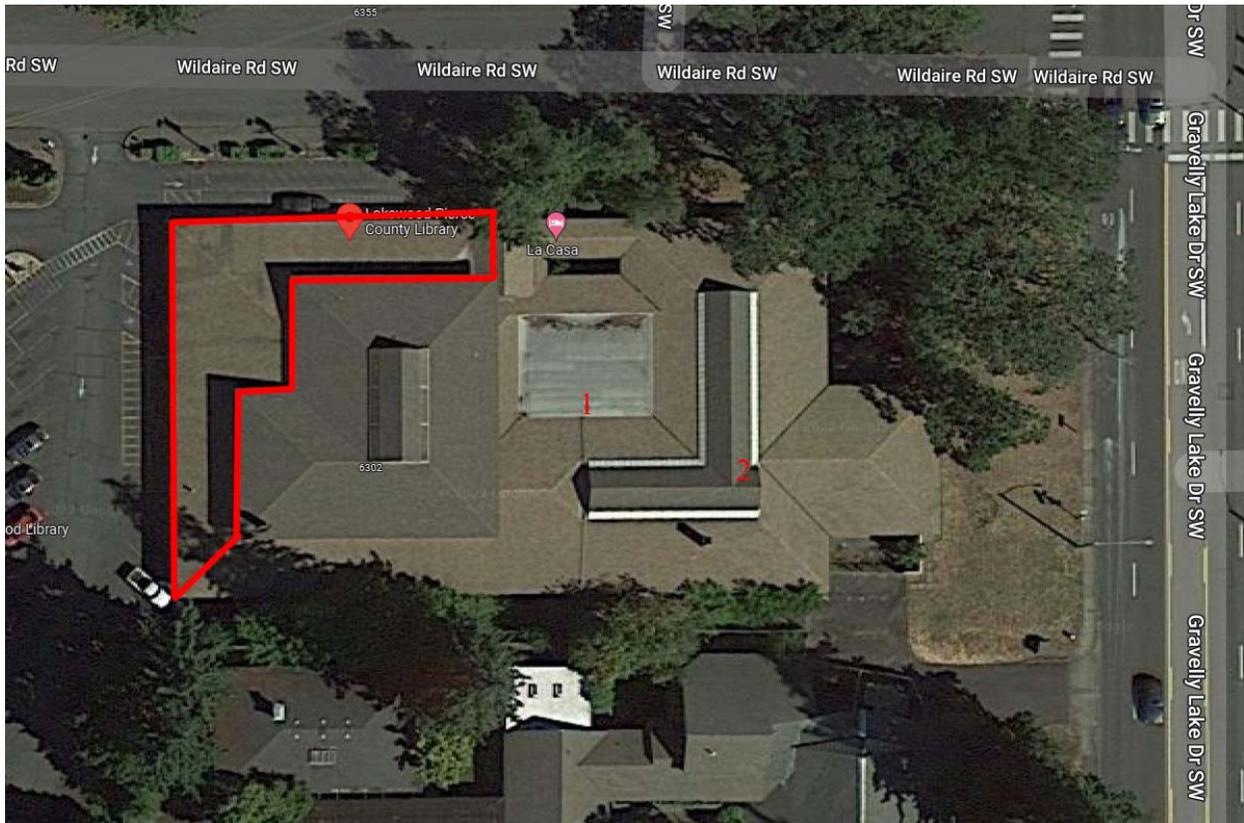
The area highlighted above are the north and west lower roof areas. The locations noted as 1 and 2 are the areas of water entry noted.

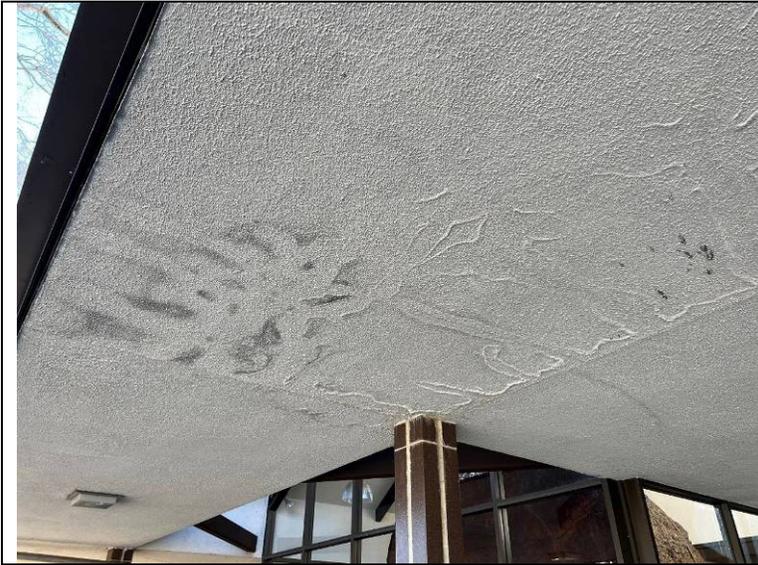
Photograph 4: Water staining at the soffit under the area where test openings were made.

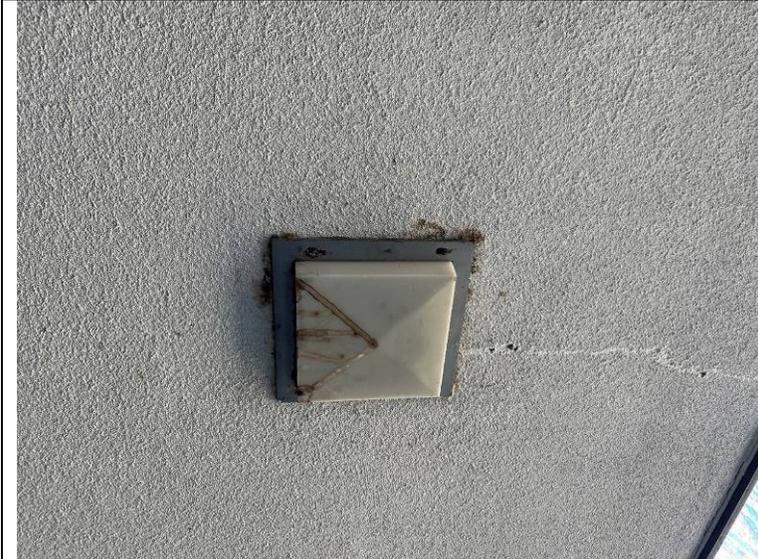
Photograph 5: Water staining at a light fixture in the soffit under the area where test openings were made.

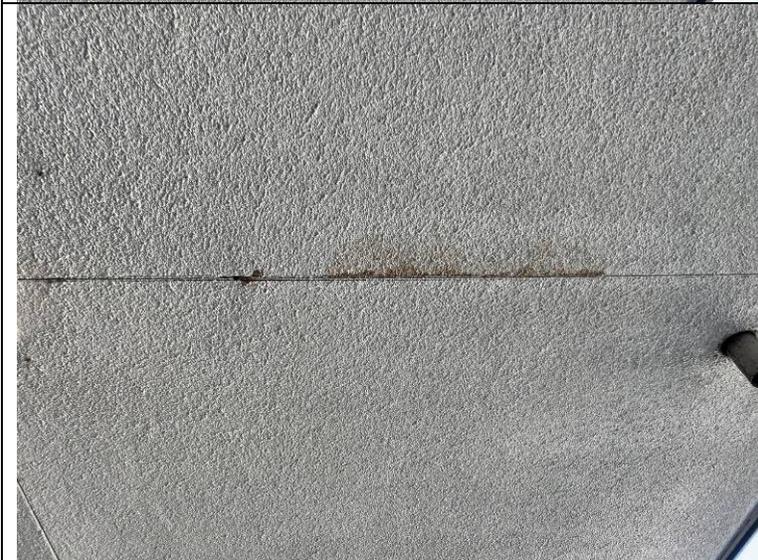
Photograph 6: Water staining at the soffit under the area where test openings were made.

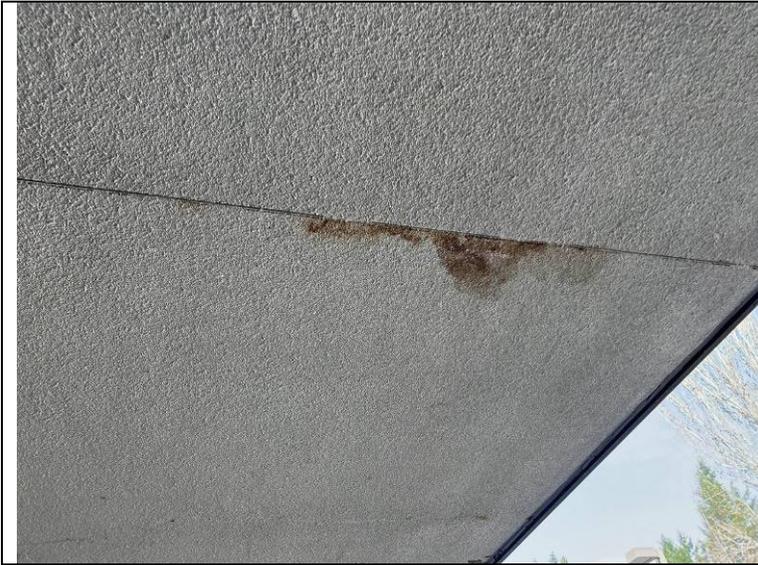
Photograph 7: Water staining at the soffit under the area where test openings were made.

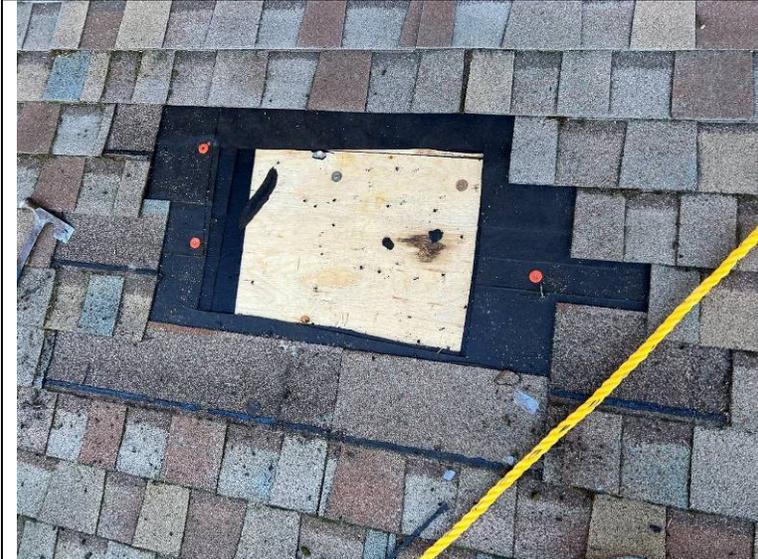
Photograph 8: Test opening #1 was situated under the overhang from the upper roof. The plywood at this location appears light in color and solid.

The underlayment was in good condition.

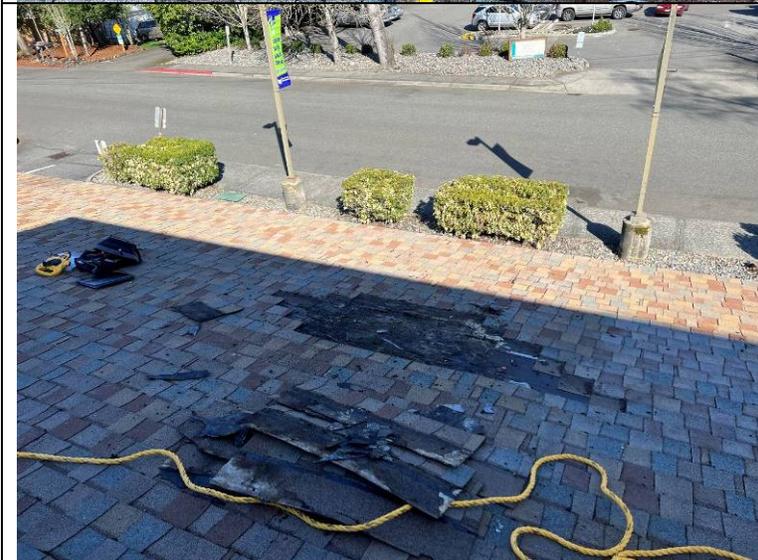
Photograph 9: Overview of test opening location #2.

The plywood at this location which was exposed is deteriorated and black in color.

The underlayment was deteriorated.

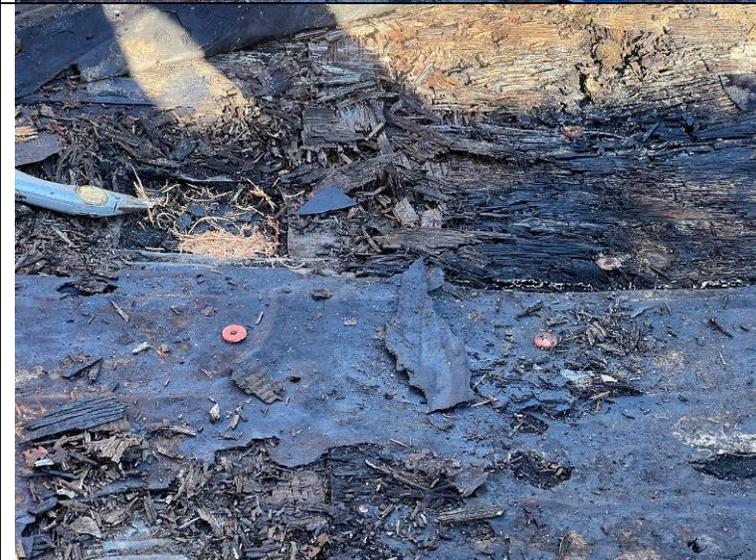
Photograph 12: Closer view of the area shown in Photograph 11.

Note the plywood sheathing and cementitious wood fiber are deteriorated.

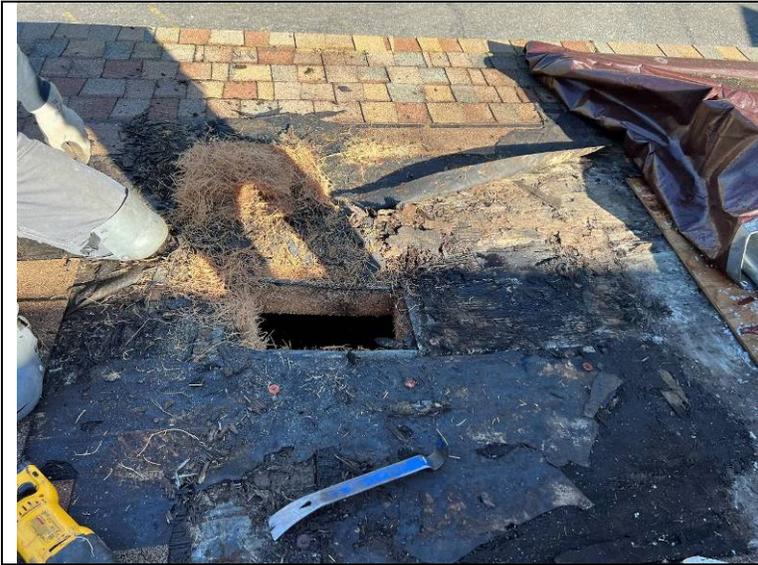
Photograph 13: Portion of the cementitious wood fiber substrate was removed to provide visual access to the structure below.

Note the cementitious wood fiber substrate board is deteriorated.

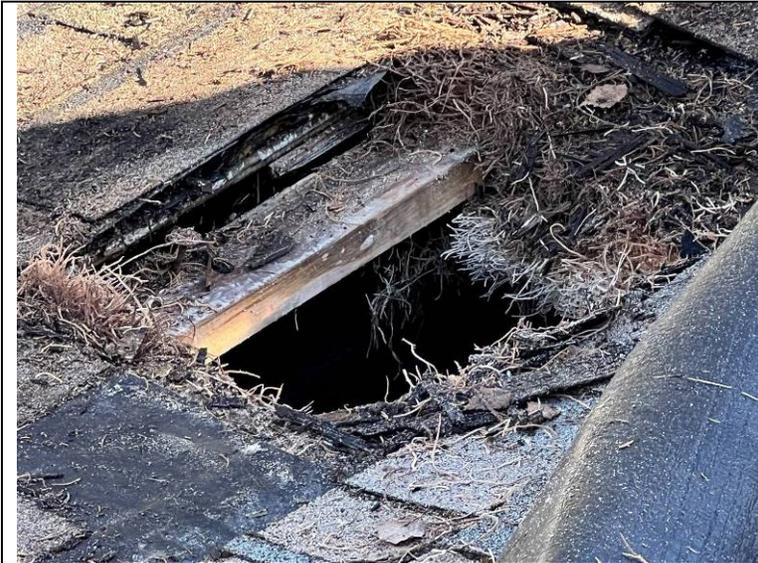
Photograph 19: Closer view of test opening #4 showing the deteriorated cementitious wood fiber substrate board.

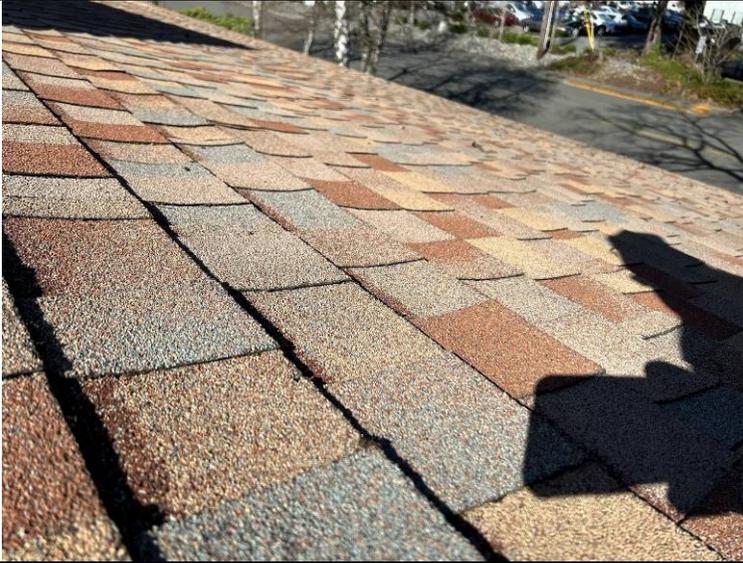
Photograph 25: Slight curling or cupping of the Tamko shingles was observed in various areas of the roof.

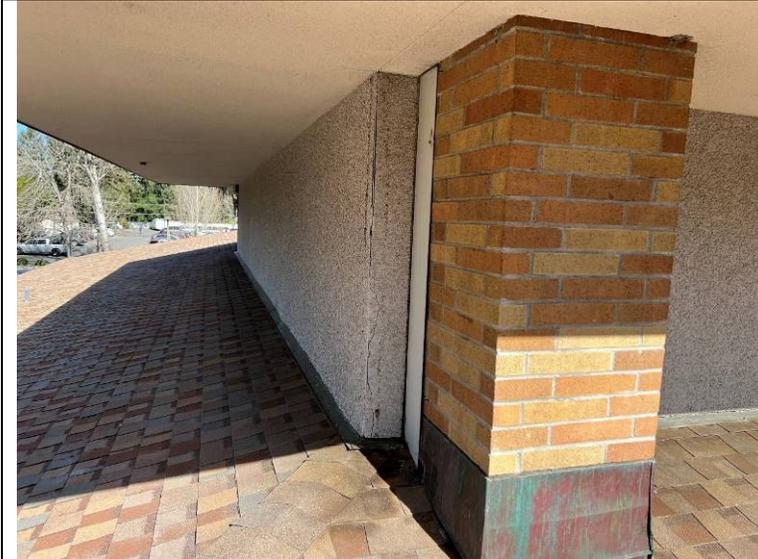
Photograph 35: Cracked marblecrete at a rising wall corner transition.

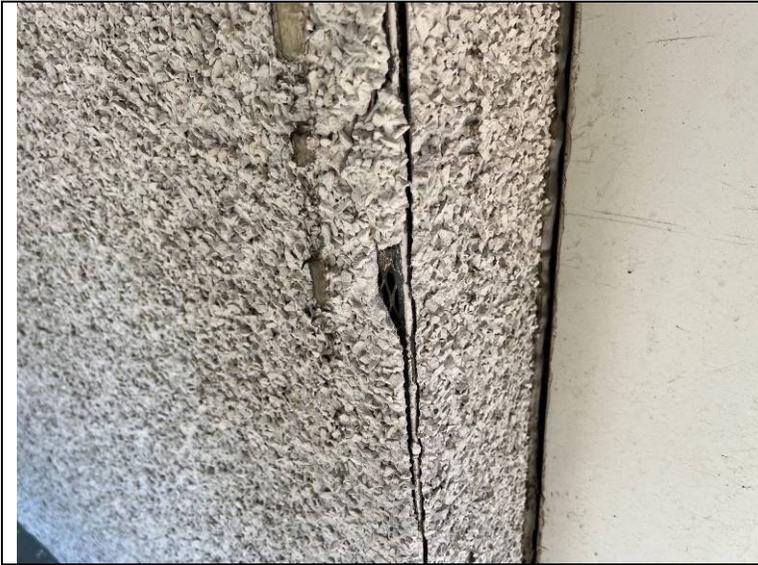
Photograph 37: Closer view of the area shown in Photograph 35.

Damage is likely due to age, settling, and differential movement.

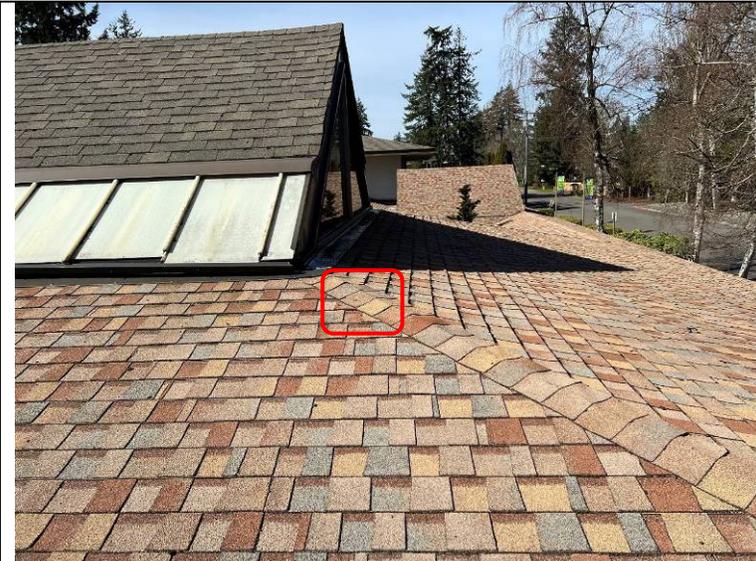
Photograph 46: Hip condition, roofed with hip shingles.

Note the backed-out nails (highlighted).

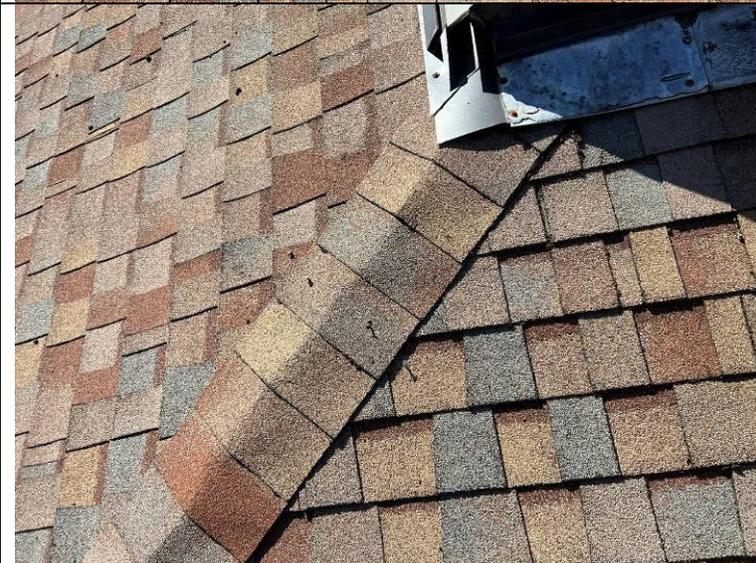
Photograph 47: Closer view of the backed-out nails.

Note Wayne's Roofing personnel drove the nails in and applied roof cement over the nail heads as a temporary measure.

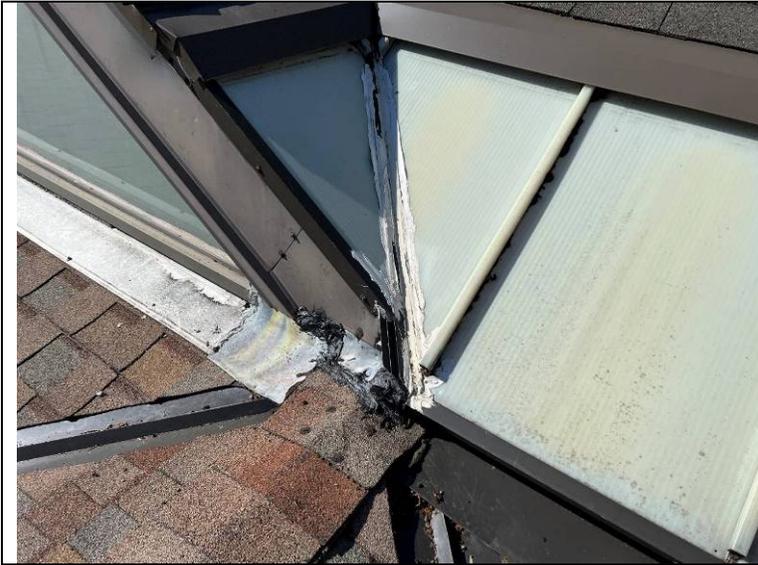
Photograph 52: Closer view of the area shown in Photograph 51.

Roof cement appears to have been applied in response to the previous water entry.

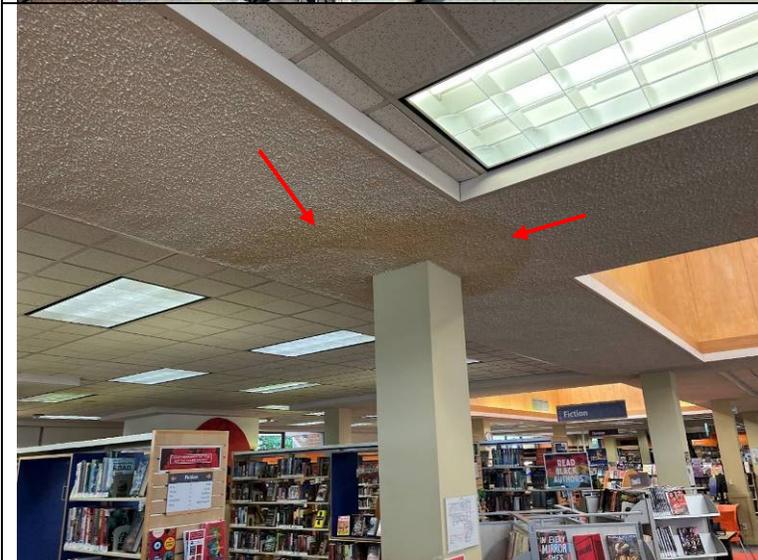
Photograph 54: Area below the area circled in Photograph 51.

Arrows indicate apparent water staining on the ceiling.

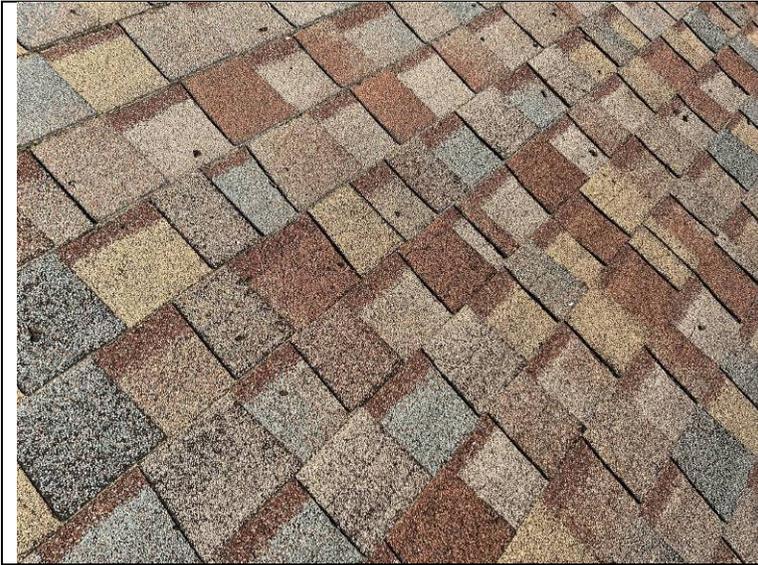
Photograph 61: At the south sloping roofs, the mineral granules are eroding from the surface of the shingles.

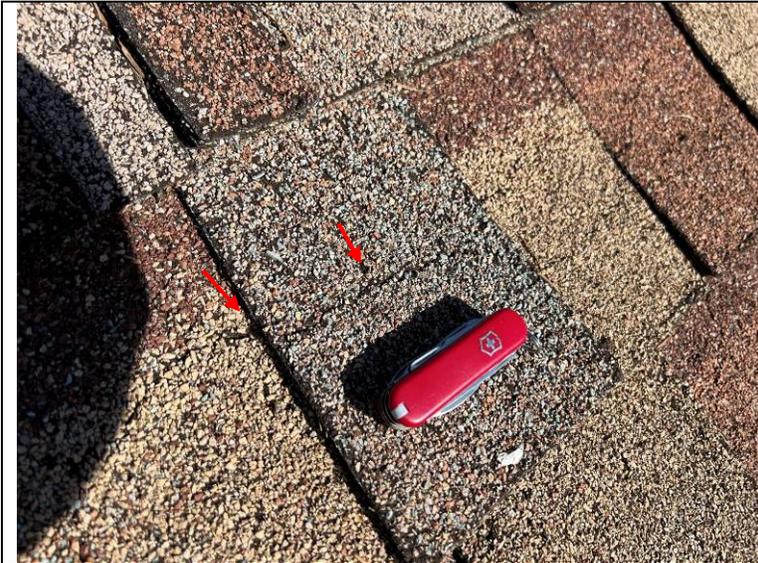
Photograph 64: Cracked shingles at the south sloping roof. (Arrows)

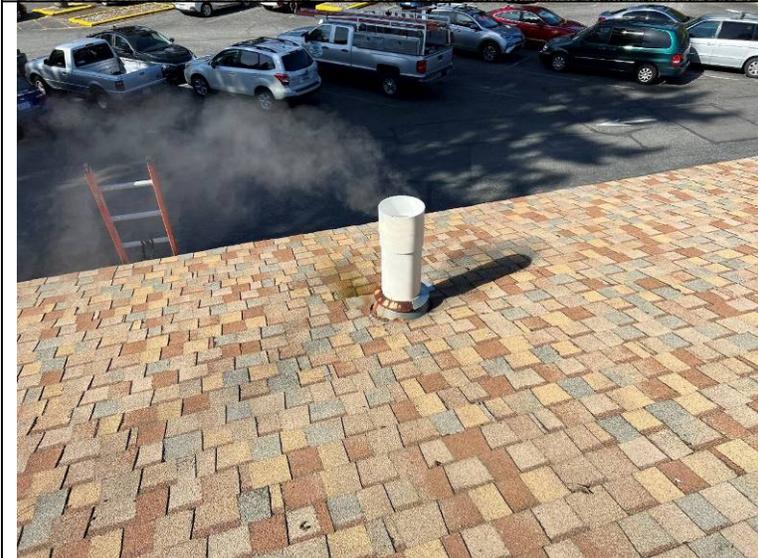
Photograph 65: Boiler vent penetration.

The PVC penetration is flashed with a b-vent, with a storm collar above the flashing.

The storm collar is rusty.

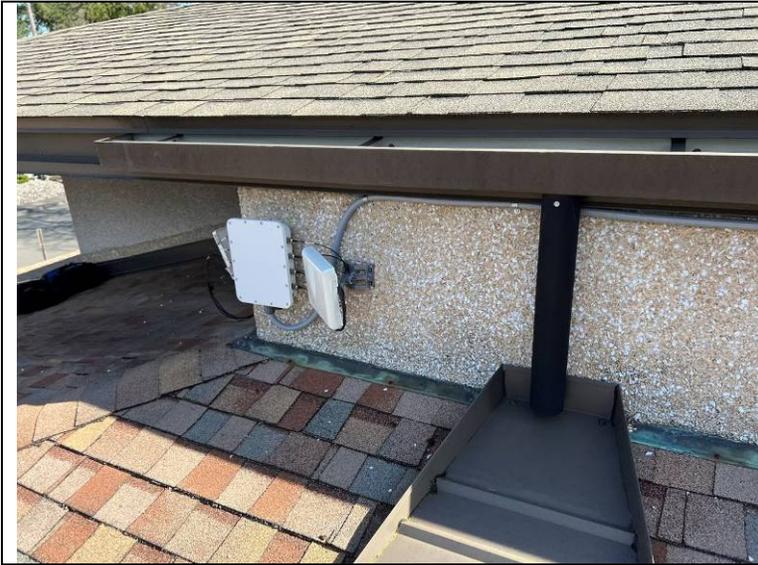
Photograph 67: Equipment mounted to the exterior wall through the marblecrete.

The fastener penetrations are not sealed.

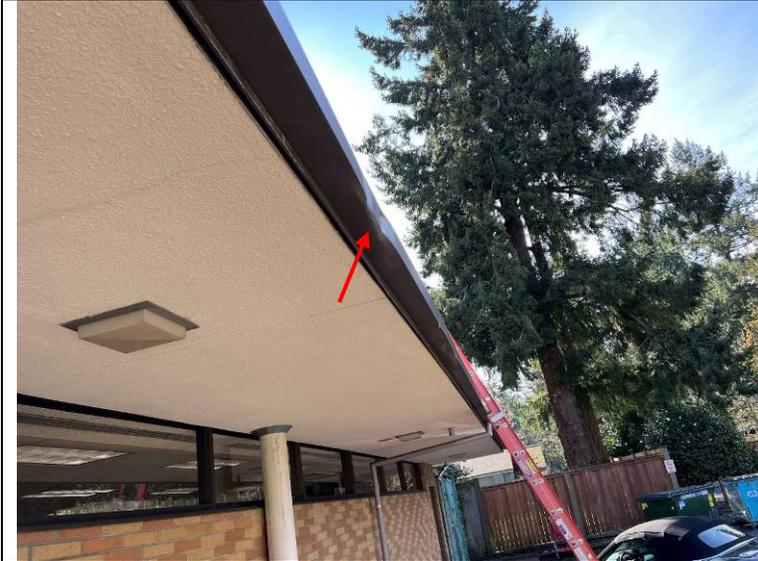
Photograph 68: Damaged gutter (arrow) at the west side of the roof.

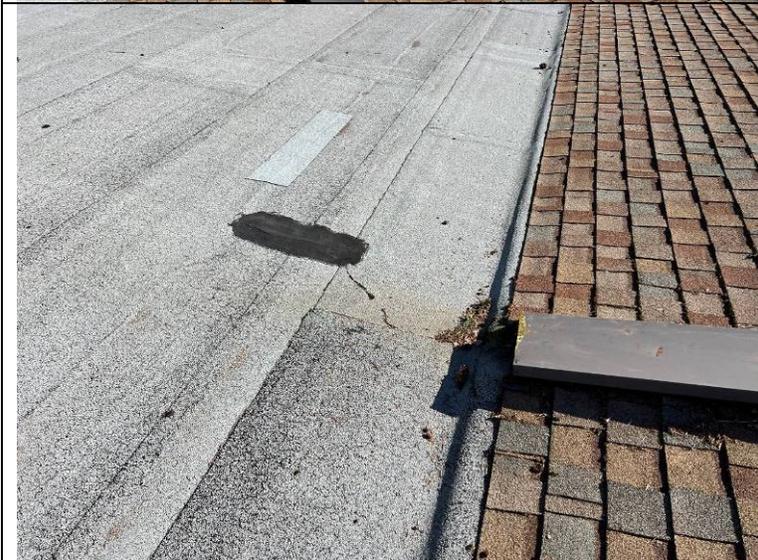
Photograph 78: Closer view of the roof cement patch circled in Photograph 77.

Note the repair was performed by Wayne's Roofing in response to previous water entry.

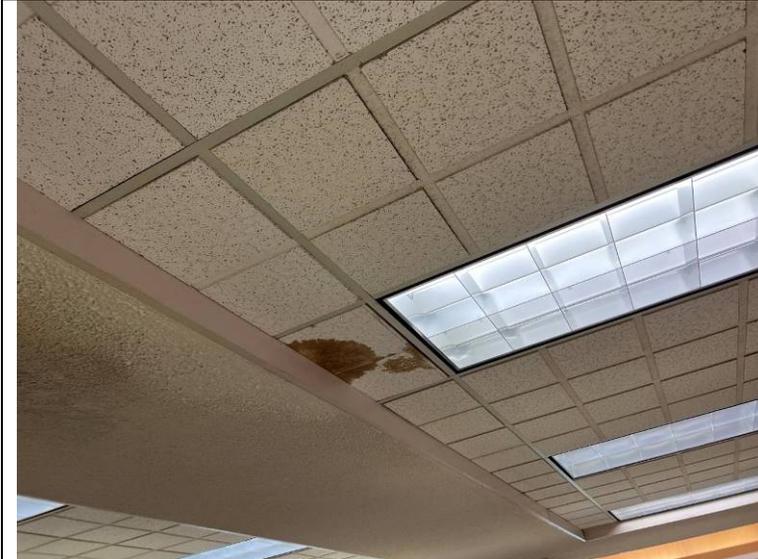
Photograph 80: Closer view of stained ceiling tiles shown in Photograph 79.

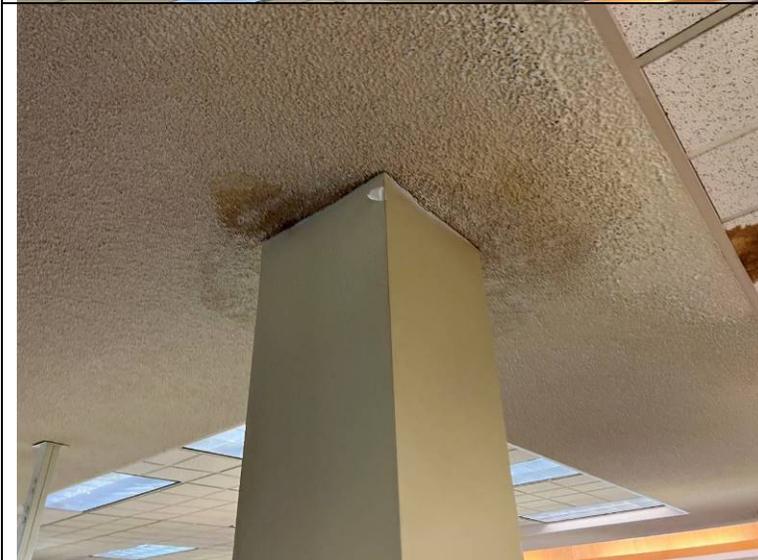
Photograph 81: Closer view of the stained ceiling in the general area shown in Photograph 79.

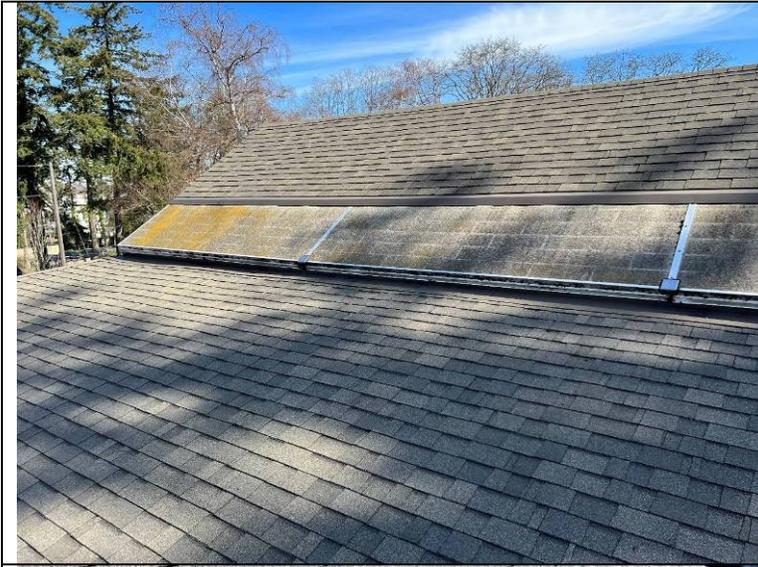
Photograph 88: Overview of the skylights at the upper roof.

Note the lichen growth on the surface of the skylight lenses.

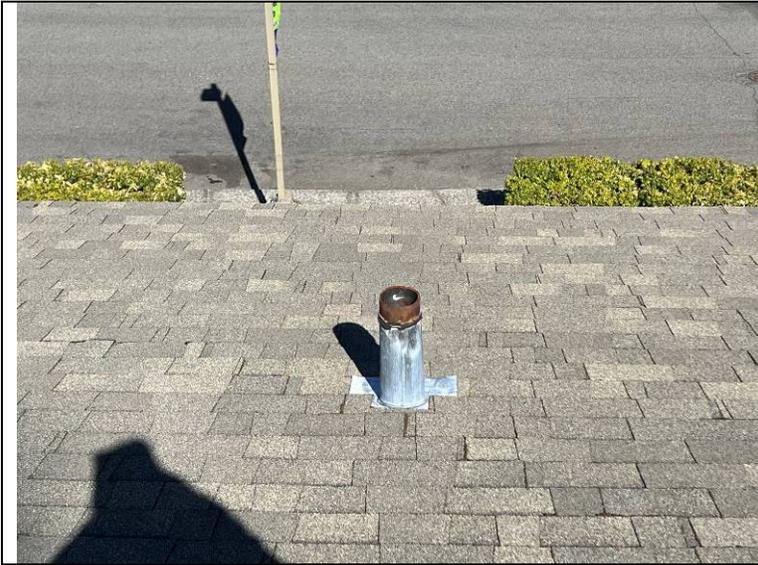
Photograph 97: Pipe penetration flashed with a lead flashing.

Note the lead flashing does not extend to the top of the penetration and is typically sealed with sealant.

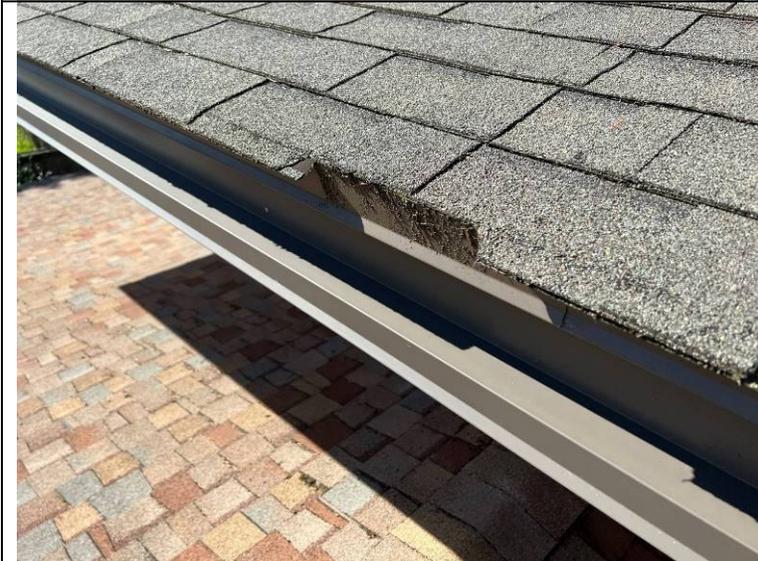
Photograph 104: Damaged shingle at the eave edge.

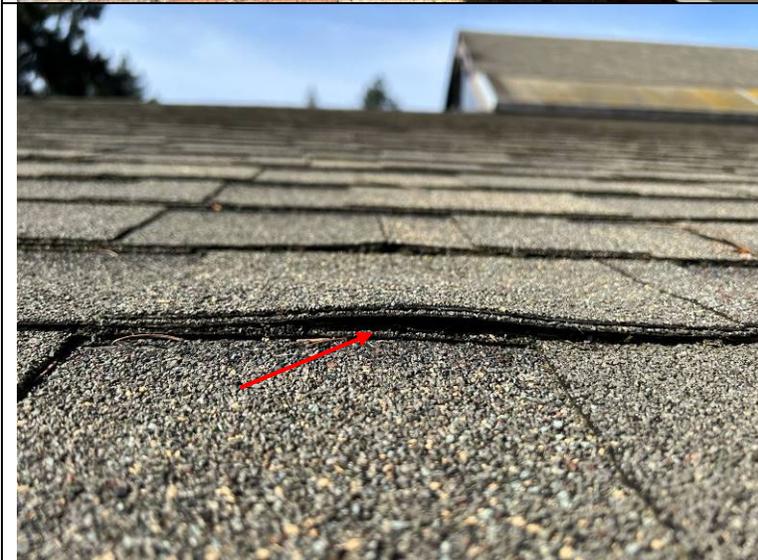
Photograph 105: Arrow indicates an apparent nail backing out and lifting the overlying shingle.

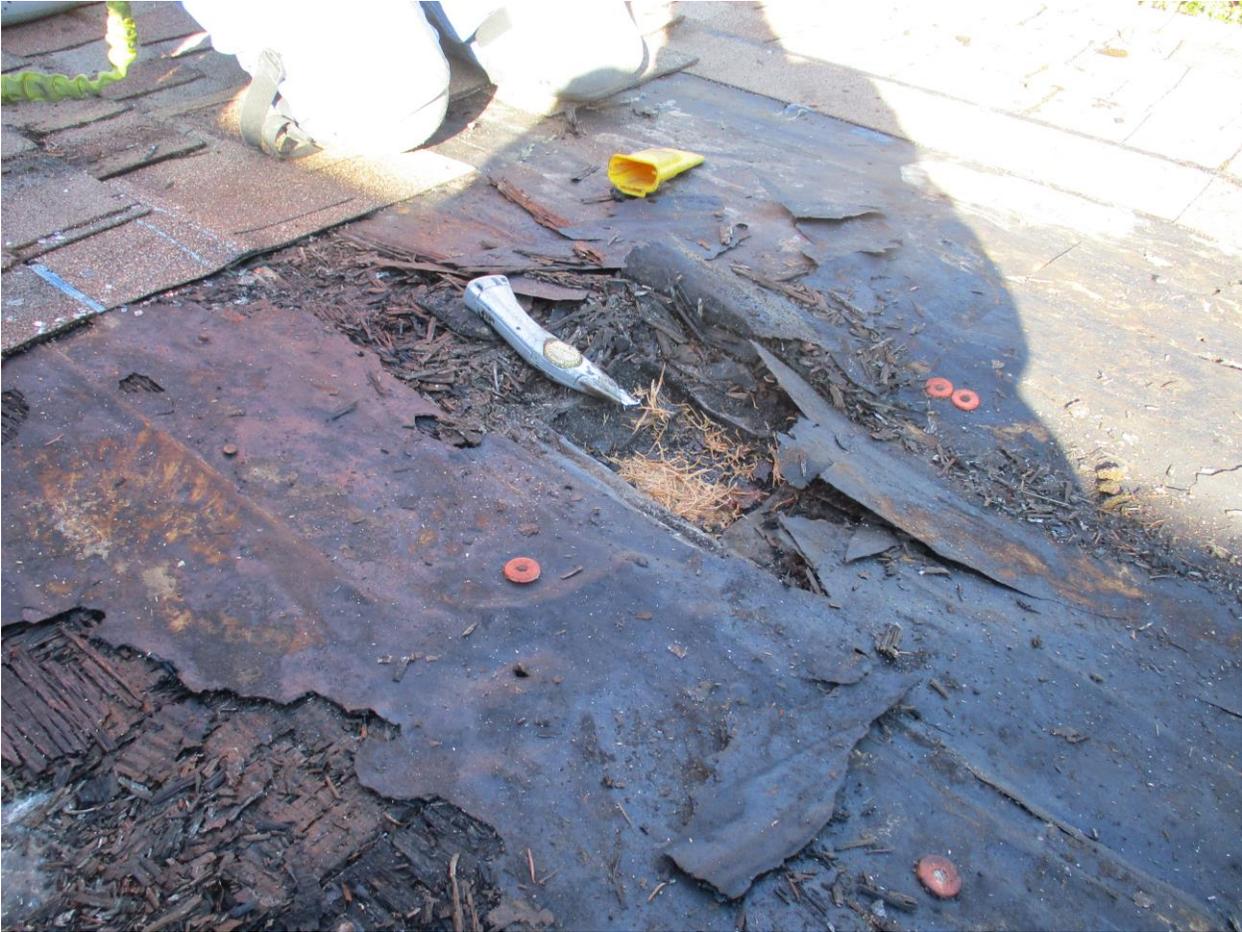
Photo 1 – Deteriorated Plywood Low Roof @ North

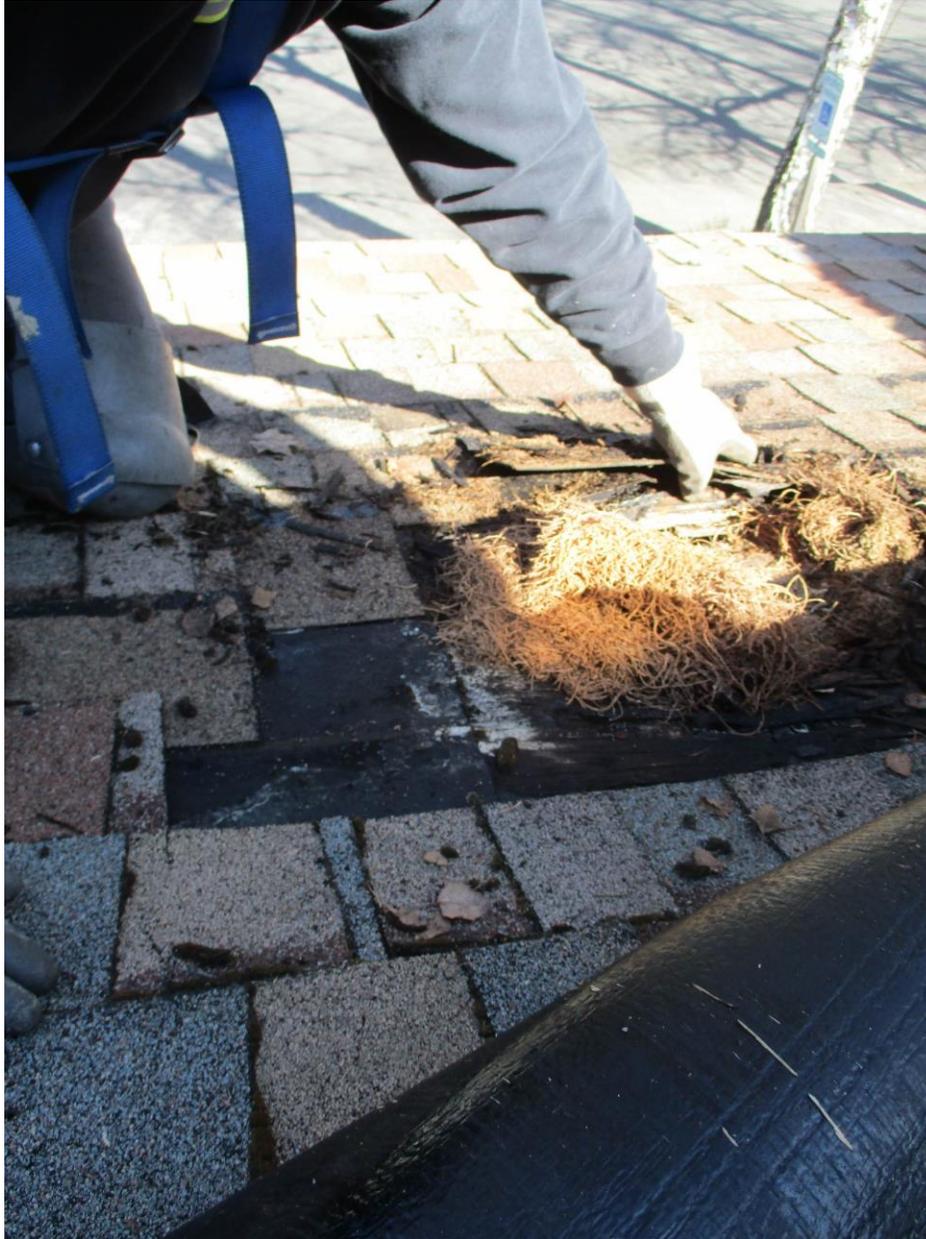
Photo 3 - Tectum Water Damage
