W E T H E R H O L T   A N D   A S S O C I A T E S ,   I N C .

**LAKWOOD LIBRARY  
ROOF EVALUATION  
MARCH 10, 2022**

Pierce County Library System  
3005 112<sup>th</sup> Street E  
Tacoma, WA 98446

April 1, 2022

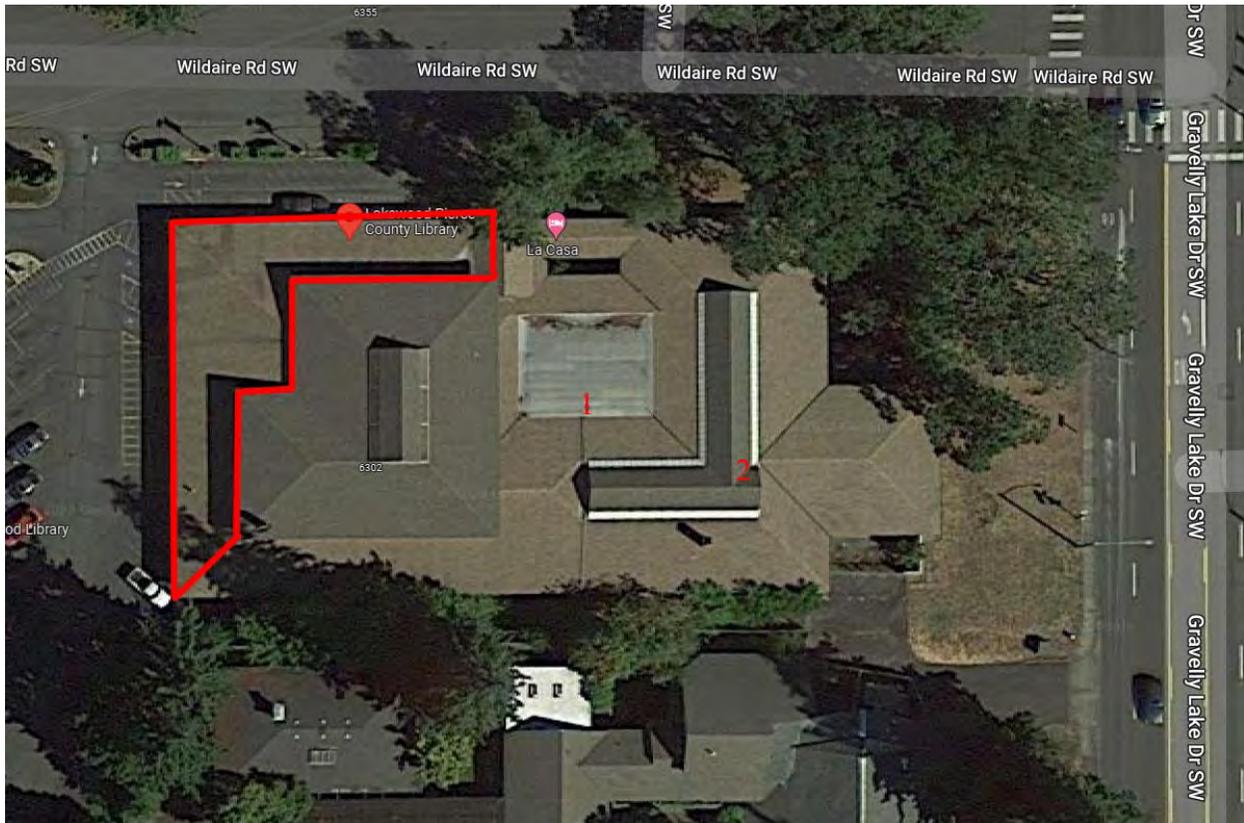
The area highlighted above are the north and west lower roof areas. The locations noted as 1 and 2 are the areas of water entry noted.

The low slope roof should be cleaned of organic debris, and the area where roof cement was applied should be patched with an application of Alsan RS. The surface of the roof should be prepped, and the patch should extend a minimum of 6-inches in all direction away from the damaged area. The approximate area of the temporary repair is marked with a 1 on the overview photo below.

A leak (marked with a 2) was reported in an area below the transition between the skylight and steep slope roof. Application of sealant at the skylight appears to be aged indicating that water entry in this location has likely occurred multiple times. A new application of roof cement at the bottom of the skylight by Wayne's Roofing prior to this writer's site visit has reportedly stopped the water entry. The skylight panels and area below can be cleaned and prepped and an application of Alsan RS can be applied over the area as a long-term patch.

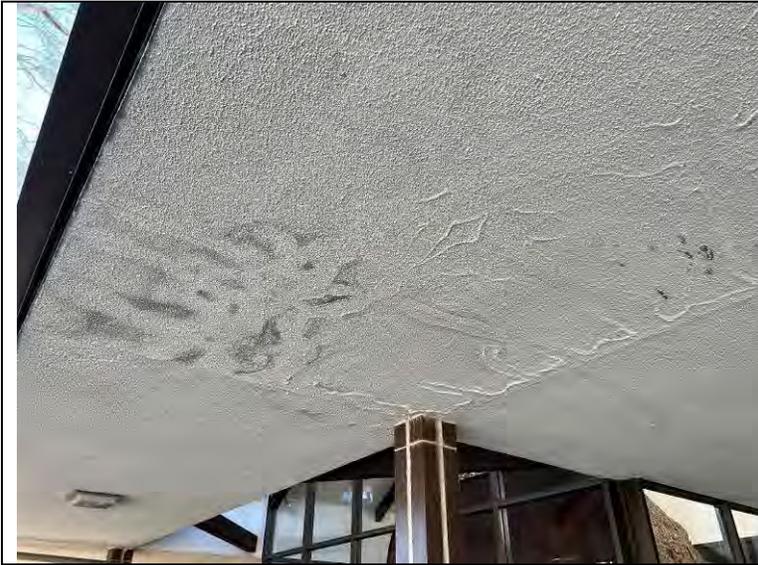
Photograph 4: Water staining at the soffit under the area where test openings were made.

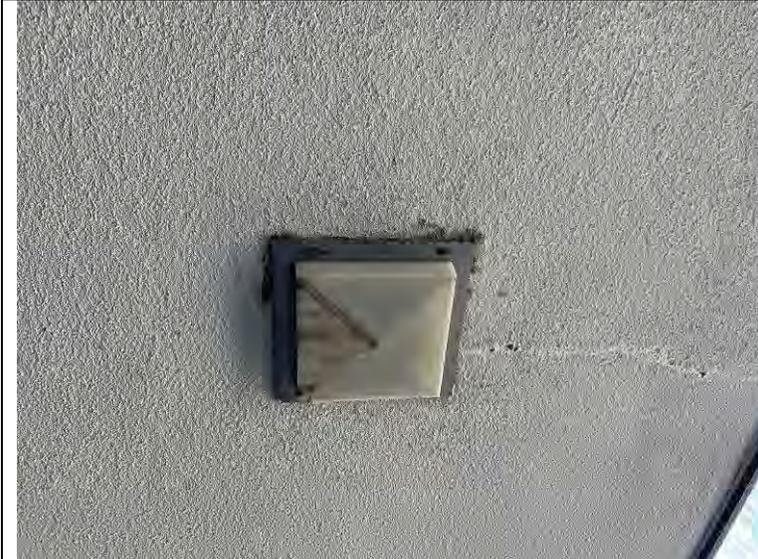
Photograph 5: Water staining at a light fixture in the soffit under the area where test openings were made.

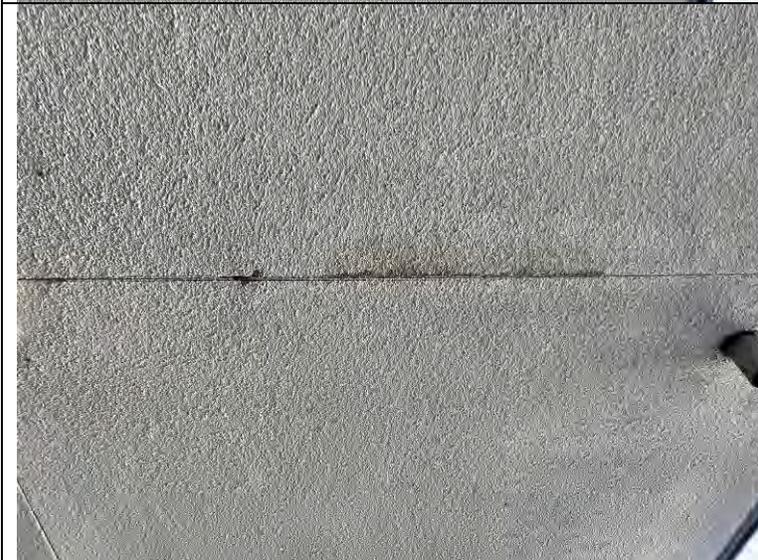
Photograph 6: Water staining at the soffit under the area where test openings were made.

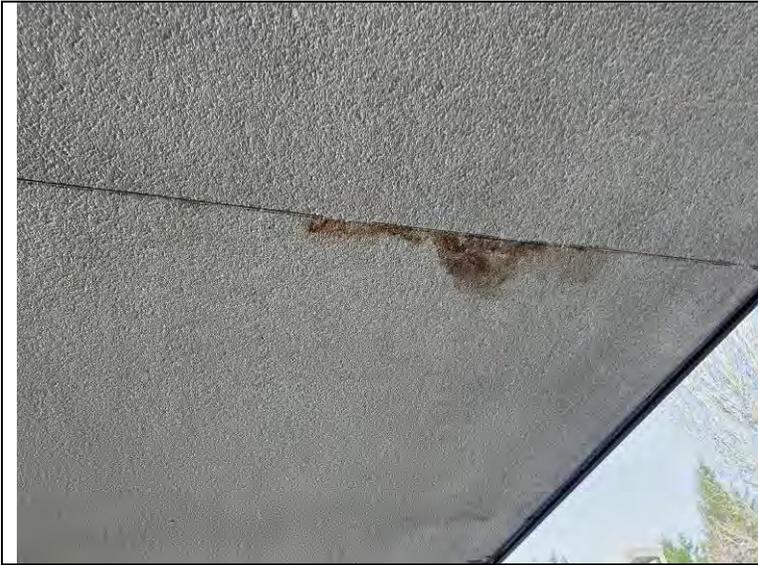
Photograph 7: Water staining at the soffit under the area where test openings were made.

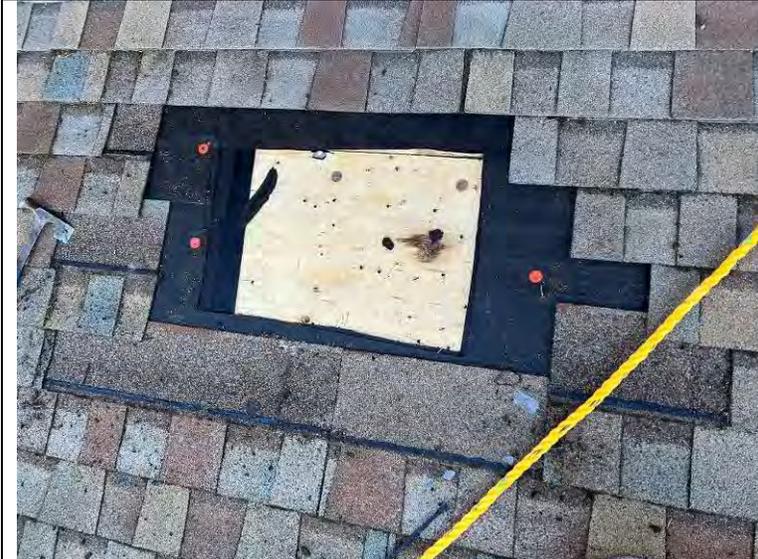
Photograph 8: Test opening #1 was situated under the overhang from the upper roof. The plywood at this location appears light in color and solid.

The underlayment was in good condition.

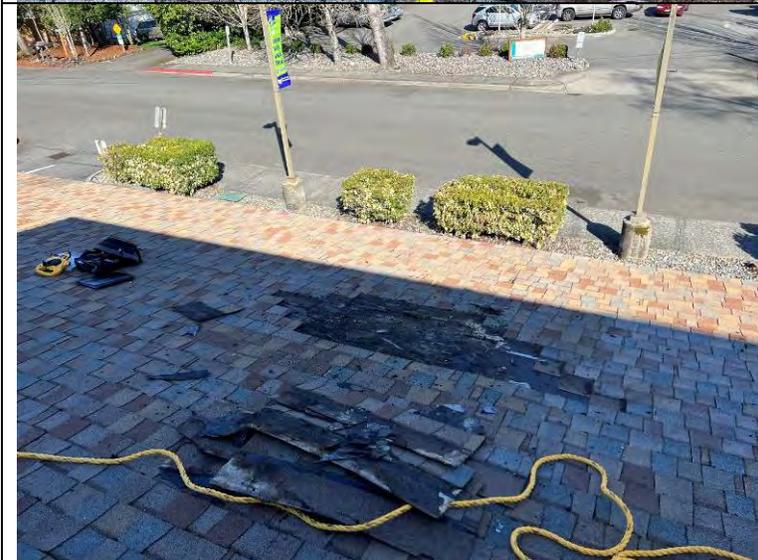
Photograph 9: Overview of test opening location #2.

The plywood at this location which was exposed is deteriorated and black in color.

The underlayment was deteriorated.

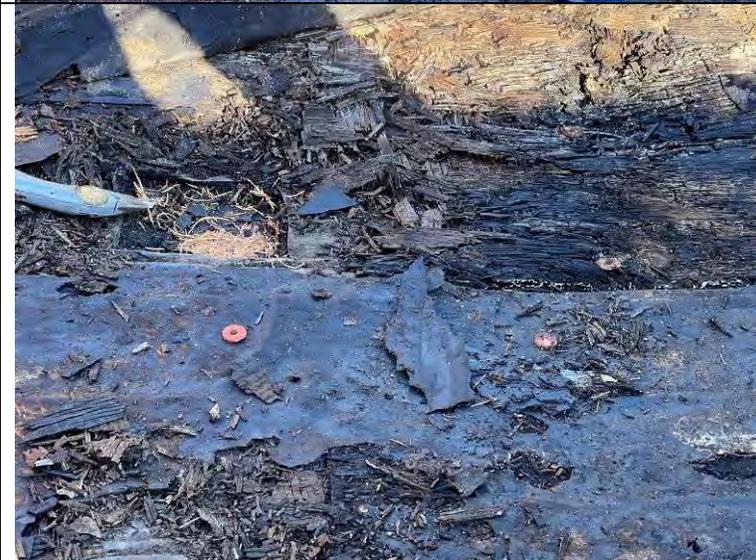
Photograph 12: Closer view of the area shown in Photograph 11.

Note the plywood sheathing and cementitious wood fiber are deteriorated.

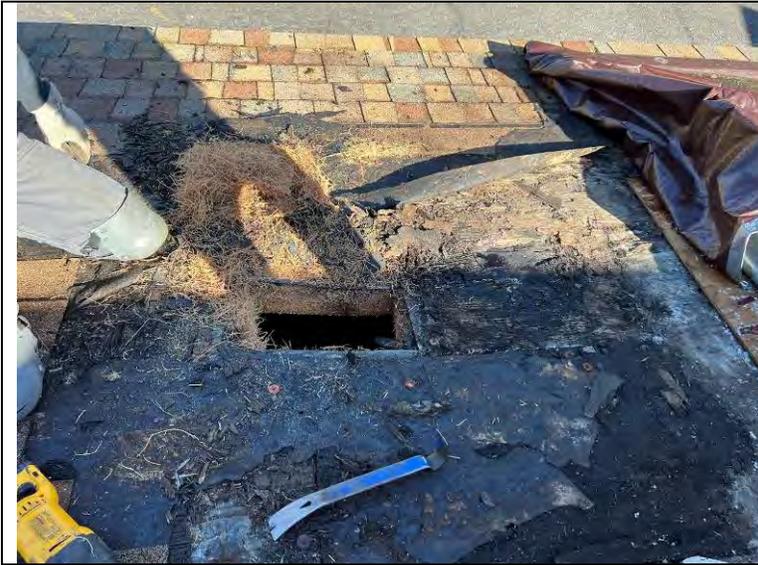
The cementitious wood fiber substrate board is deteriorated in many areas, and likely not serviceable to maintain a solid substrate for a new roof system. Where observed cementitious binder was washed away leaving only the wood fibers. The lack of binder has caused the cementitious wood fiber substrate board to weaken and deflect. The deflecting substrate boards cause the shingles to deflect, further exacerbating water entry as water can travel laterally creating further water entry and damage.

Photograph 13: Portion of the cementitious wood fiber substrate was removed to provide visual access to the structure below.

Note the cementitious wood fiber substrate board is deteriorated.

The lower roof areas to the north and west of the second story (west half of the building) are no longer serviceable. The existing roof system, plywood, and cementitious wood fiber substrate board should be removed to expose the steel structure. Any needed repairs to the steel structure should be performed once exposed. This scope of work will create a condition where the interior under the roof areas noted will be exposed to weather.

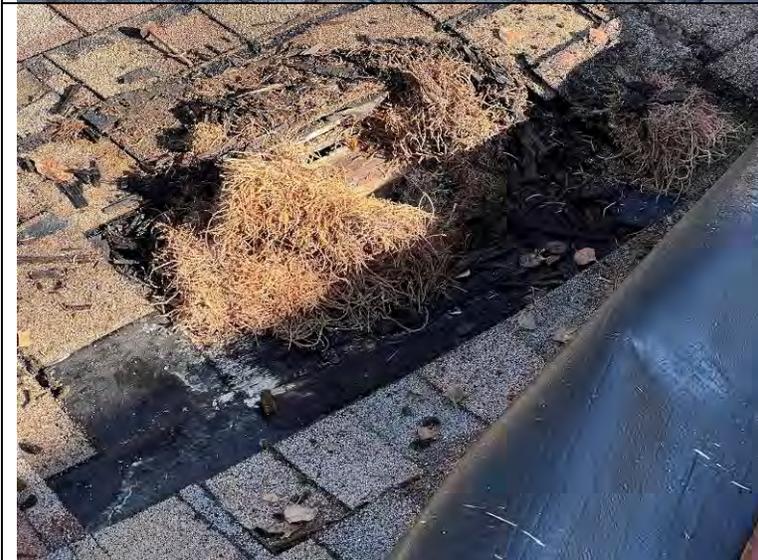
Photograph 18: Cementitious wood fiber substrate board removed at test opening #4.

Similar to test opening #3 the cementitious binder has washed away and only the wood fibers remained.

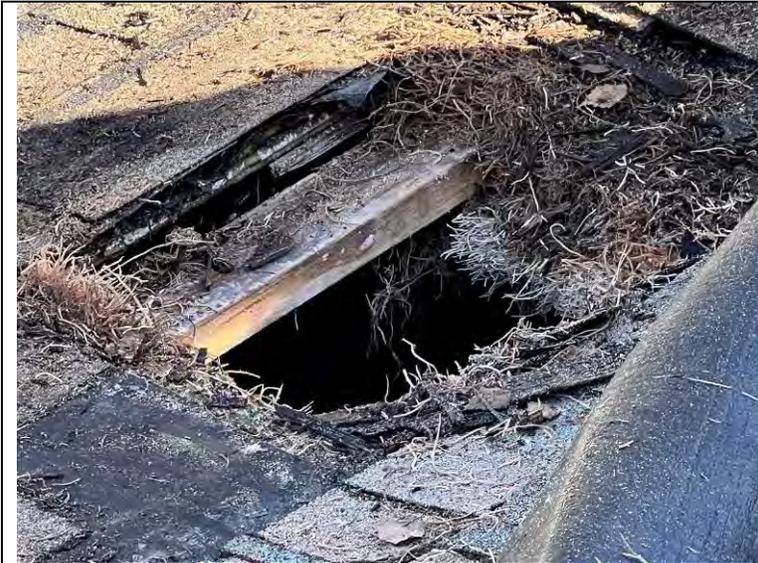
Photograph 19: Closer view of test opening #4 showing the deteriorated cementitious wood fiber substrate board.

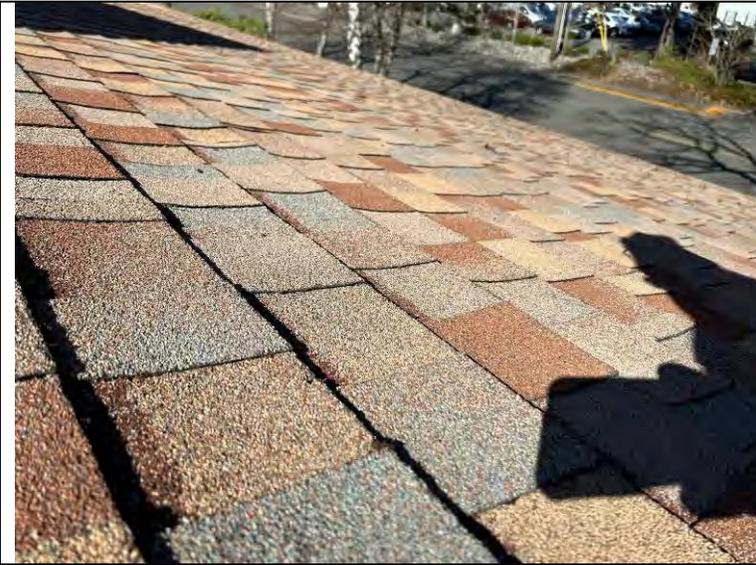
Cupping shingles were noted at the lower north sloping roof area adjacent to the second story, minor mineral granule loss, and cracked shingles were noted at the lower south slope roof areas. The cracking shingles should be carefully removed and replaced with matching shingles. Moss growth was observed at the perimeters of the upper roof areas, if desired the moss can be cleaned from the surface of the roof with a medium bristle push broom, removal of the moss is not necessary. Nails were observed backed out and penetrating the overlying shingles at the east sloping roof at the east half of the building. At the east sloping upper roof nails were observed to be backed out but not penetrating the overlying shingles. Backed out nails not penetrating the overlying shingles should be driven and the overlying shingle hand tabbed down. Where nails have penetrated the overlying shingles, the nails should be driven and the overlying shingle replaced with new to match the existing.

Photograph 25: Slight curling or cupping of the Tamko shingles was observed in various areas of the roof.

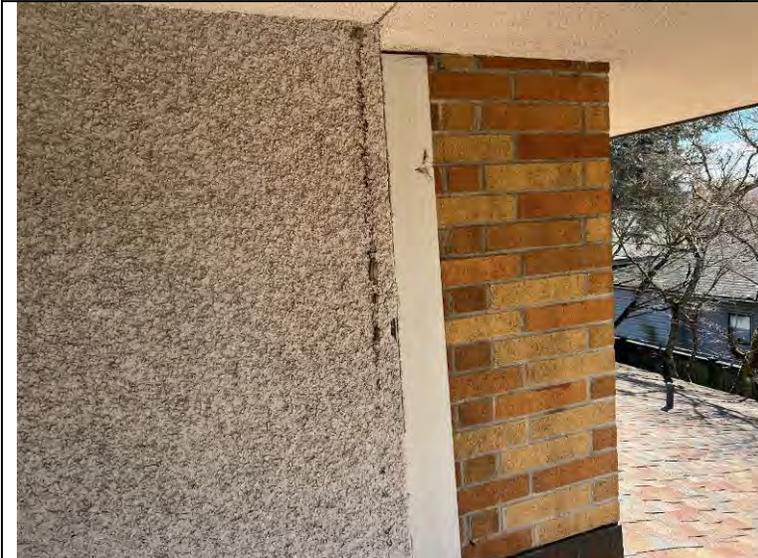
Photograph 36: Closer view of the damage shown in Photograph 35.

Damaged marblecrete at the rising walls above the lower roof areas, should be cut out and patched with new marblecrete. Holes in the soffits should be covered or patched.

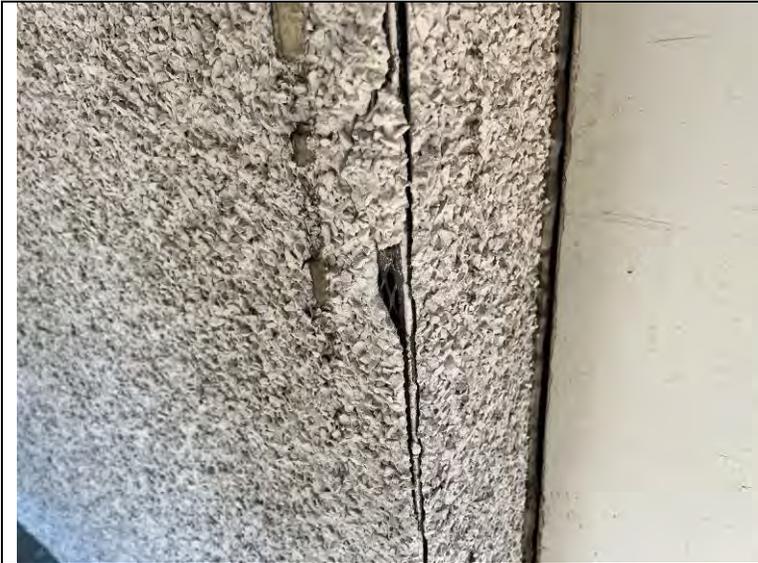
Photograph 37: Closer view of the area shown in Photograph 35.

Damage is likely due to age, settling, and differential movement.

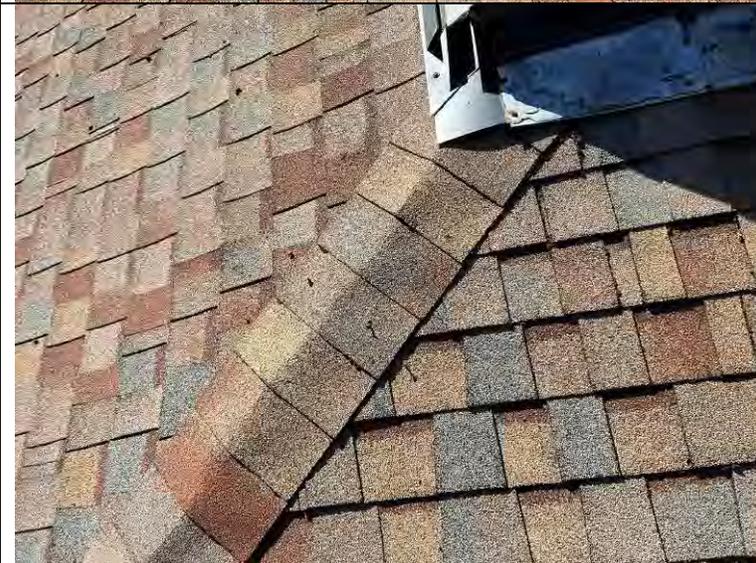
Photograph 47: Closer view of the backed-out nails.

Note Wayne's Roofing personnel drove the nails in and applied roof cement over the nail heads as a temporary measure.

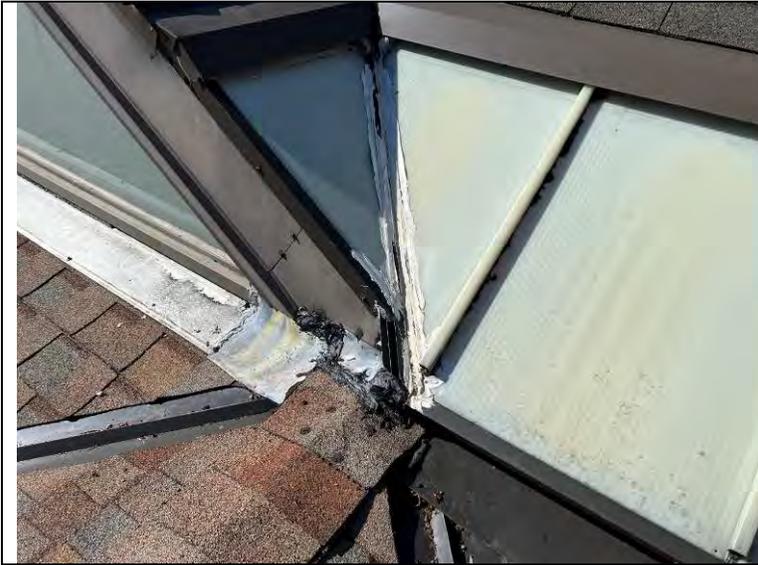
Photograph 52: Closer view of the area shown in Photograph 51.

Roof cement appears to have been applied in response to the previous water entry.

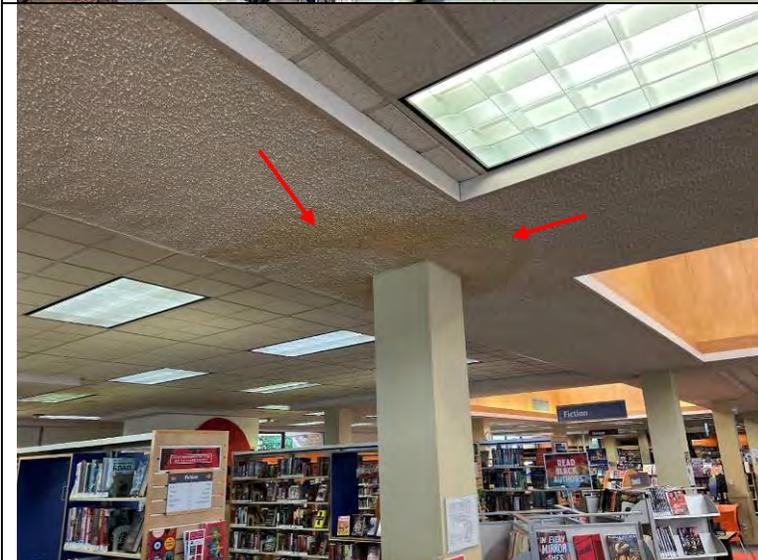
Photograph 54: Area below the area circled in Photograph 51.

Arrows indicate apparent water staining on the ceiling.

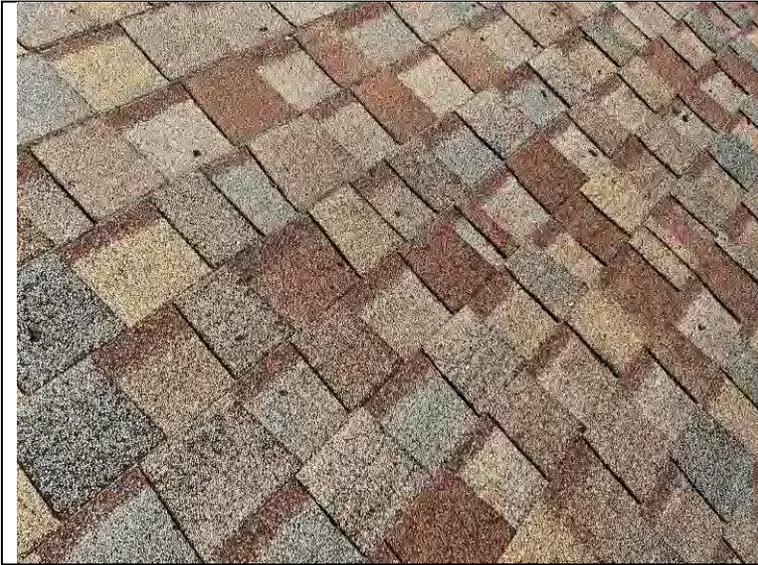
Photograph 61: At the south sloping roofs, the mineral granules are eroding from the surface of the shingles.

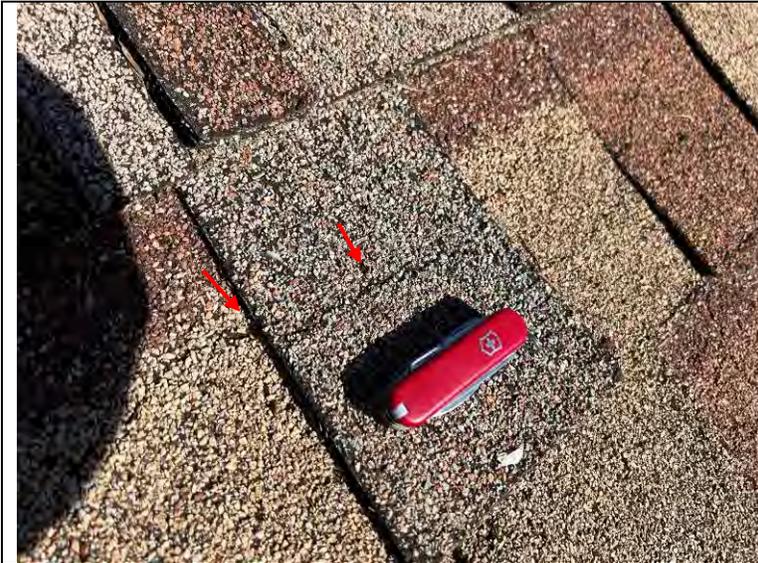
Photograph 64: Cracked shingles at the south sloping roof. (Arrows)

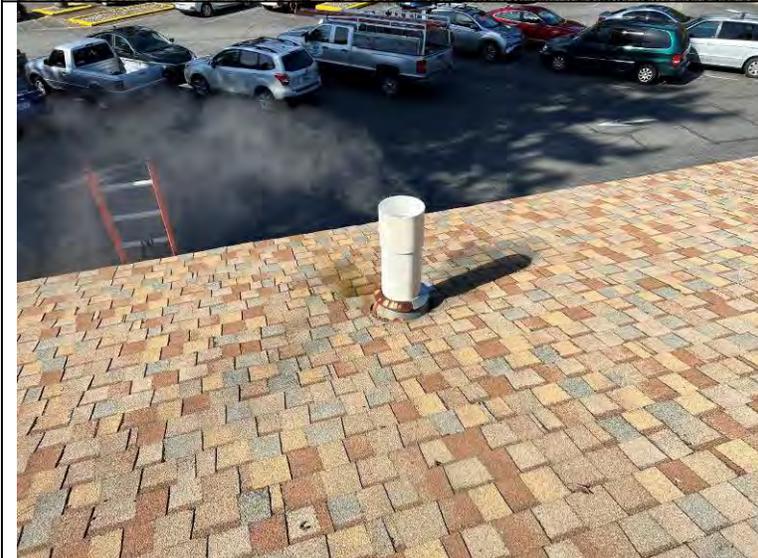
Photograph 65: Boiler vent penetration.

The PVC penetration is flashed with a b-vent, with a storm collar above the flashing.

The storm collar is rusty.

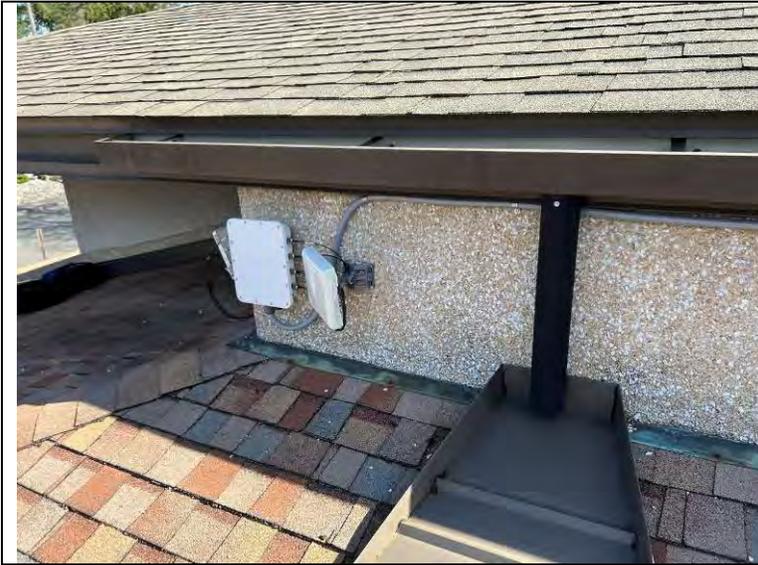
Photograph 67: Equipment mounted to the exterior wall through the marblecrete.

The fastener penetrations are not sealed.

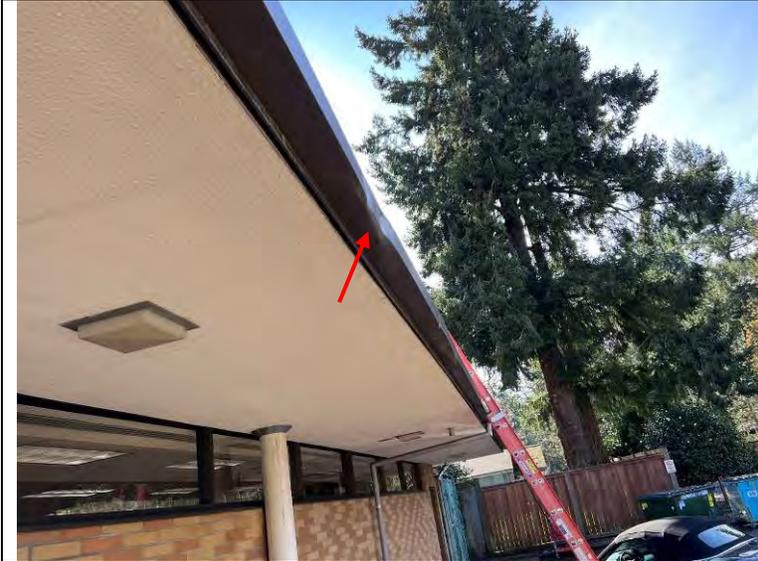
Photograph 68: Damaged gutter (arrow) at the west side of the roof.

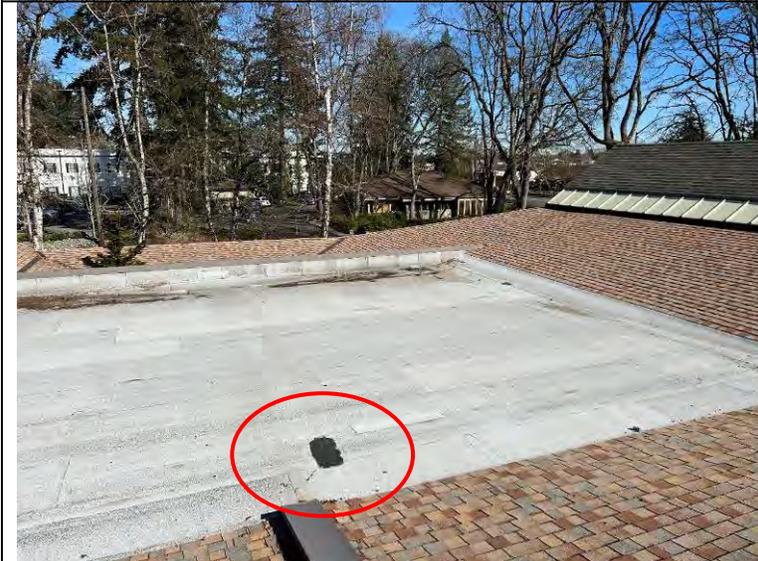
Photograph 77: Roof cement patch over an apparent location of damage.

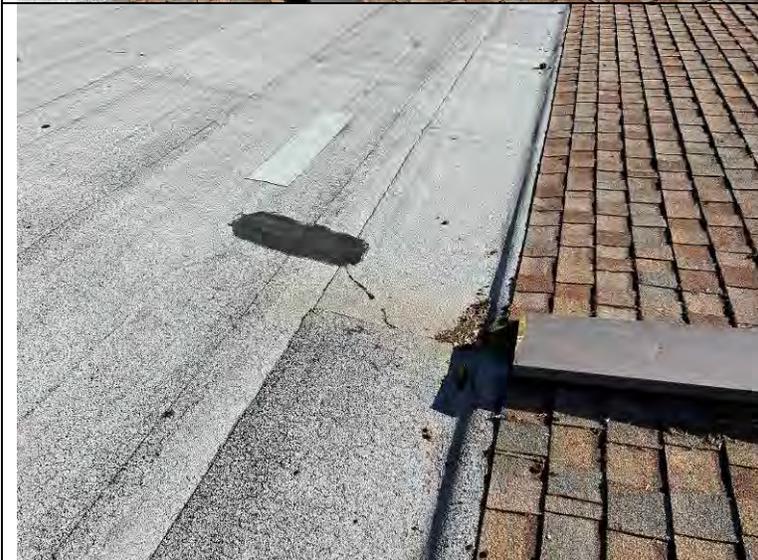
Photograph 78: Closer view of the roof cement patch circled in Photograph 77.

Note the repair was performed by Wayne's Roofing in response to previous water entry.

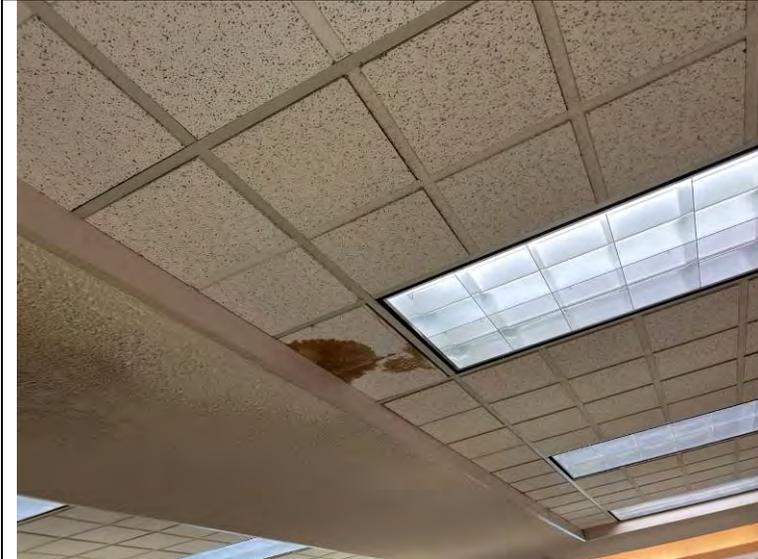
Photograph 80: Closer view of stained ceiling tiles shown in Photograph 79.

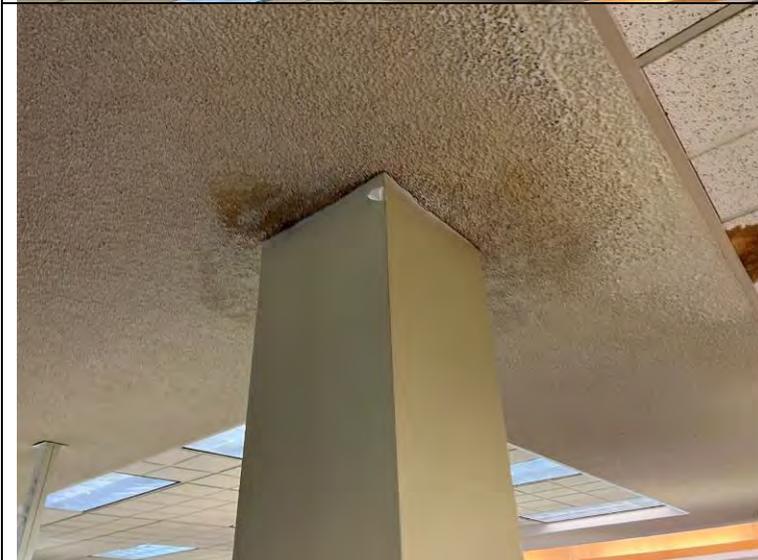
Photograph 81: Closer view of the stained ceiling in the general area shown in Photograph 79.

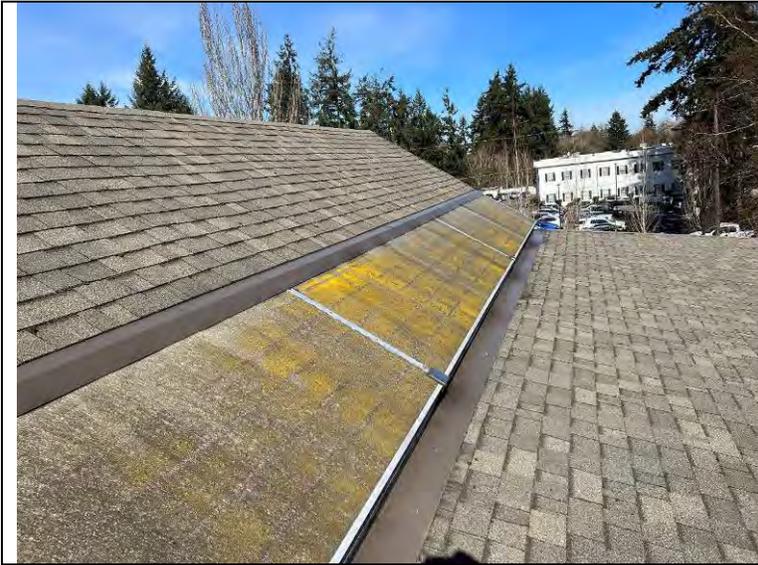
Photograph 91: Looking laterally across the skylight.

The skylight lens is discolored and has lichen growing on it.

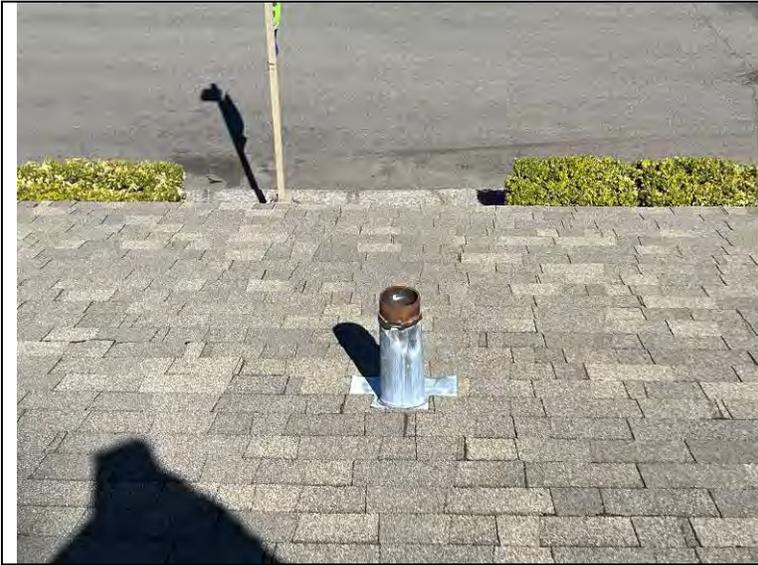
Photograph 97: Pipe penetration flashed with a lead flashing.

Note the lead flashing does not extend to the top of the penetration and is typically sealed with sealant.

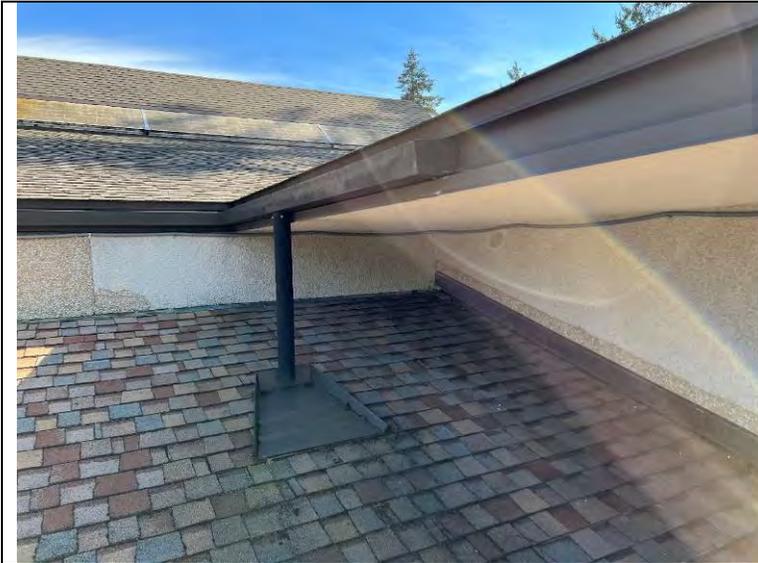
Photograph 100: Downspout and splash pad.

Repair to the marbled concrete can be seen in the background of the photo. The darker colored marbled concrete is the newer patched areas.

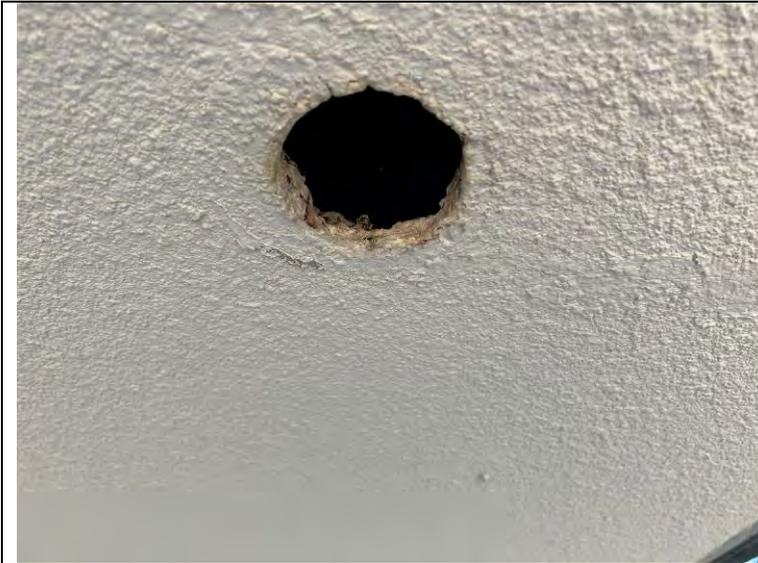
Photograph 103: Closer view of the hole indicated by the arrow in Photograph 102.

Holes in the soffit should be covered to prevent rodent or insects from entering into the building.

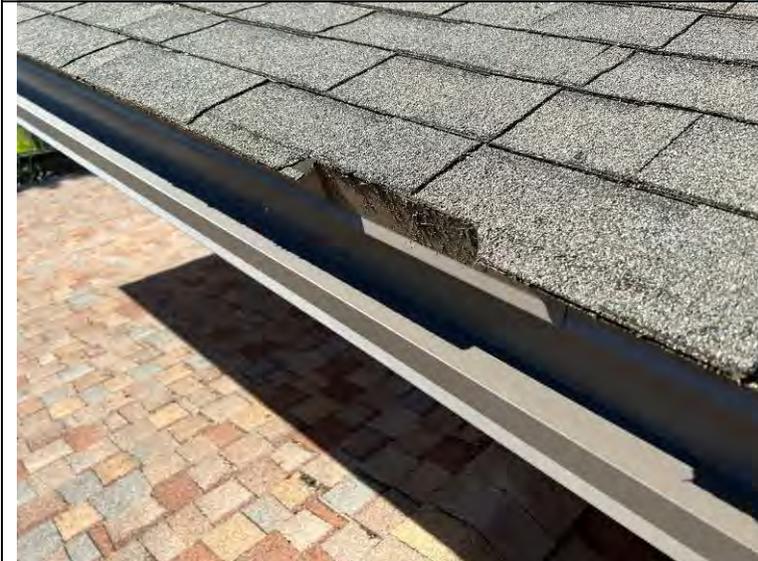
Photograph 104: Damaged shingle at the eave edge.

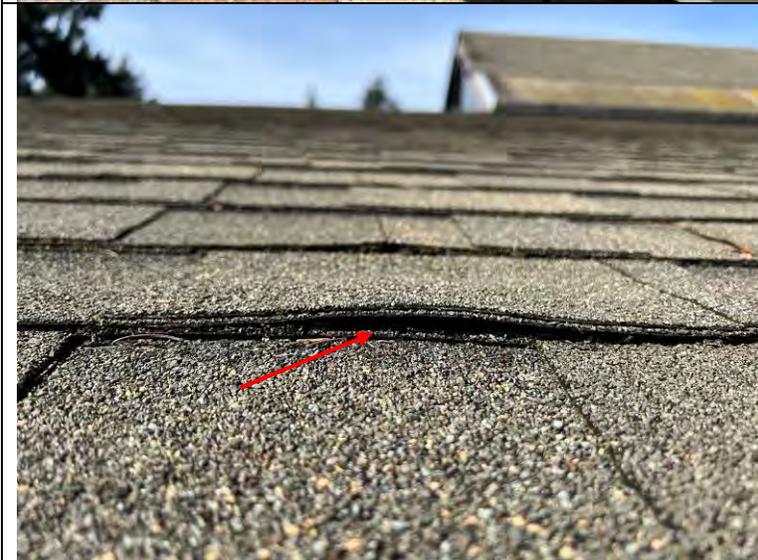
Photograph 105: Arrow indicates an apparent nail backing out and lifting the overlying shingle.
