Pierce County Library System

Condition Assessment Report for Lakewood Library and Tillicum Library

October 20, 2021

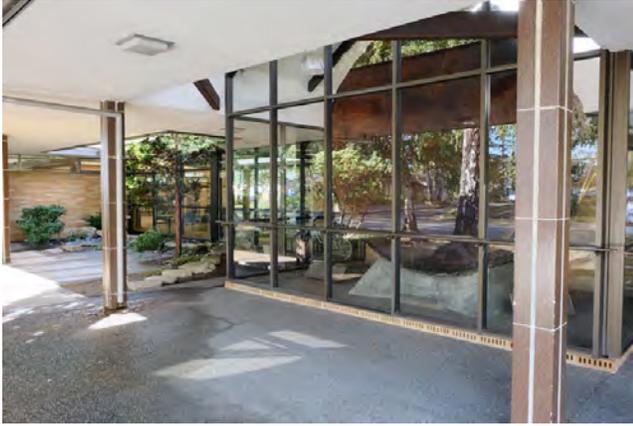
Windows near entry

Windows are original, single pane and insulated units in wood frames.
All are in poor condition and/or do not meet current energy code requirements.
All wondows should be replaced with new.

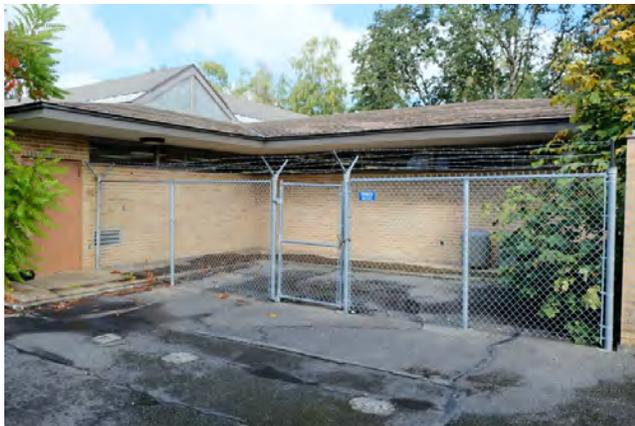
Fenced area at NE presents a security problem

Safety and security of the site needs to be addressed - areas of the site are open to the public yet hidden from view. Unauthorized access to the service areas and to the roof of the building occur.

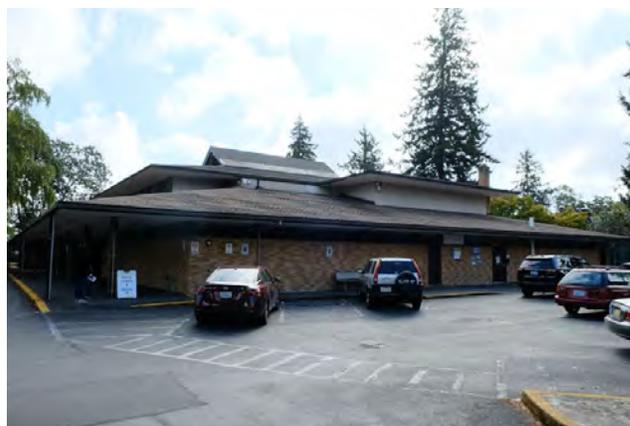
Parking lot

Need new surfacing, layout, and striping

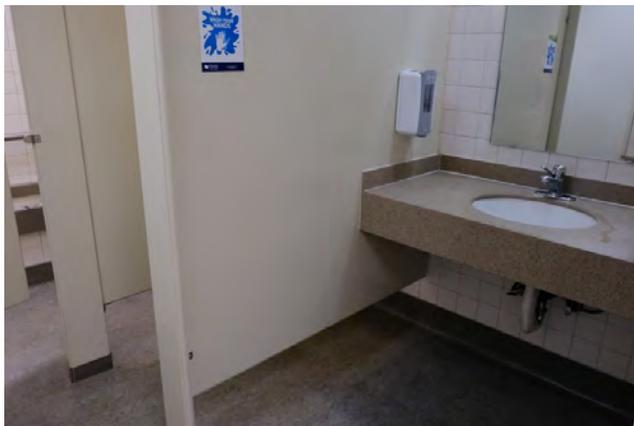
Public Restroom

Public restrooms are not ADA compliant. Need to be renovated / enlarged.

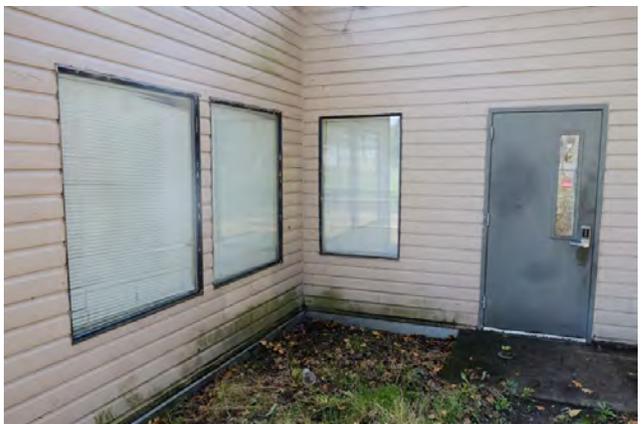
North-east exterior walls with evident ewater damage

The wood siding has deteriorated to a critical condition. A visual inspection shows that the building has significant water intrusion through the roof and the siding. It is likely that mold and rot is occurring inside the wall cavity and to the wall framing. The condition is severe and not acceptable for a public facility.

- remove existing siding and replace damaged framing, remove mold damage
- new insulation, new sheathing, weather barrier, and flashing
- new siding, trim, and paint
- new windows and exterior doors
- new roofing

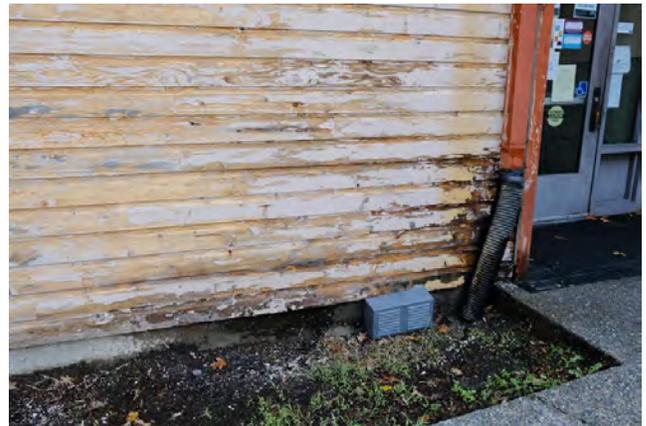
Exterior wall water damage and deterioration

As noted above - severe deterioration of the exterior wood siding, resulting in water intrusion and damage to the wall assembly.

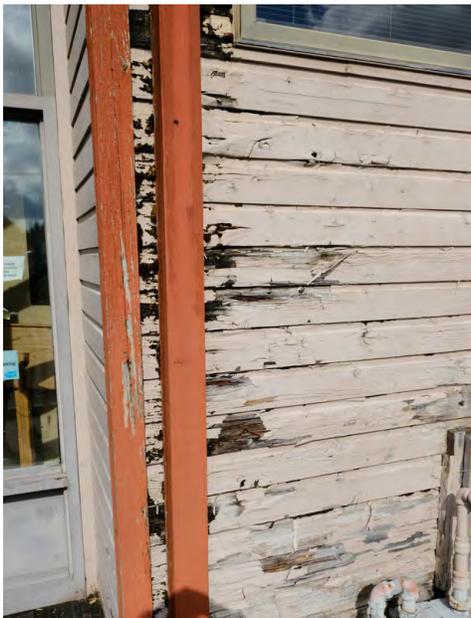
Exterior wall water damage and deterioration

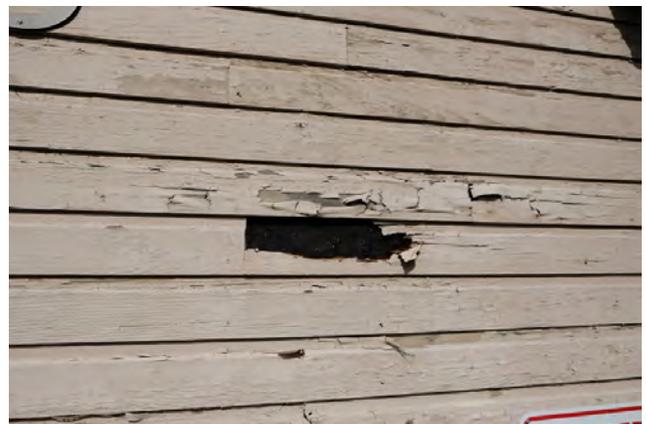
Exterior wall water damage and deterioration

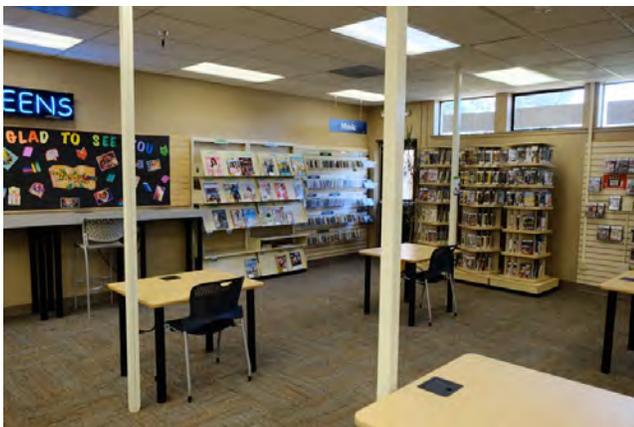
Reading Room with interior columns
