Special Meeting of the Pierce County Library System Board of Trustees September 22, 2022 | 3:30 p.m.

The meeting will be held in person at: 3005 112th St E, Tacoma WA 98446

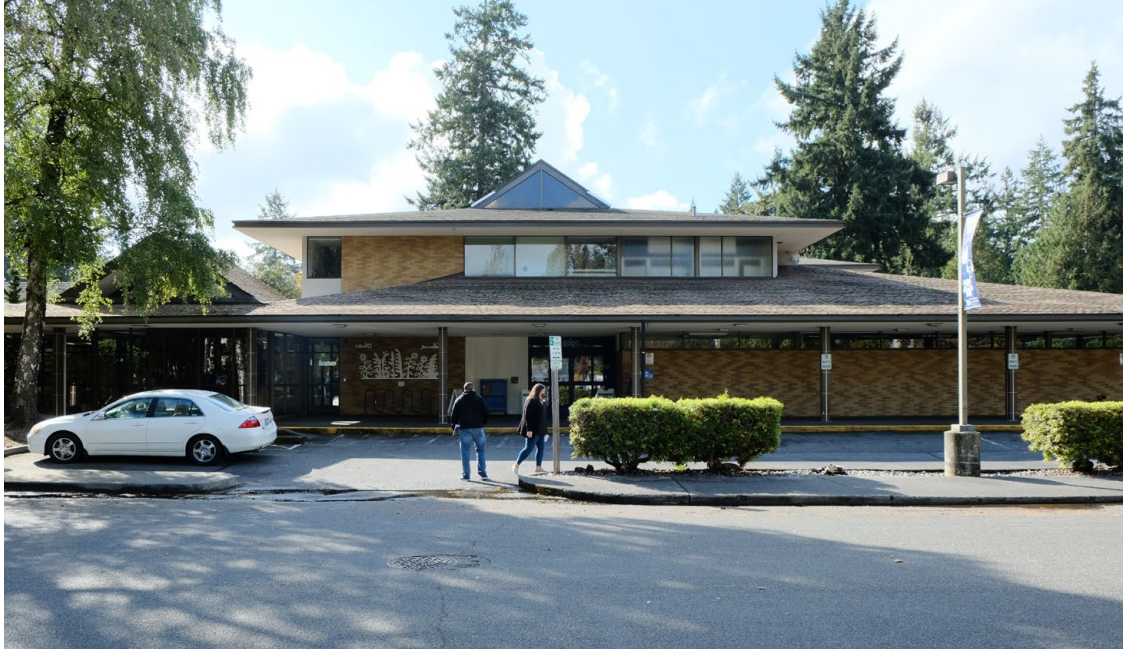
Matt Aalfs AIA
Principal

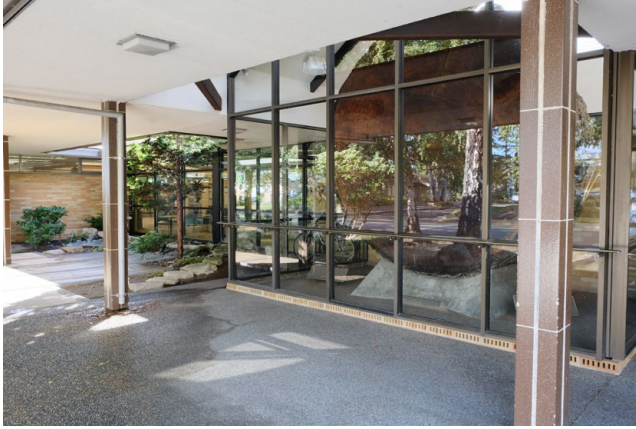
Lakewood Library Photo Survey

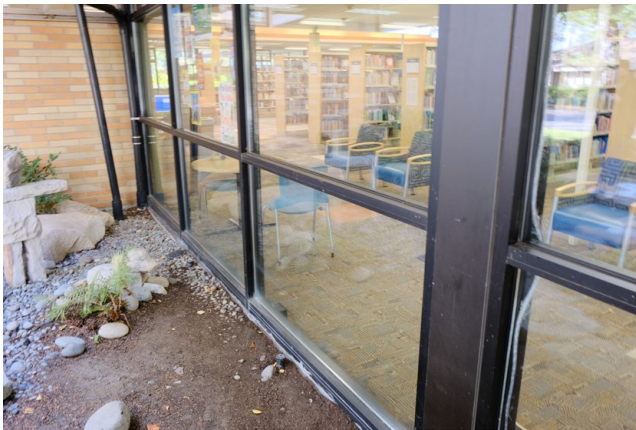
Windows near entry with failed glazing seals

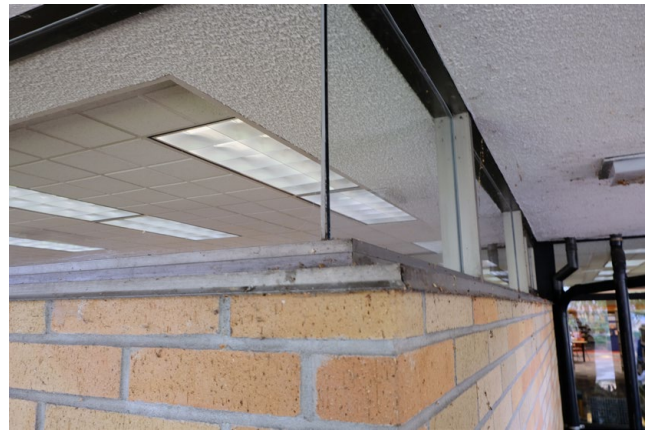
Single pane windows with failed seal at corner joint

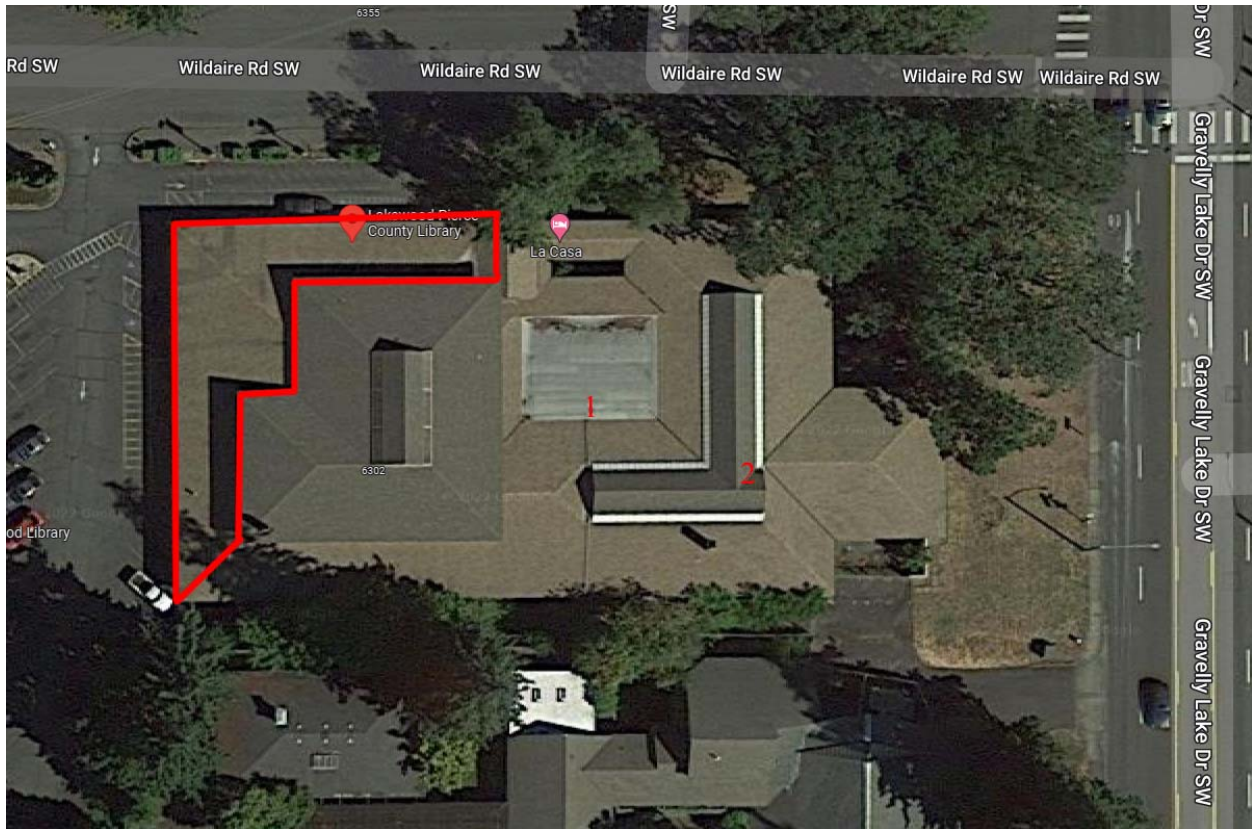
The area highlighted above are the north and west lower roof areas. The locations noted as 1 and 2 are the areas of water entry noted.

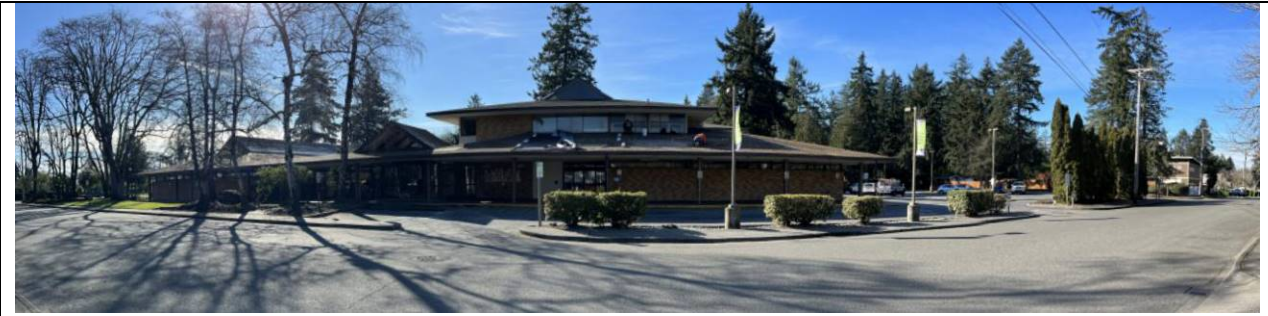
Photograph 1: Overview of the north elevation of the Lakewood Library.

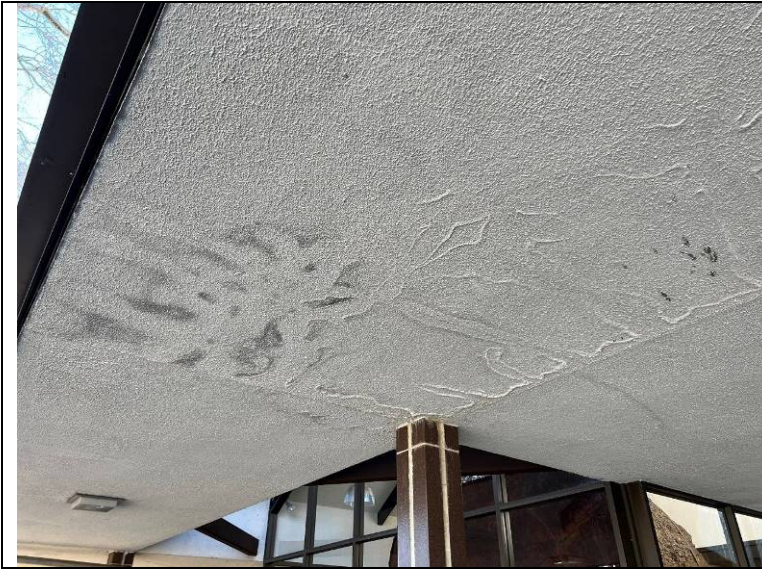
Photograph 4: Water staining at the soffit under the area where test openings were made.

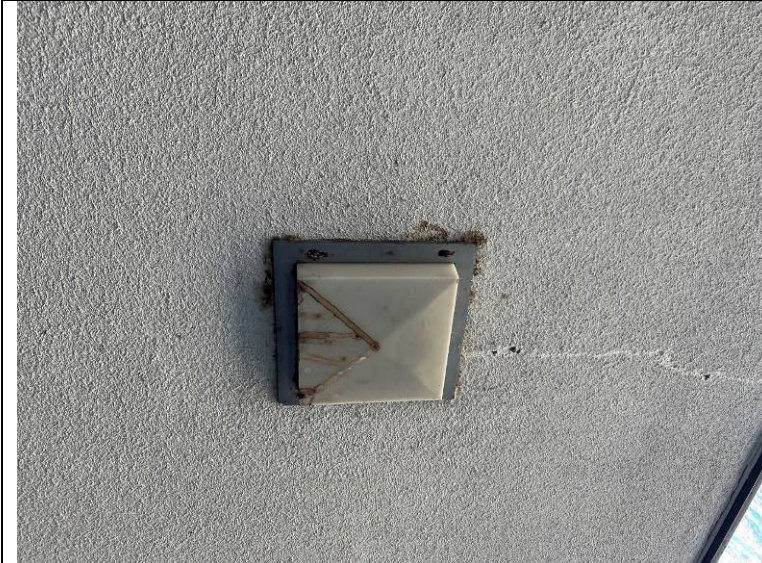
Photograph 5: Water staining at a light fixture in the soffit under the area where test openings were made.

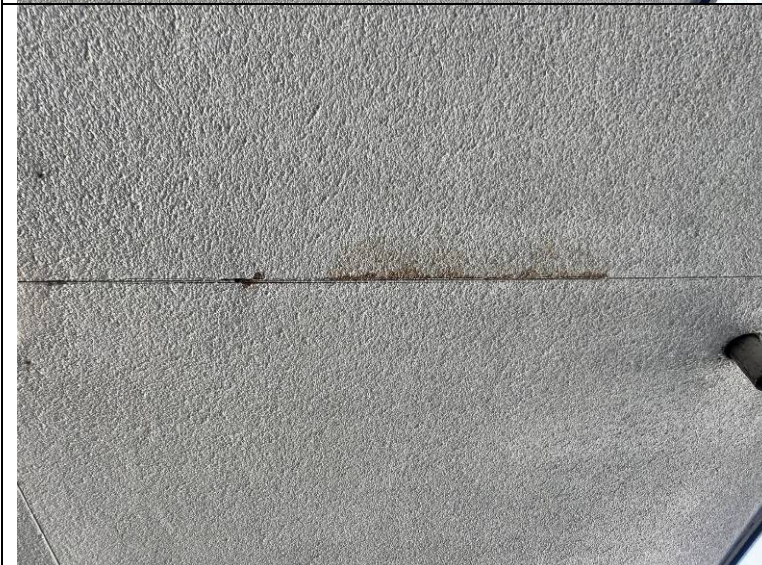
Photograph 6: Water staining at the soffit under the area where test openings were made.

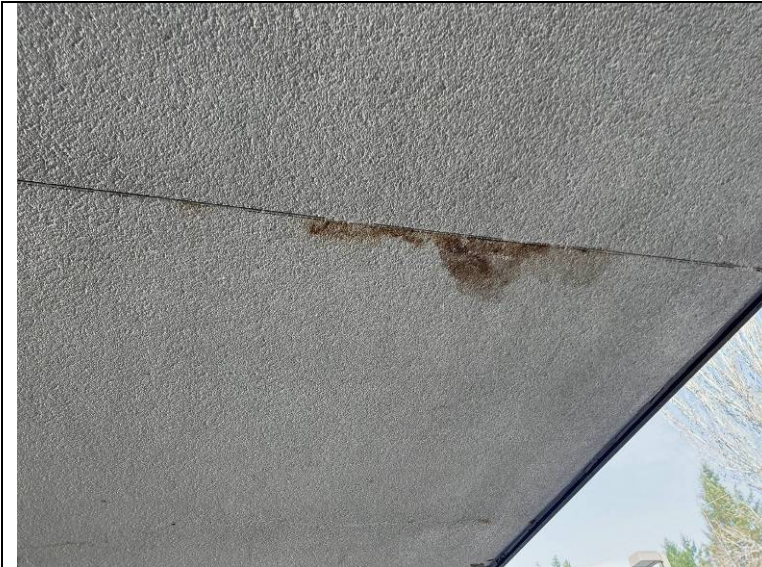
Photograph 7: Water staining at the soffit under the area where test openings were made.

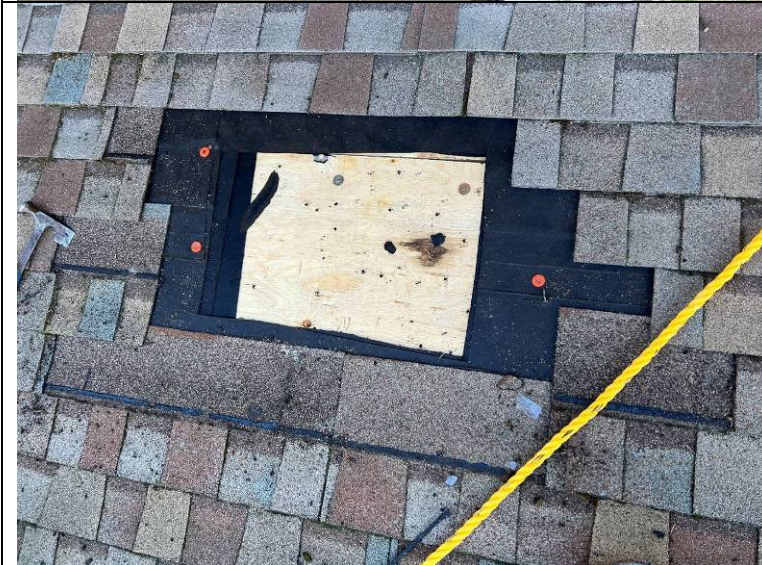
Photograph 8: Test opening #1 was situated under the overhang from the upper roof. The plywood at this location appears light in color and solid.

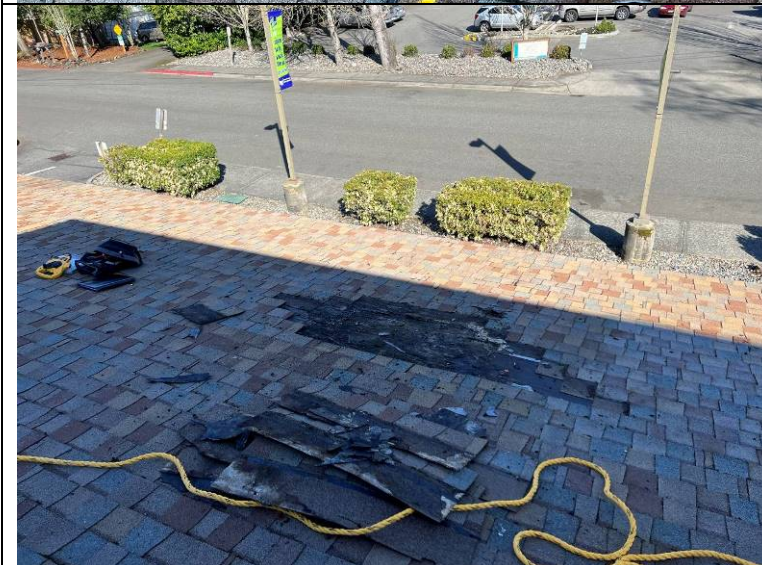
Photograph 9: Overview of test opening location #2.

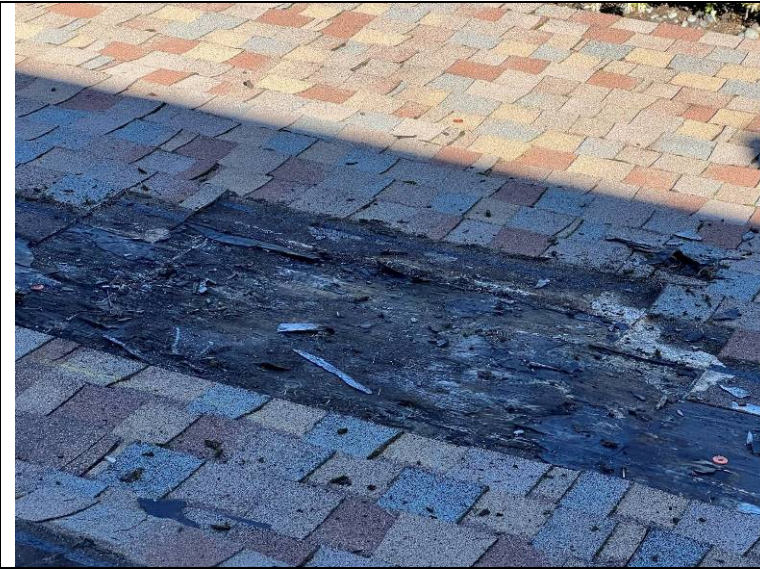
Photograph 10: Closer view of the area shown in Photograph 9.

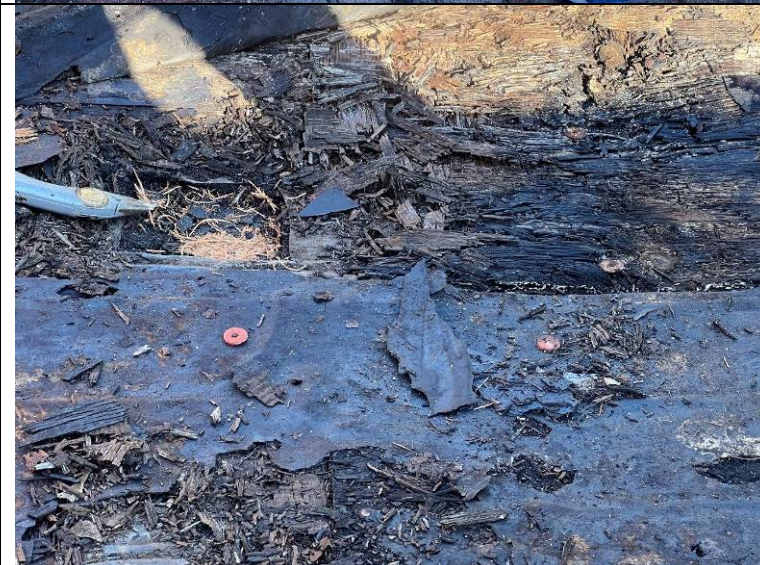
Photograph 12: Closer view of the area shown in Photograph 11.

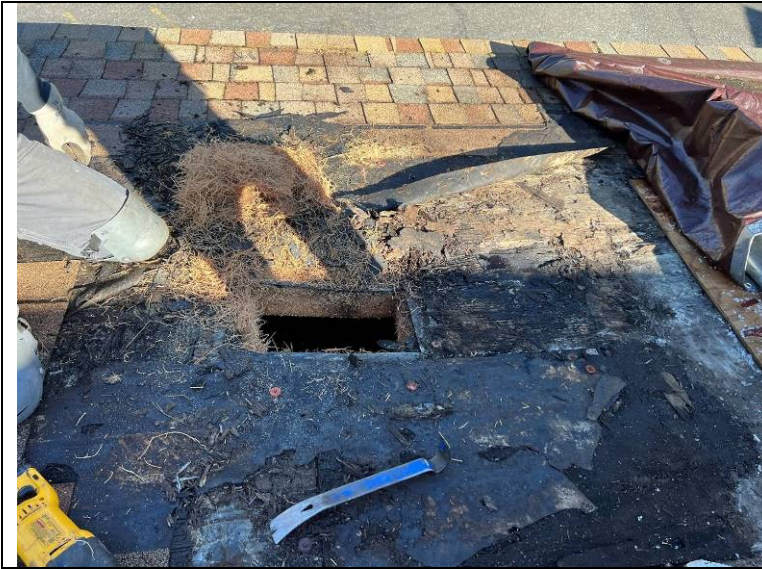
Photograph 13: Portion of the cementitious wood fiber substrate was removed to provide visual access to the structure below.

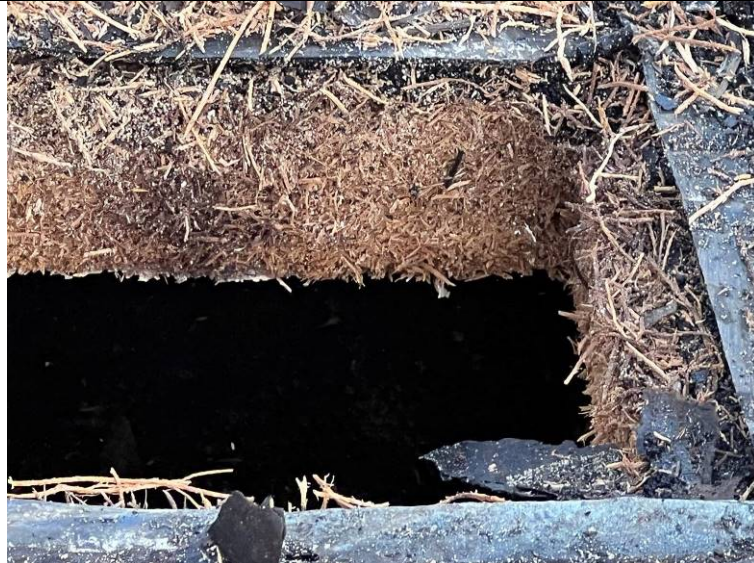
Photograph 14: Closer view of the cementitious wood fiber substrate board at the test opening.

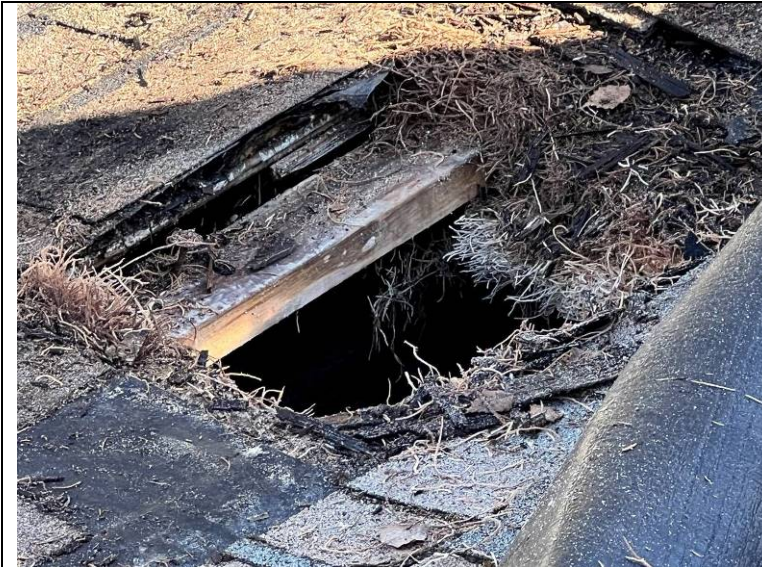
Photograph 19: Closer view of test opening #4 showing the deteriorated cementitious wood fiber substrate board.

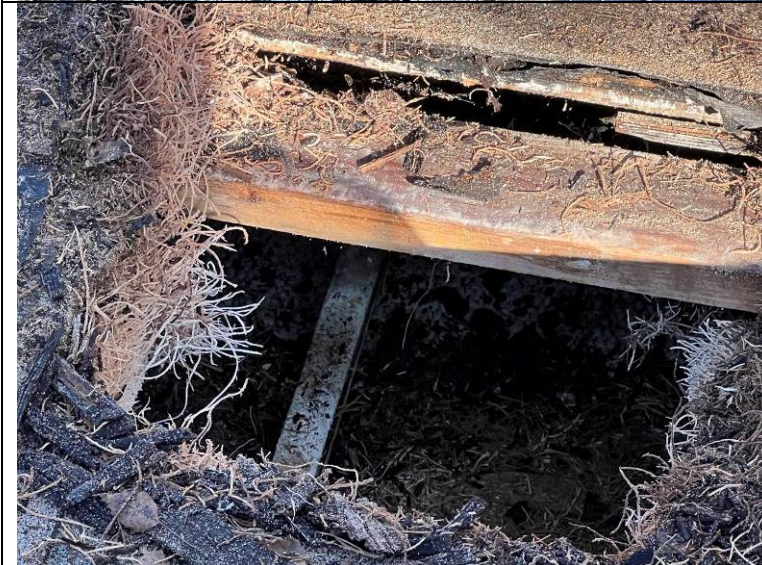
Photograph 20: Alternate view of the area shown in Photograph 19.

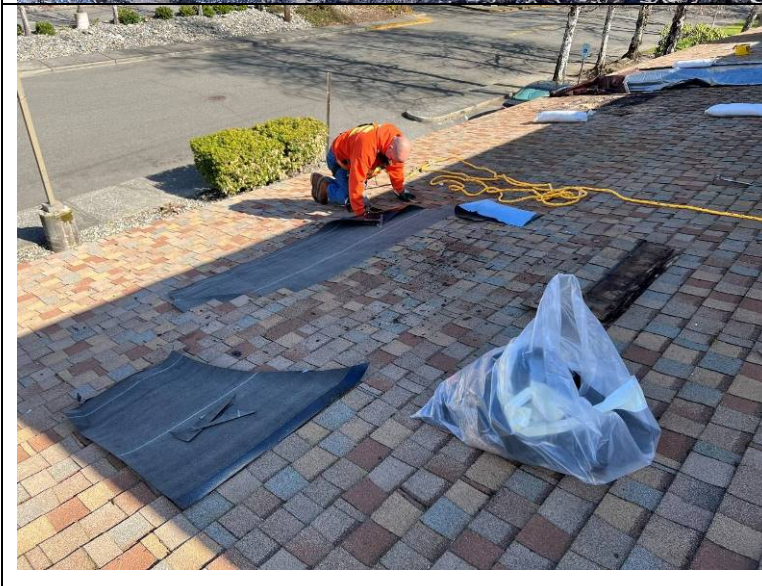
Photograph 21: Temporary roof repairs were made with self-adhered membrane integrated into the shingles in a water shedding manner.

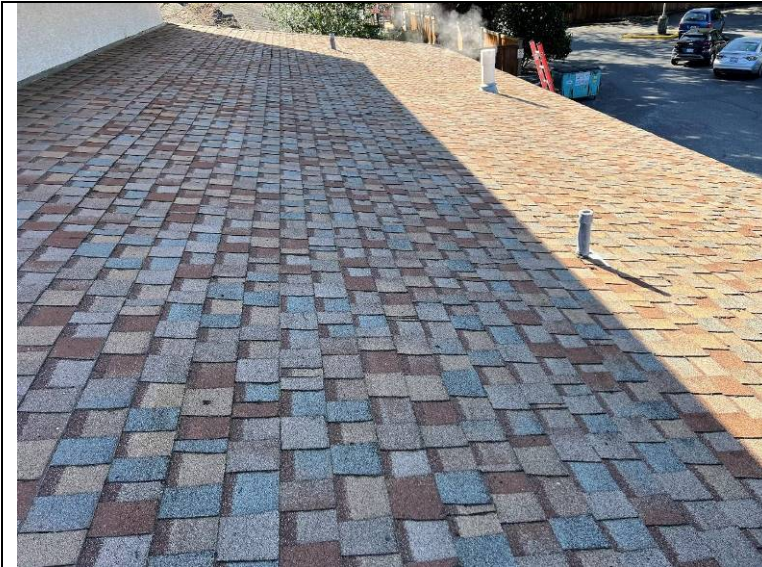
Photograph 22: Looking laterally across the Tamko architectural laminate shingles.

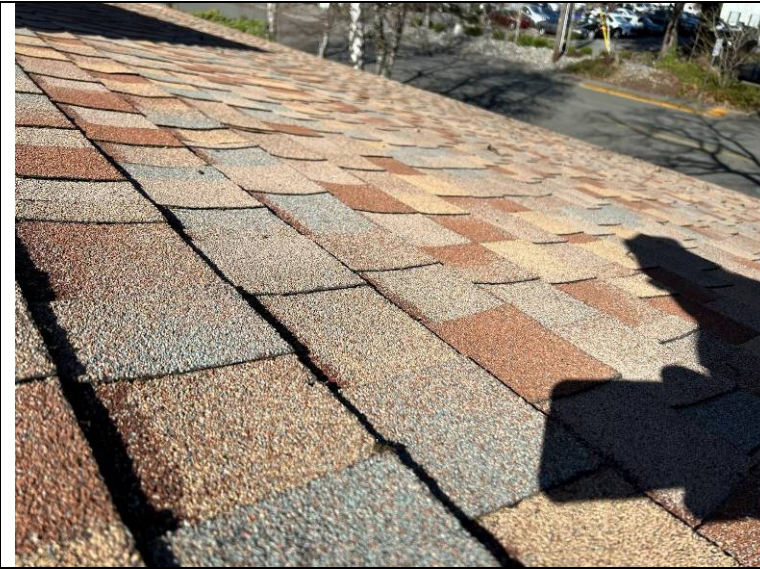
Photograph 25: Slight curling or cupping of the Tamko shingles was observed in various areas of the roof.

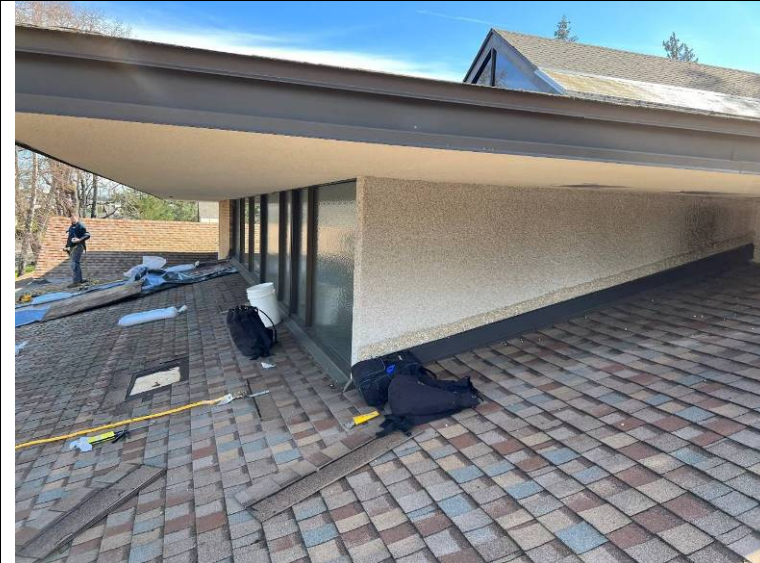
Photograph 26: Looking east along the rising window wall at the north sloping roof area.

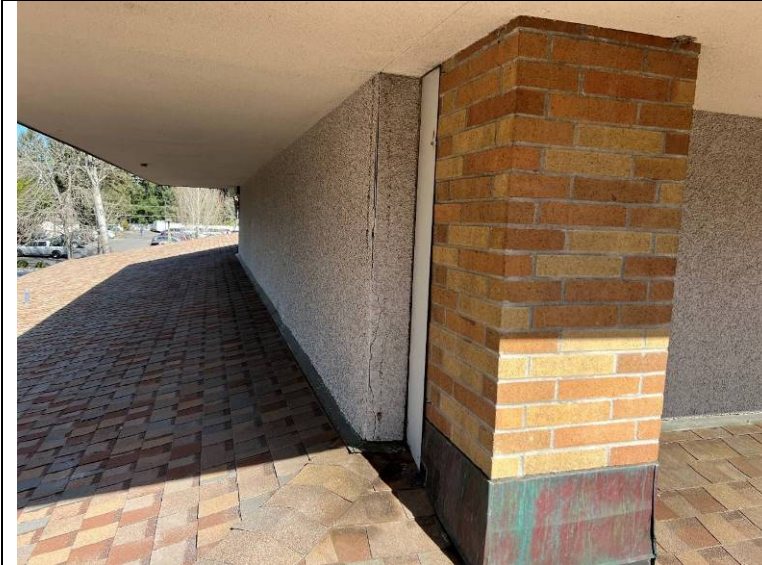
Photograph 35: Cracked marblecrete at a rising wall corner transition.

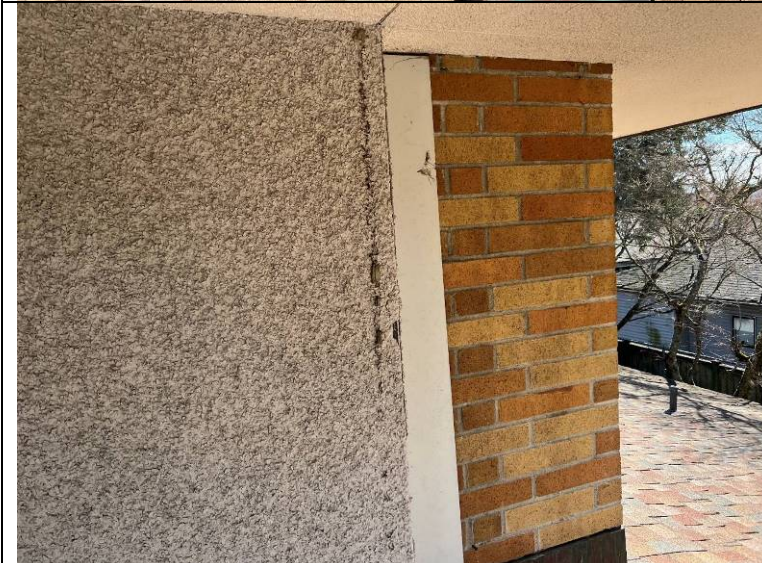
Photograph 36: Closer view of the damage shown in Photograph 35.

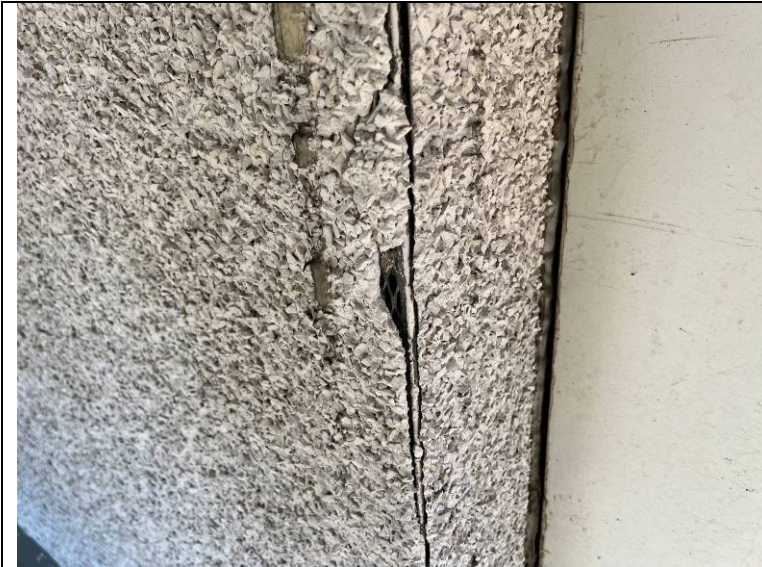
Photograph 37: Closer view of the area shown in Photograph 35.

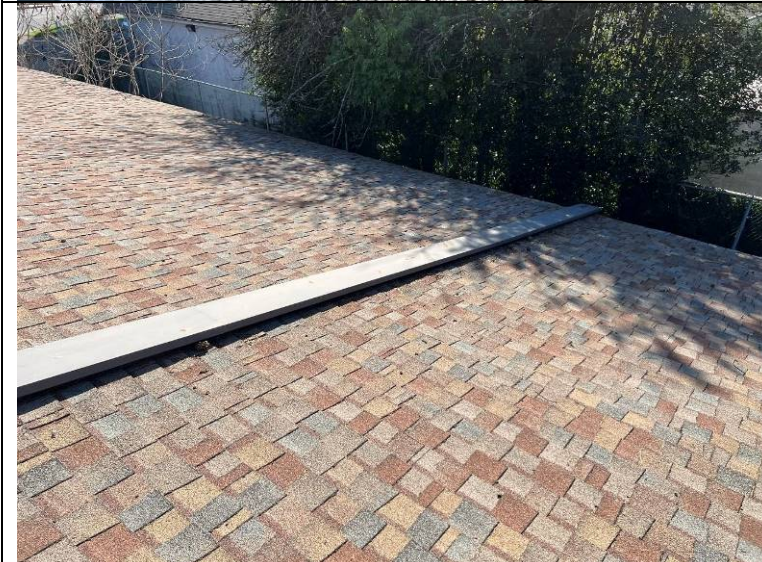
Photograph 38: Sheet metal cover over an area dividing wall.

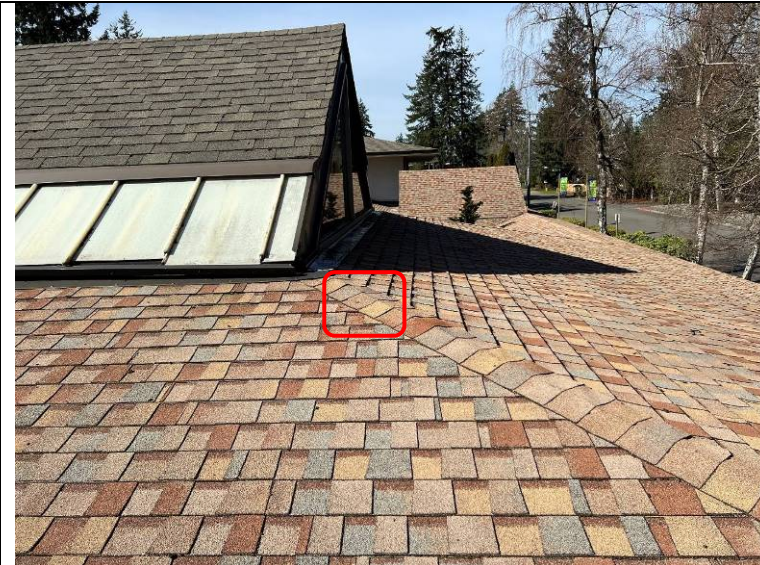
Photograph 46: Hip condition, roofed with hip shingles.

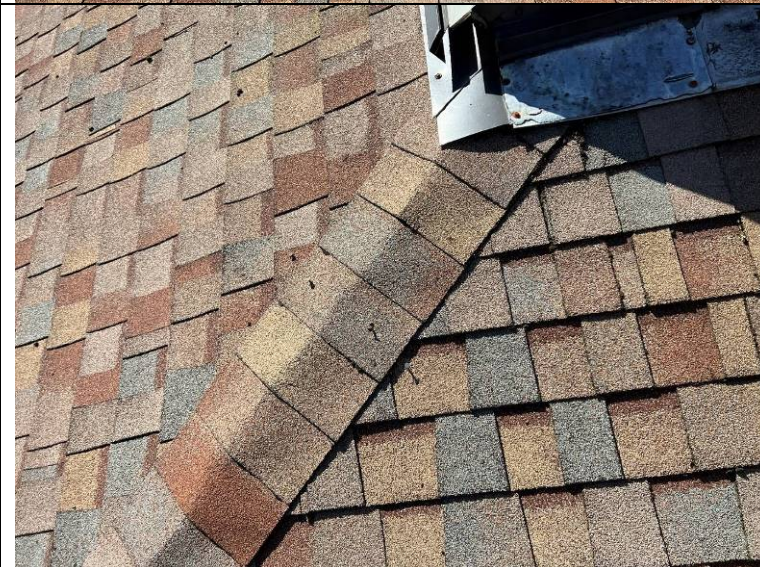
Photograph 47: Closer view of the backed-out nails.

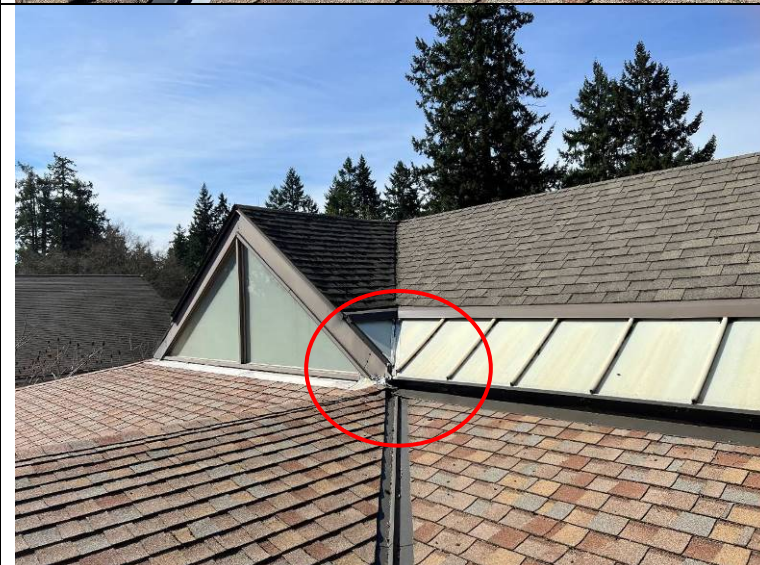
Photograph 51: Overview of a leak location temporarily sealed by Wayne's Roofing.

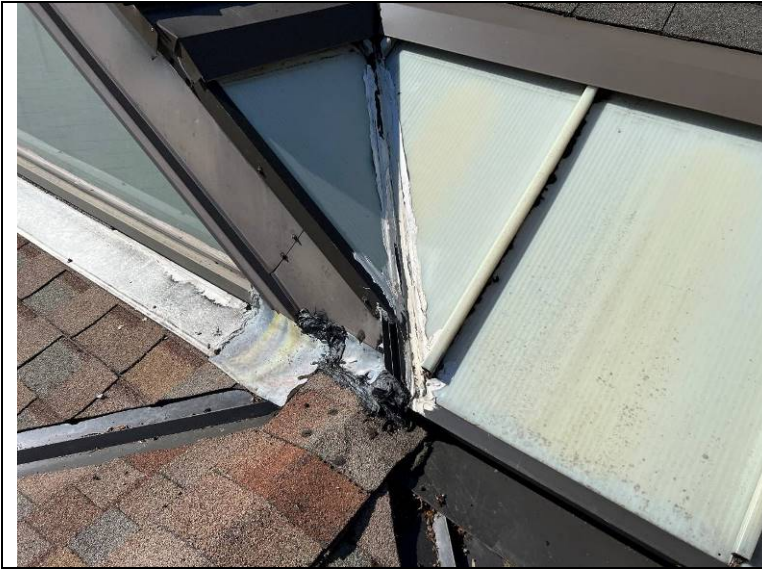
Photograph 52: Closer view of the area shown in Photograph 51.

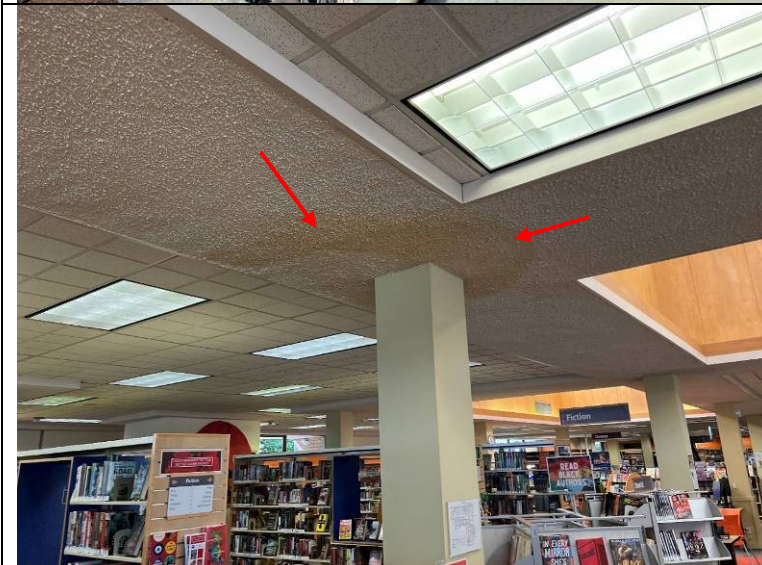
Photograph 54: Area below the area circled in Photograph 51.

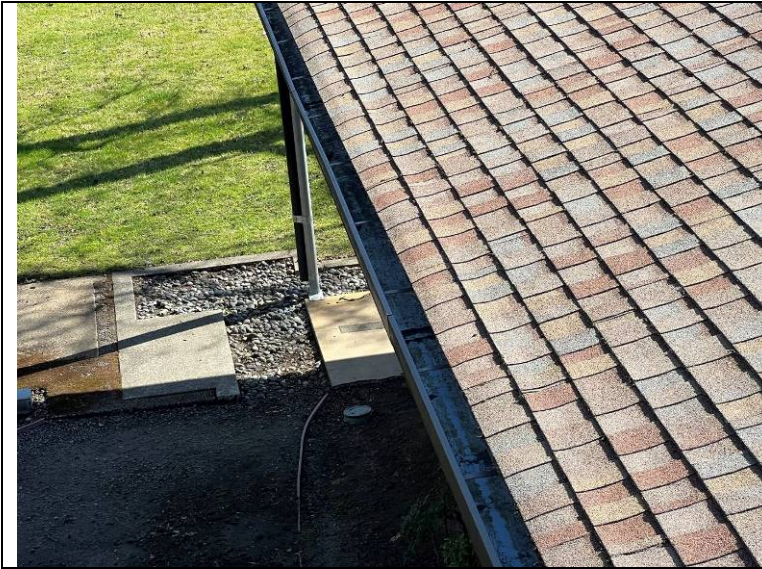
Photograph 55: Typical drainage detail with external hung gutter.

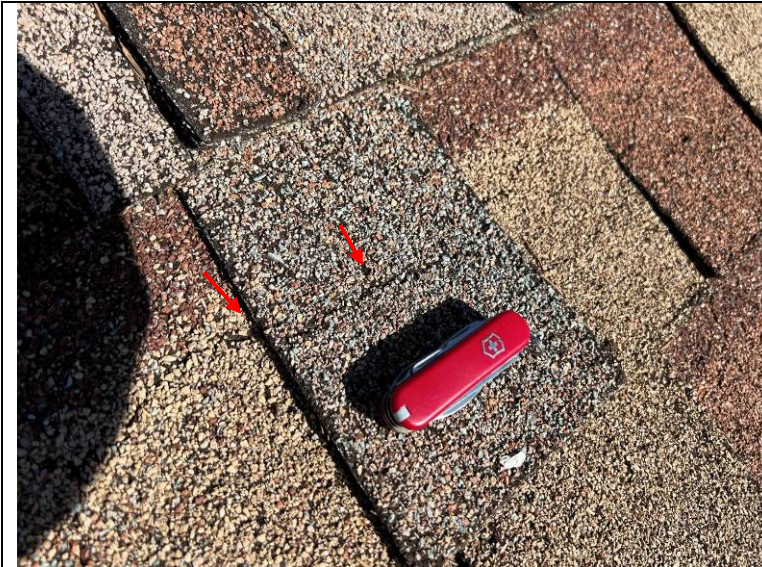
Photograph 64: Cracked shingles at the south sloping roof. (Arrows)

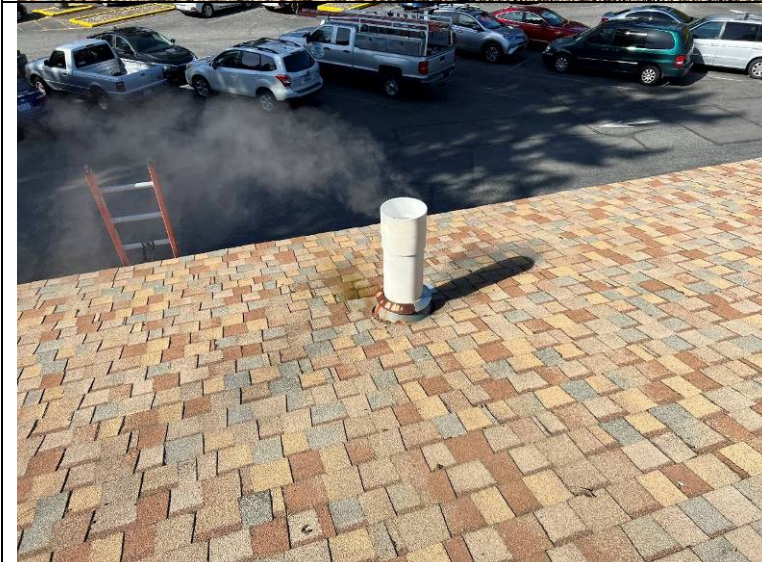
Photograph 65: Boiler vent penetration.

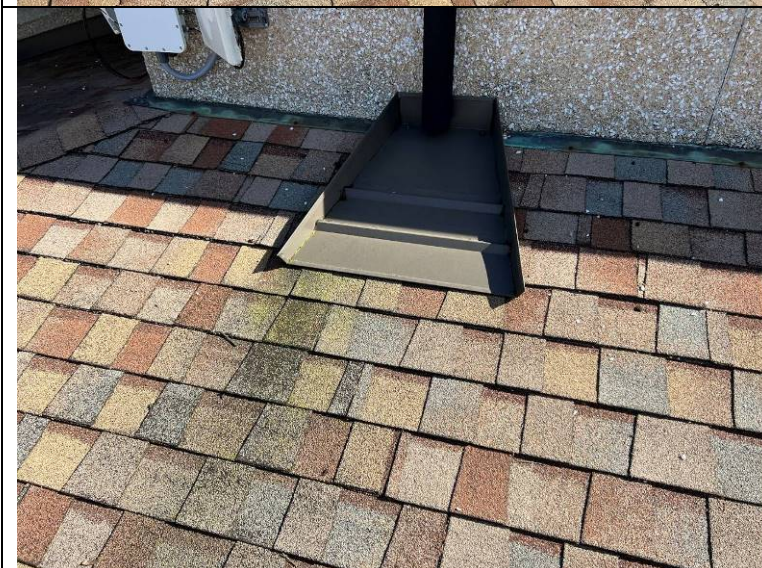
Photograph 66: Splash pad beneath the downspout from the upper roof.

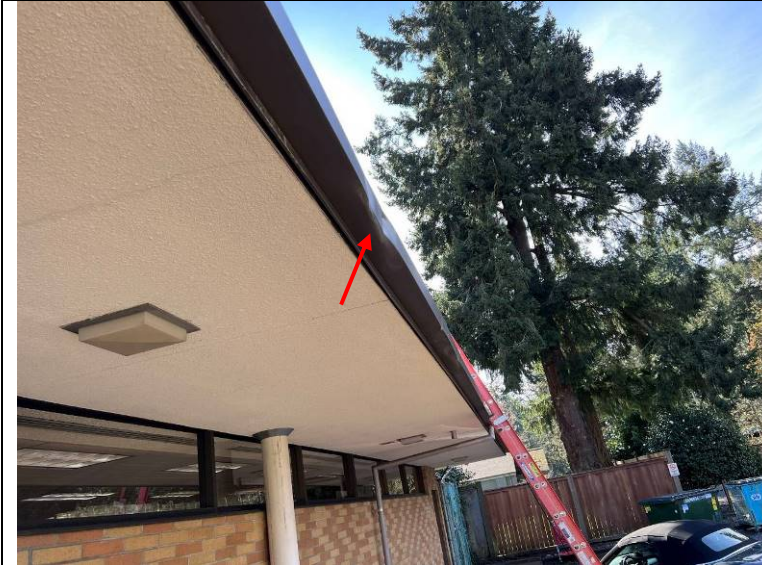
Photograph 68: Damaged gutter (arrow) at the west side of the roof.

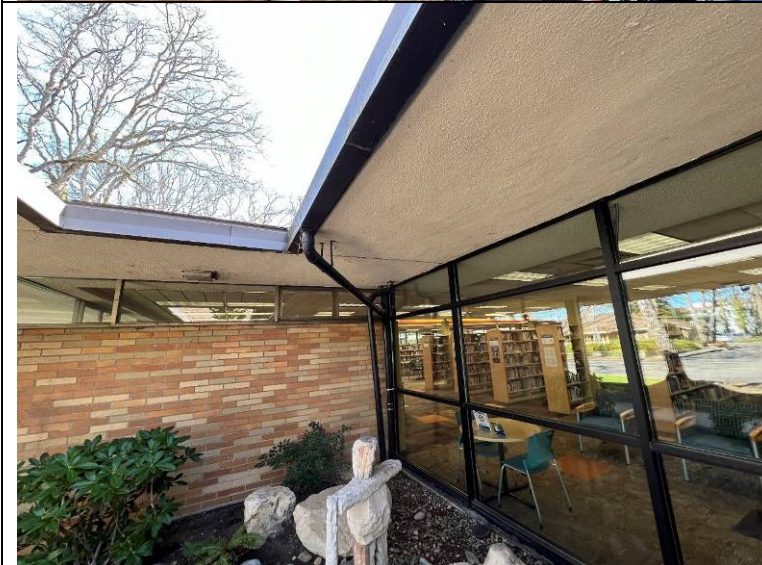
Photograph 69: Gutter downspout.

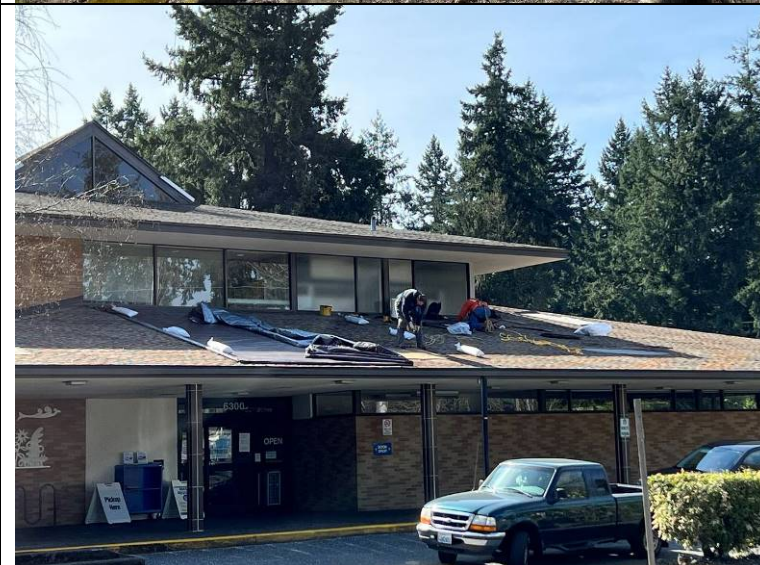
Photograph 72: Overview of the repairs at the test openings.

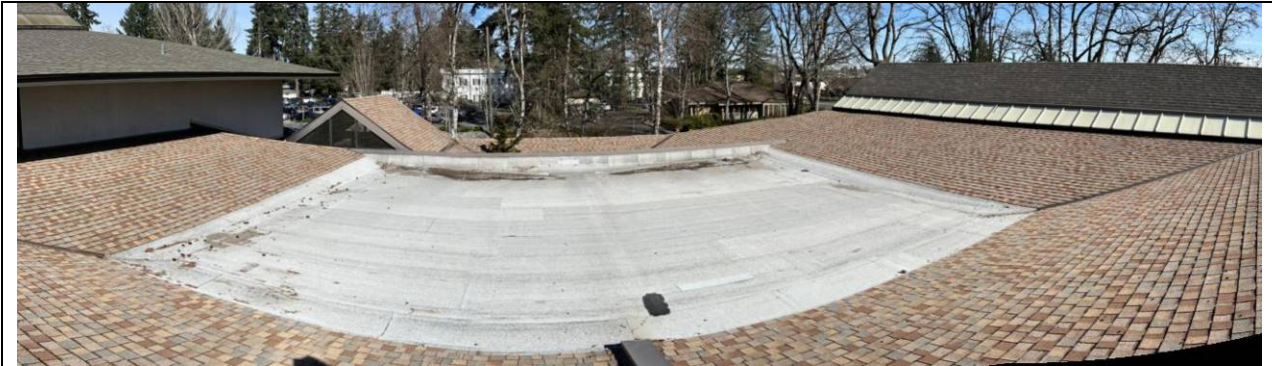
Photograph 73: Overview of the low slope roof.

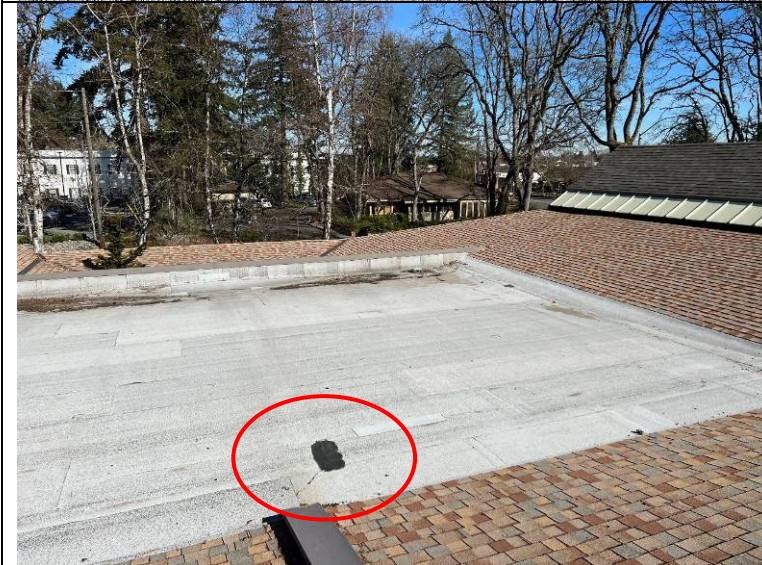
Photograph 77: Roof cement patch over an apparent location of damage.

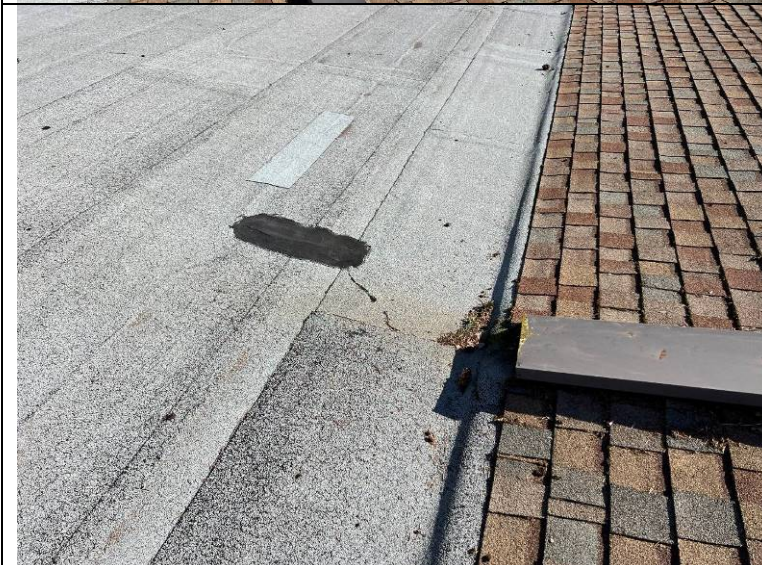
Photograph 78: Closer view of the roof cement patch circled in Photograph 77.

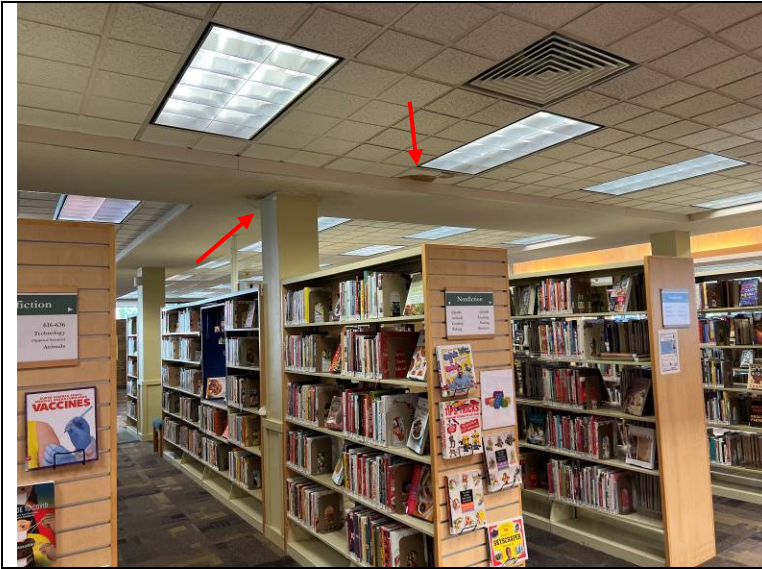
Photograph 79: Approximate area beneath the roof cement patch shown in Photographs 77 and 78.

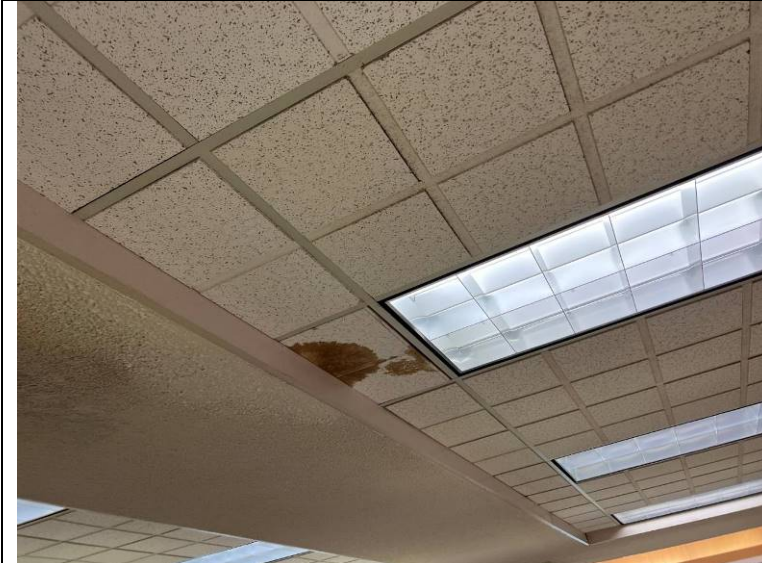
Photograph 80: Closer view of stained ceiling tiles shown in Photograph 79.

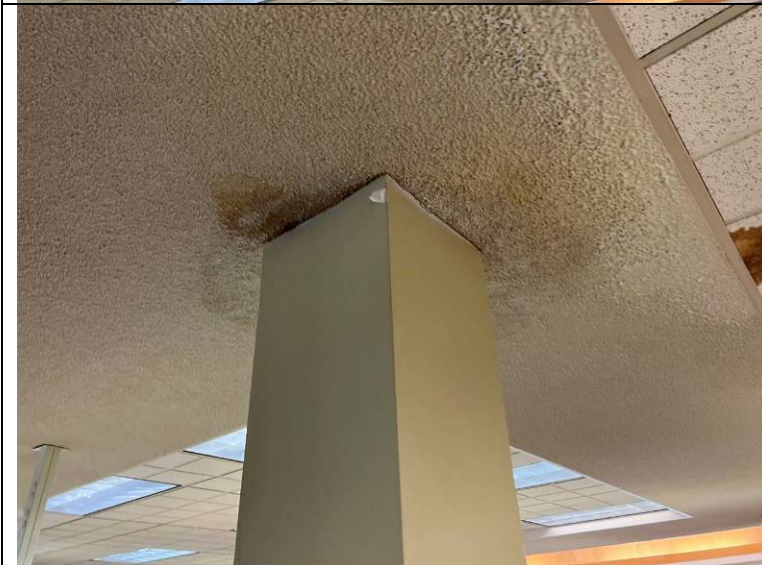
Photograph 81: Closer view of the stained ceiling in the general area shown in Photograph 79.

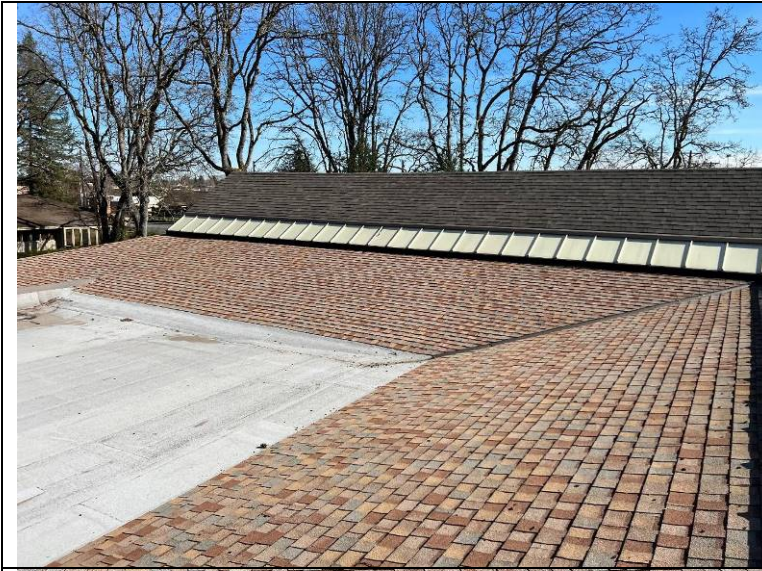
Photograph 82: Steep slope to low slope roof transition.

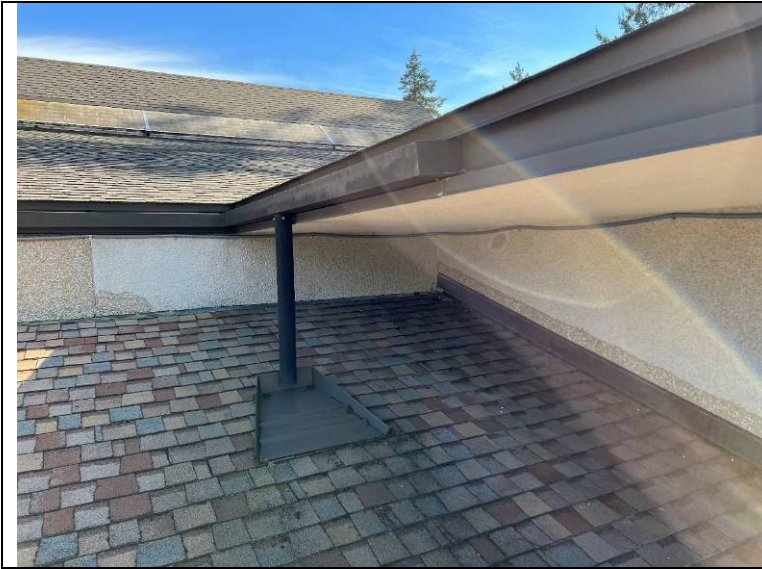
Photograph 100: Downspout and splash pad.

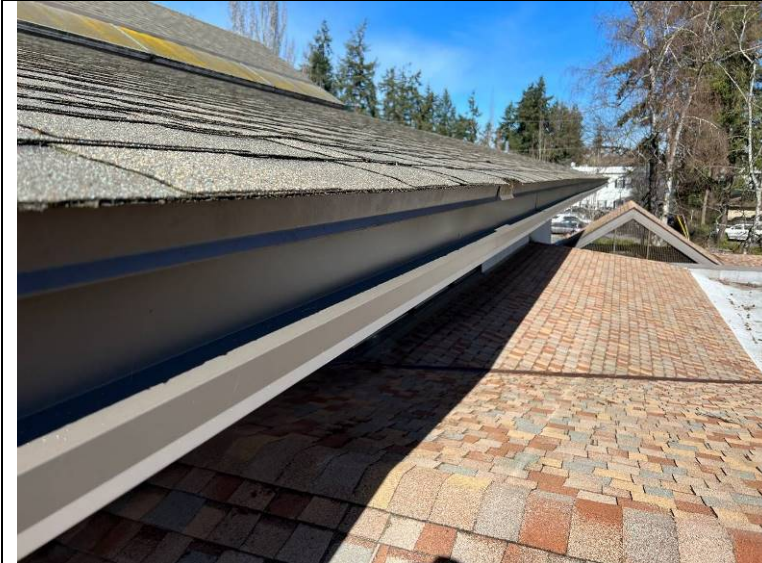
Photograph 101: Eave edge without a gutter.

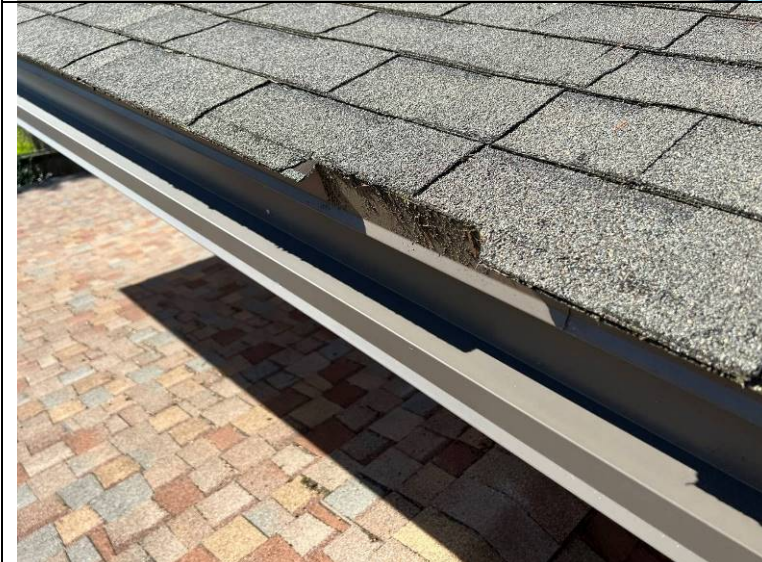
Photograph 104: Damaged shingle at the eave edge.

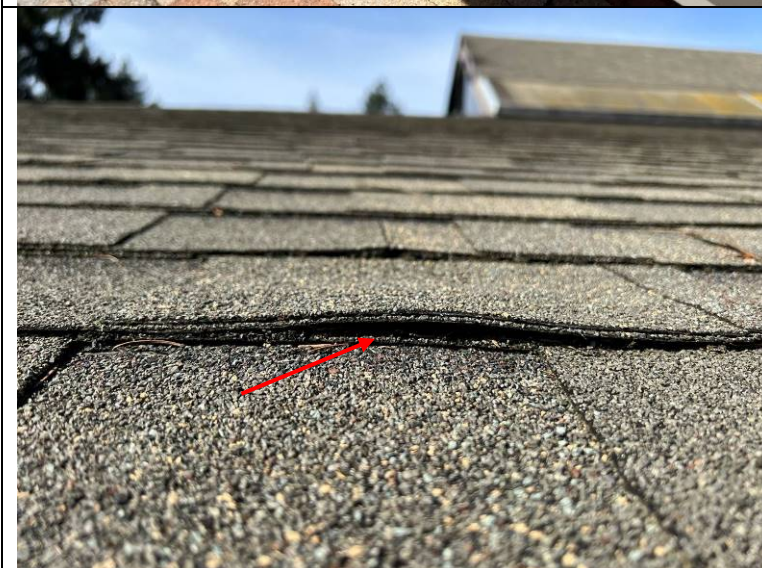
Photograph 105: Arrow indicates an apparent nail backing out and lifting the overlying shingle.

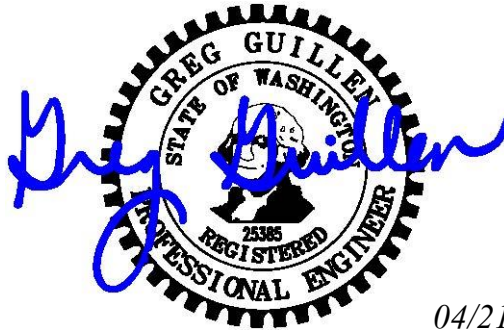
This observation is the professional opinion of CG Engineering PLLC based on the information available during this assessment or evaluation. This report does not warrant or guarantee that all conditions were discovered at the time of the observation. This report was prepared subject to the standard of care applicable to professional services at the time the services were provided.
