Special Meeting of the Pierce County Library System Board of Trustees September 22, 2022 | 3:30 p.m.

The meeting will be held in person at: 3005 112th St E, Tacoma WA 98446

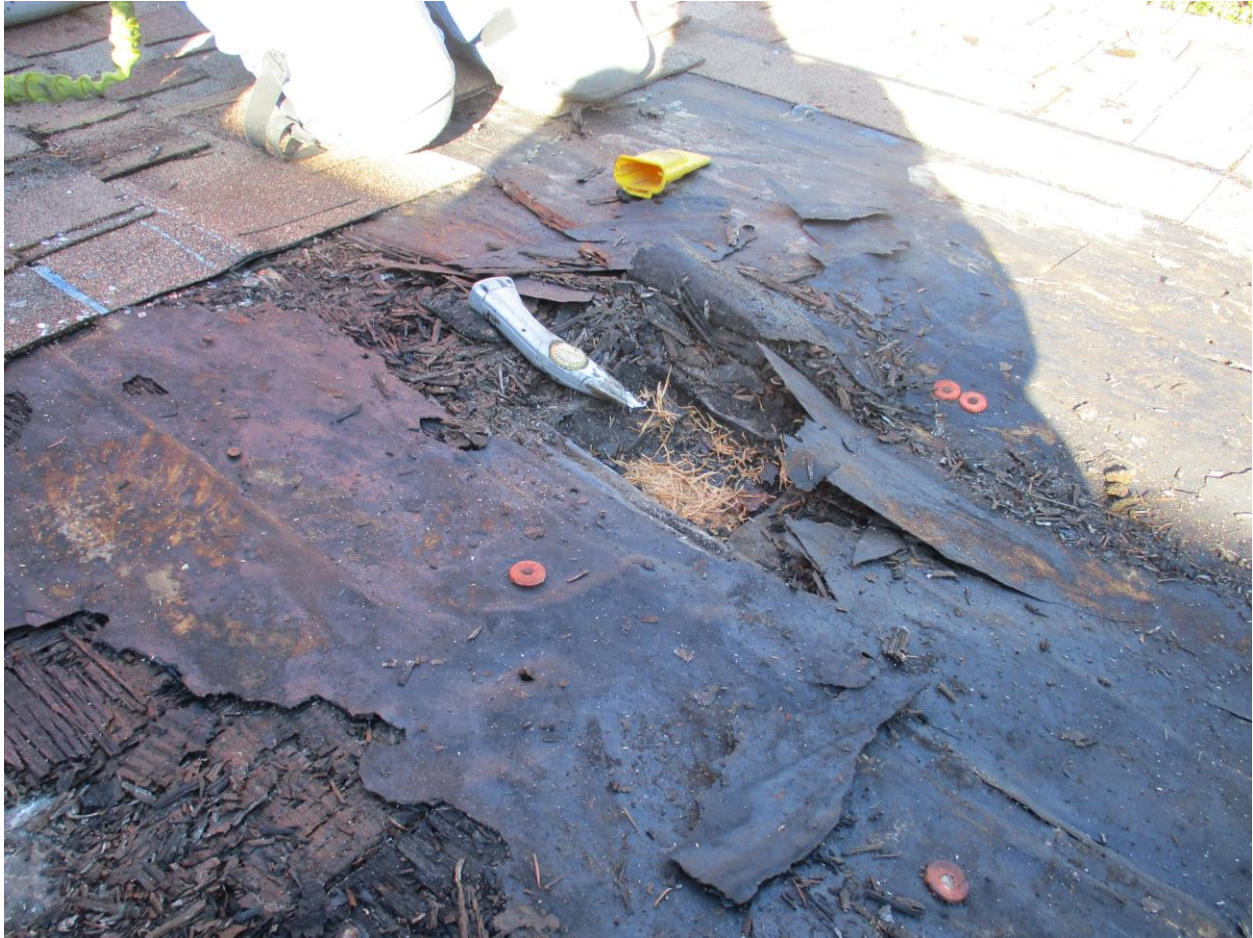
Photo 1 – Deteriorated Plywood Low Roof @ North

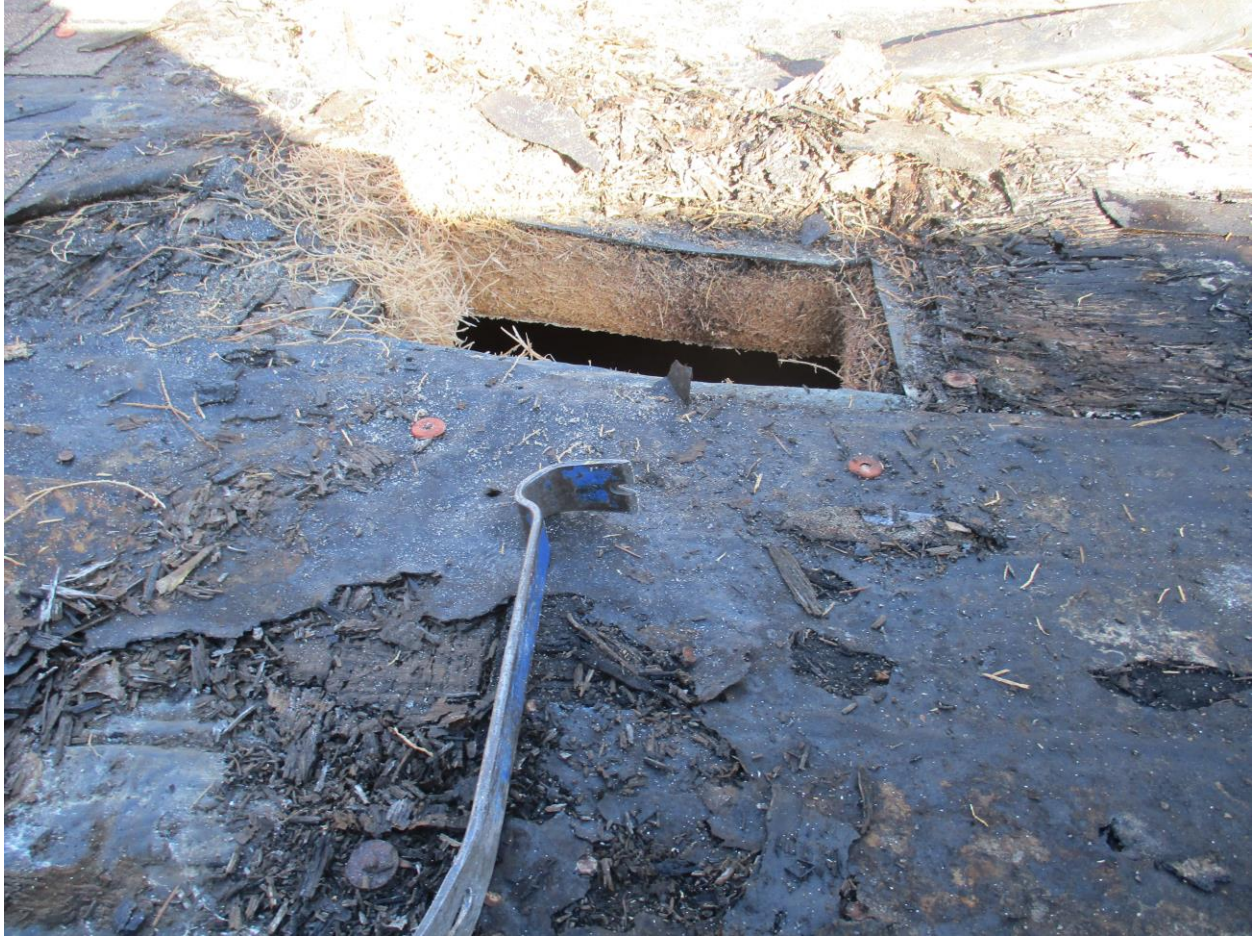
Photo 2 – Tectum Structural Panel Section

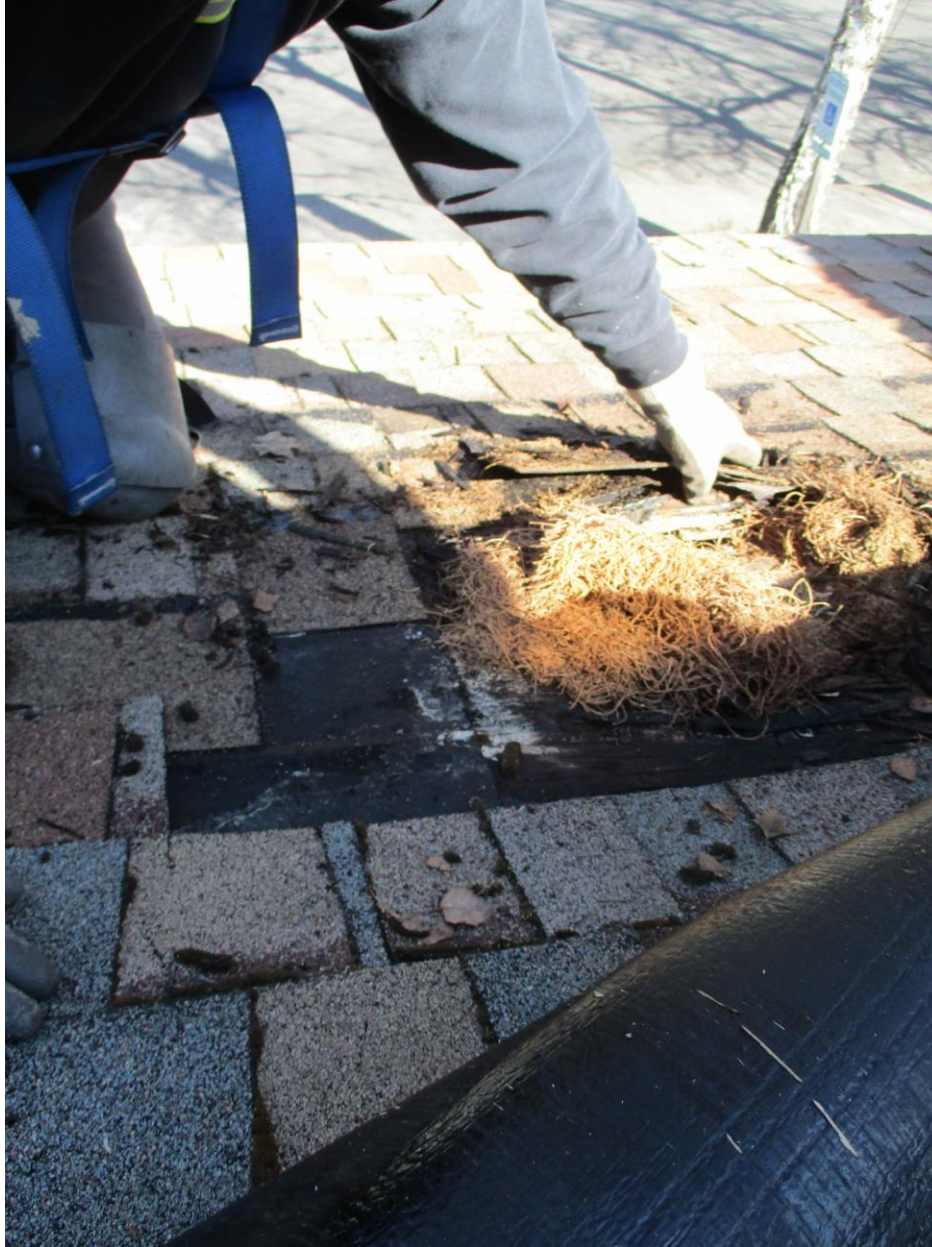
Photo 3 - Tectum Water Damage

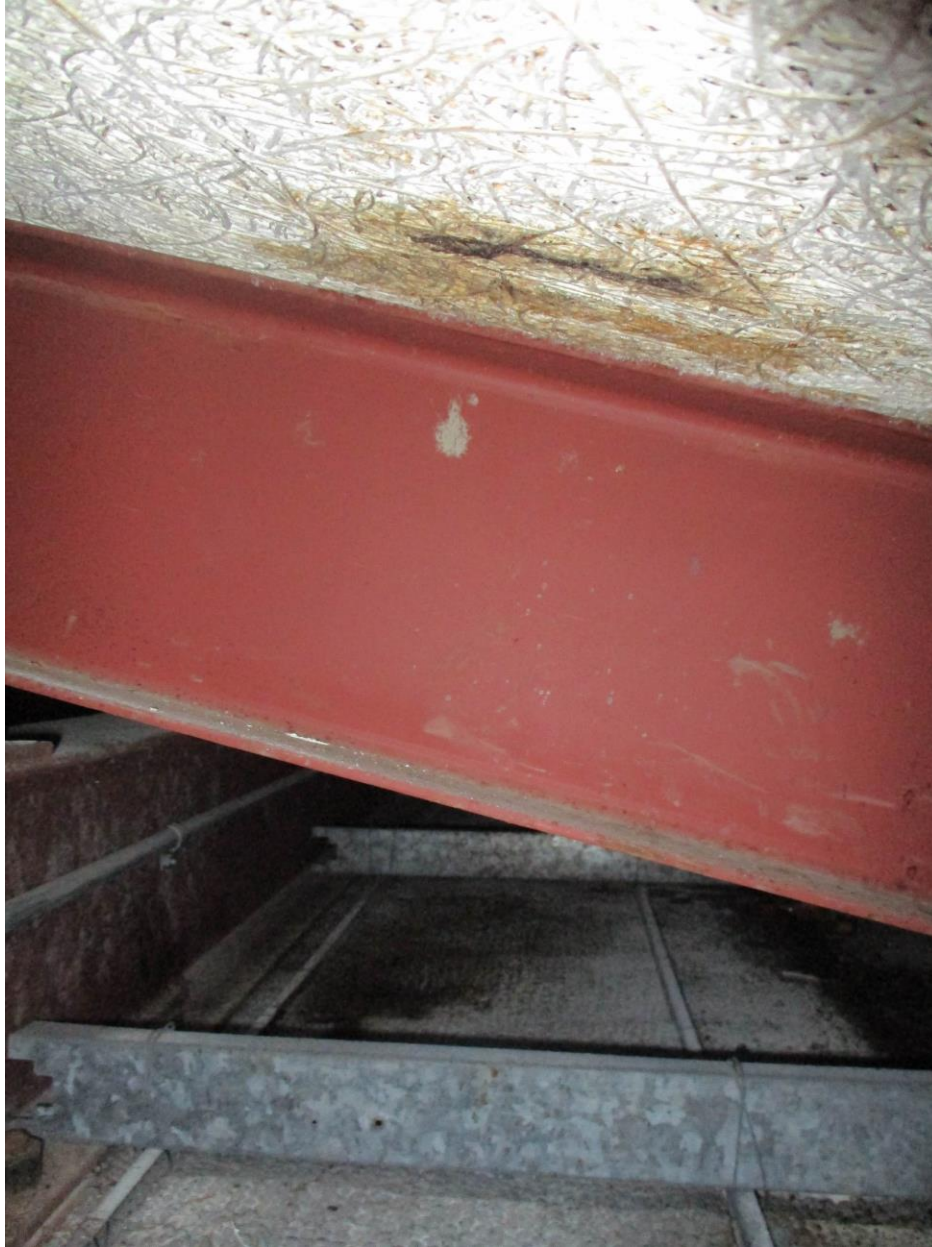
Photo 4 - Structural Steel Beams & Soffit Framing
