Narrative Appraisal Report

Pierce County Rural Library District Property
6302 Wildaire Road SW
Lakewood, WA
(Parcel No. 503000-2991)

Condition Assessment Report for Lakewood Library and Tillicum Library

**LAKWOOD LIBRARY
ROOF EVALUATION
MARCH 10, 2022**

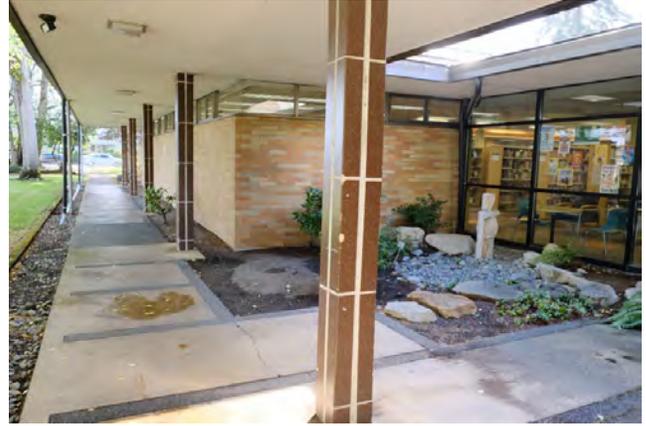
Courtyard near entry

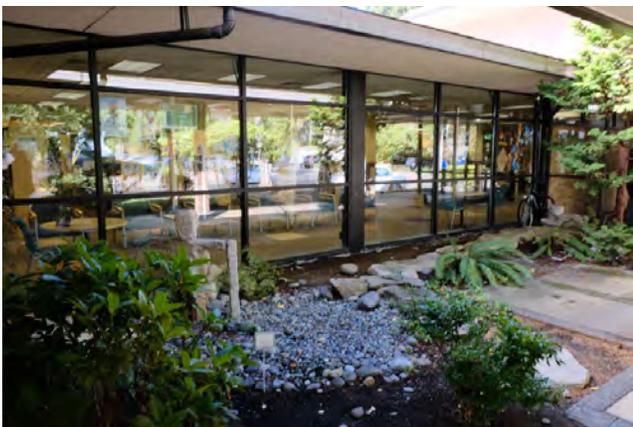
Courtyard

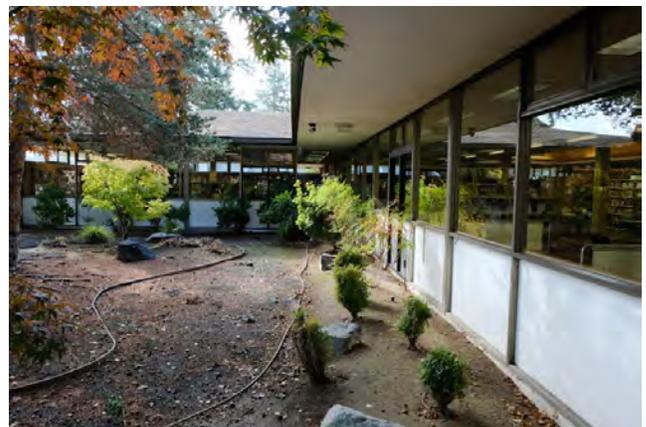
Courtyard

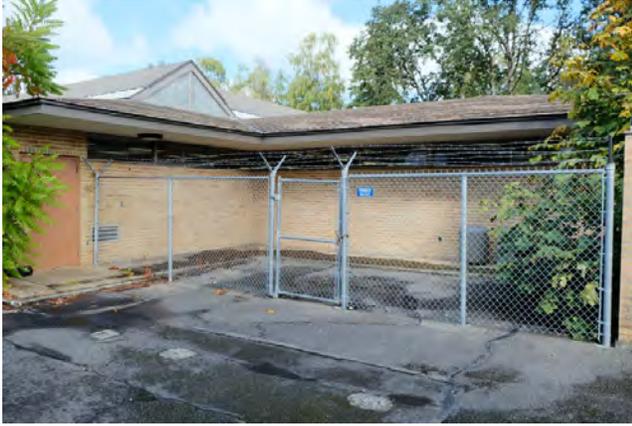
Fenced area at NE presents a security problem

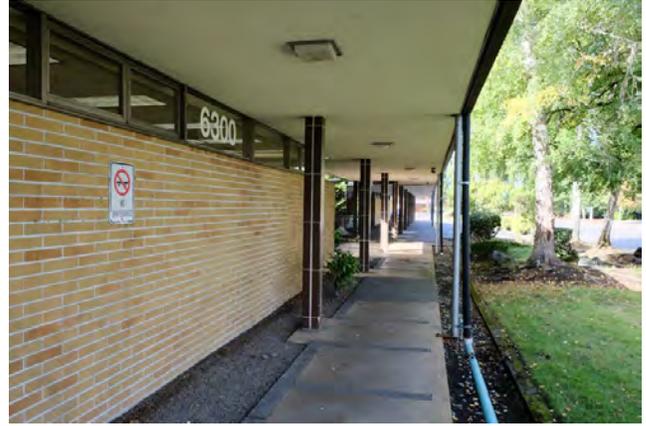
Roof overhang at north side

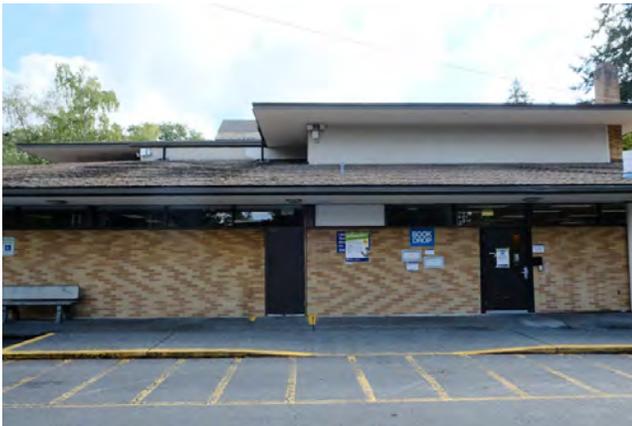
Staff Entry side

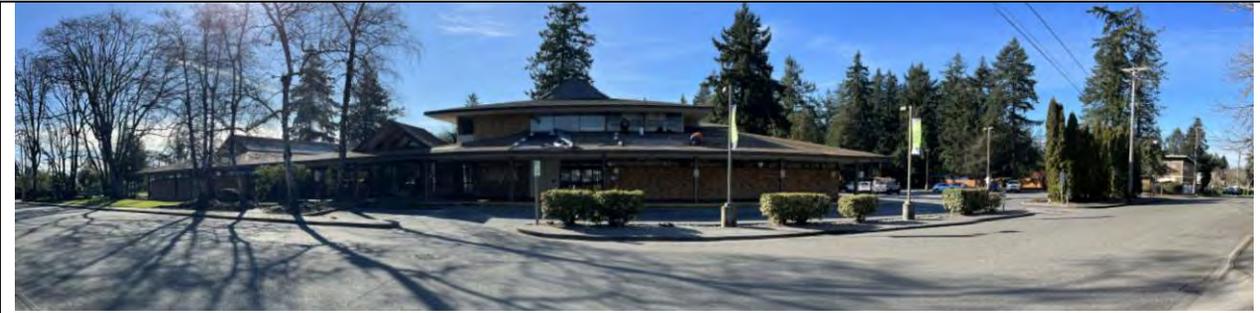
Photograph 1: Overview of the north elevation of the Lakewood Library.

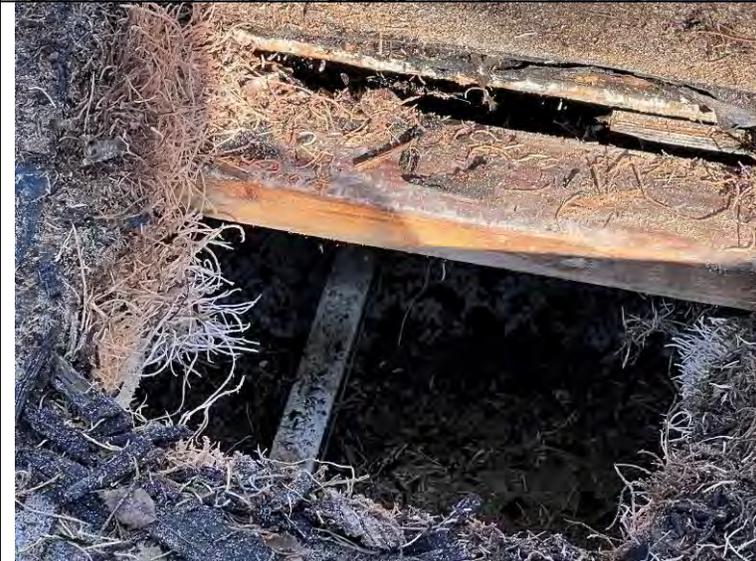
Photograph 19: Closer view of test opening #4 showing the deteriorated cementitious wood fiber substrate board.

Photograph 20: Alternate view of the area shown in Photograph 19.

In locations where the plywood sheathing and cementitious wood fiber substrate board were deteriorated and could not support weight new plywood was placed over the opening prior to placing the patch.

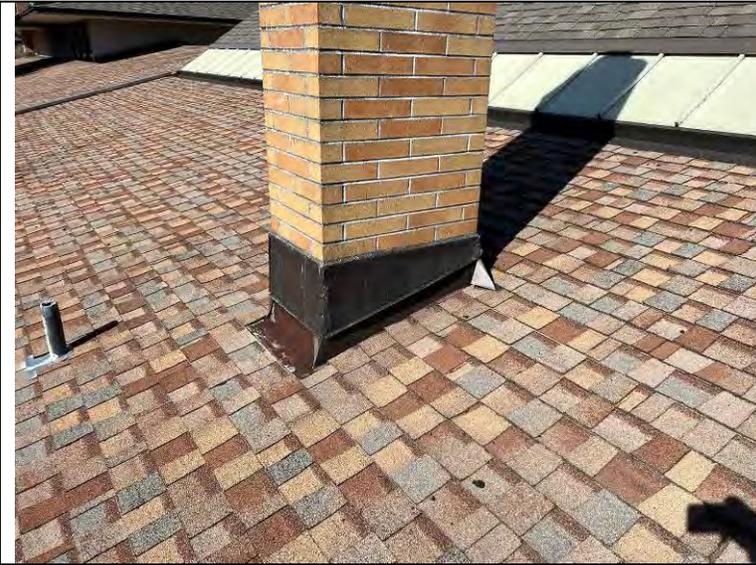
Photograph 58: Closer view of the chimney penetration shown in Photograph 57.

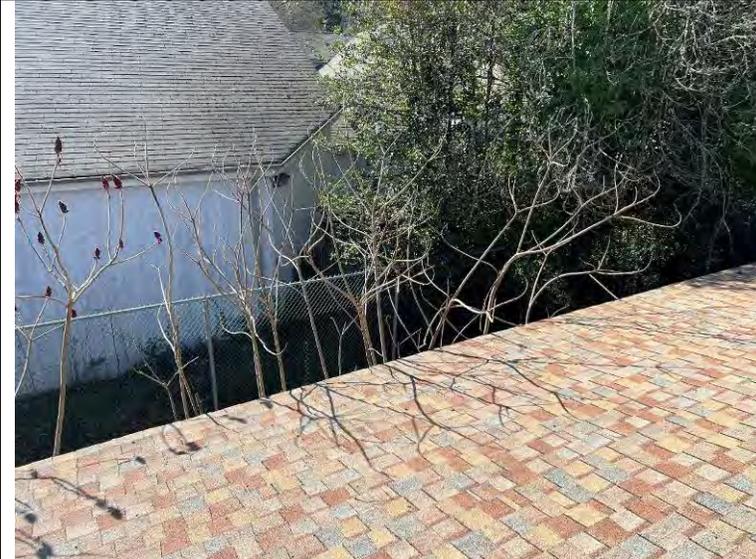
Photograph 59: Trees in close proximity to the roof along the south side of the roof.

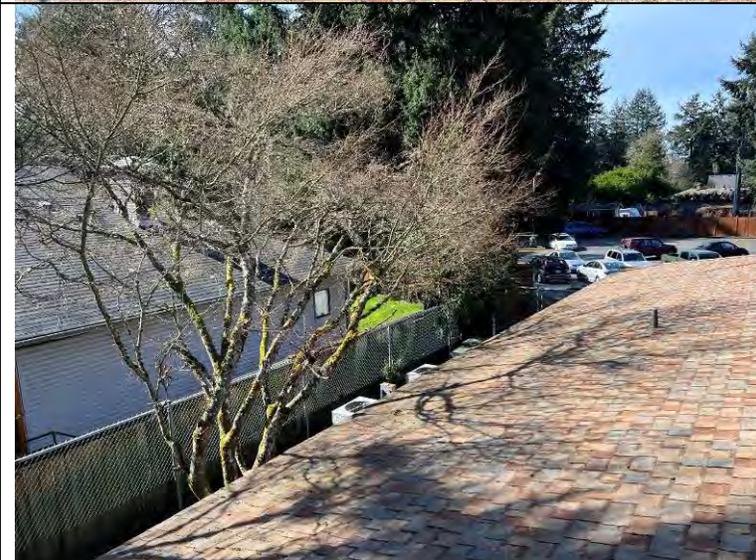
Photograph 60: Trees in close proximity to the roof along the south side of the roof.

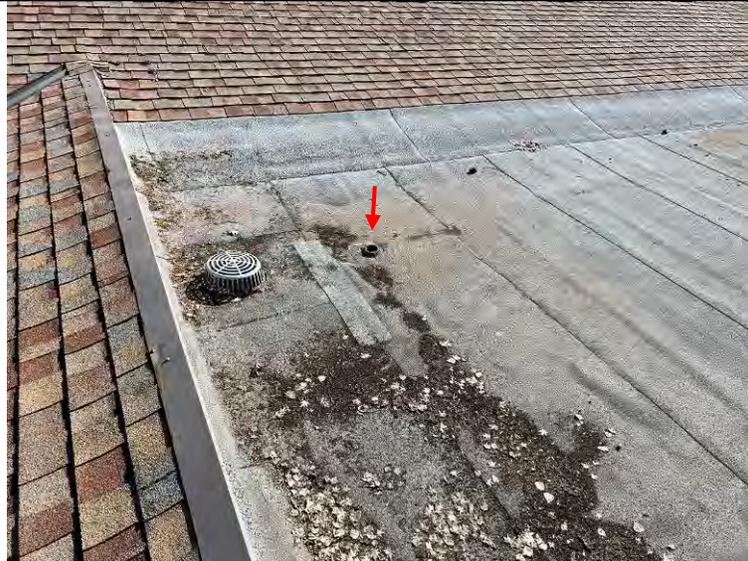
Photograph 74: Typical cast iron roof drain and adjacent contractor style overflow (arrow).

Contractor style overflows consist of a pipe stubbed above the roof flashed into the roof with a lead flashing.

Organic debris is collecting on the surface of the roof.

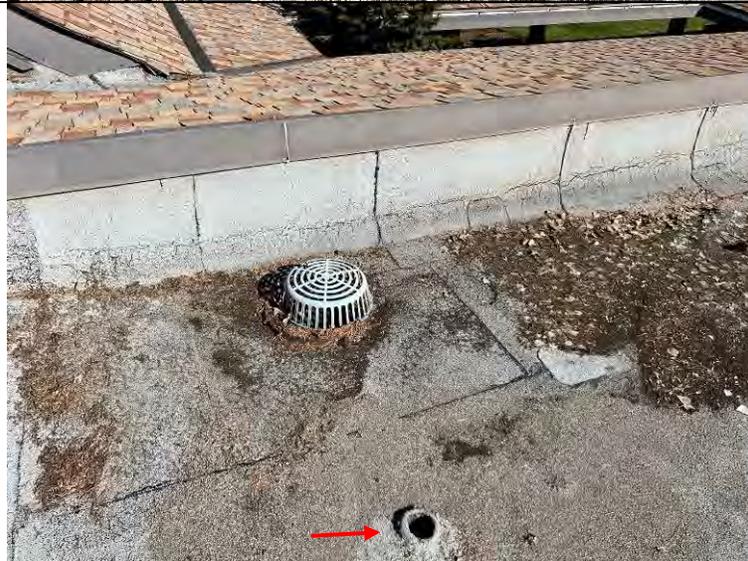
Photograph 75: Closer view of a cast iron roof drain and contractor style overflow (arrow).

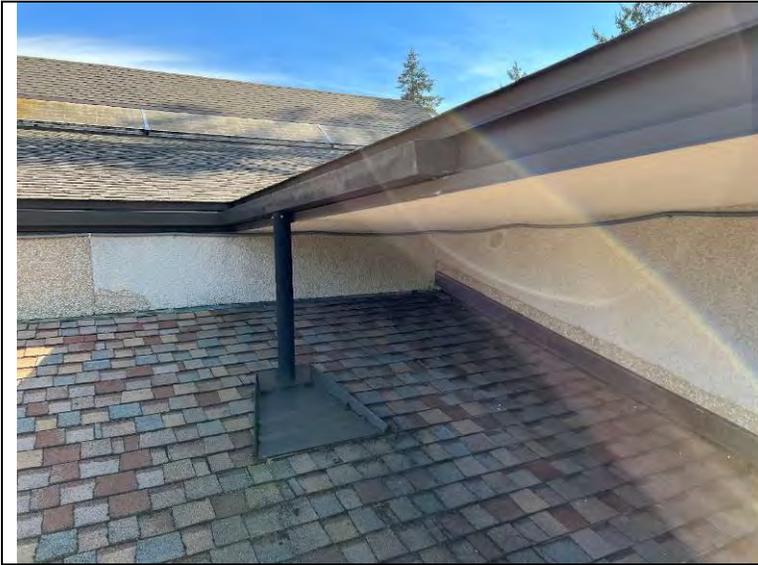
Photograph 100: Downspout and splash pad.

Repair to the marbled concrete can be seen in the background of the photo. The darker colored marbled concrete is the newer patched areas.
