**Lakewood Pierce
County Library building
condition assessment,
roof evaluation, and
structural engineering
reports**

LWD Building Analysis – Executive Summary

Condition Assessment Report for Lakewood Library and Tillicum Library

**LAKESWOOD LIBRARY
ROOF EVALUATION
MARCH 10, 2022**

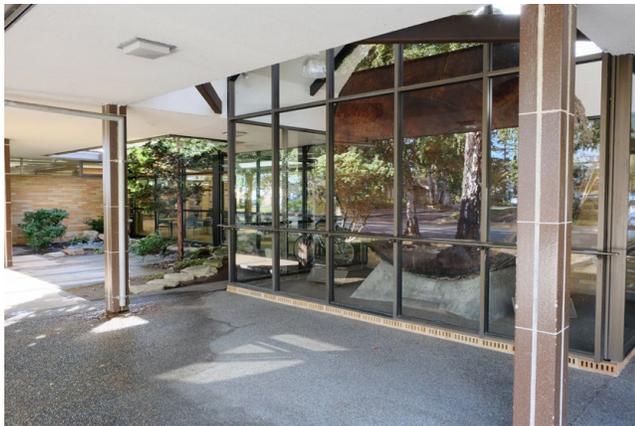
Windows near entry

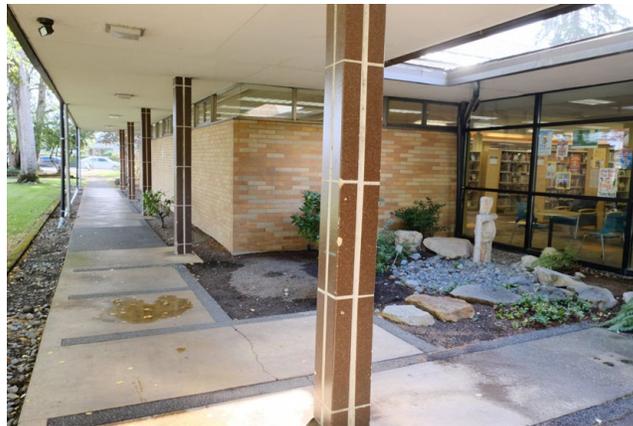
Courtyard near entry

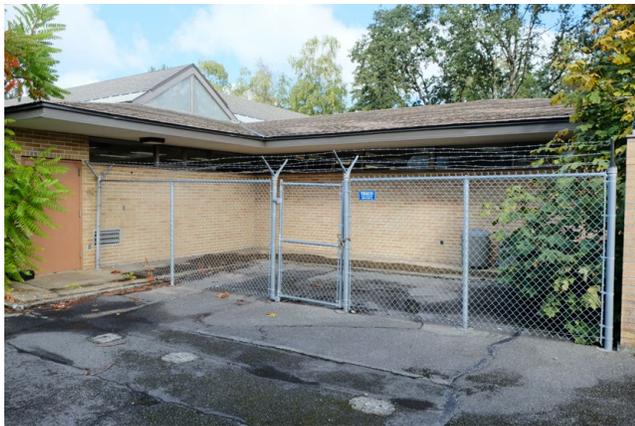
Fenced area at NE presents a security problem

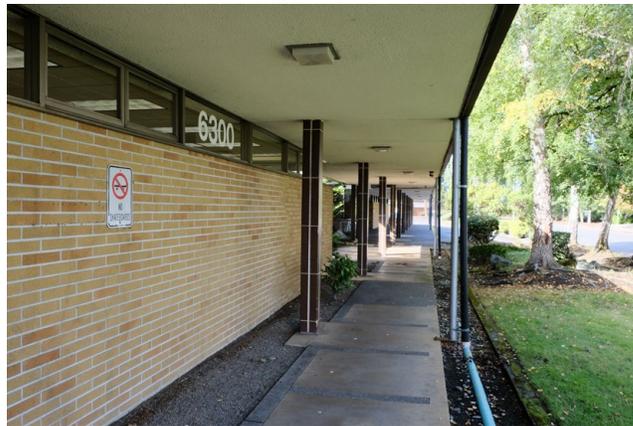
Roof overhang at north side

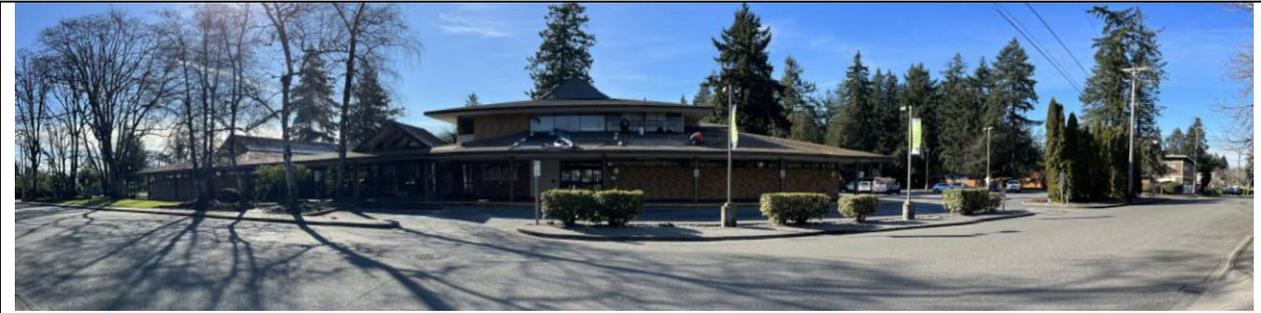
The area highlighted above are the north and west lower roof areas. The locations noted as 1 and 2 are the areas of water entry noted.

Photograph 1: Overview of the north elevation of the Lakewood Library.

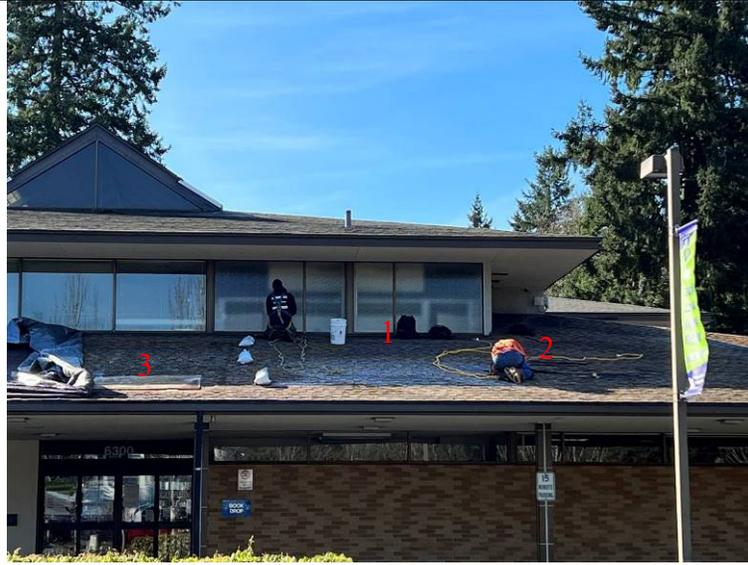
Photograph 2: Overview of the area where test openings 1-3 were made by Wayne's Roofing personnel.

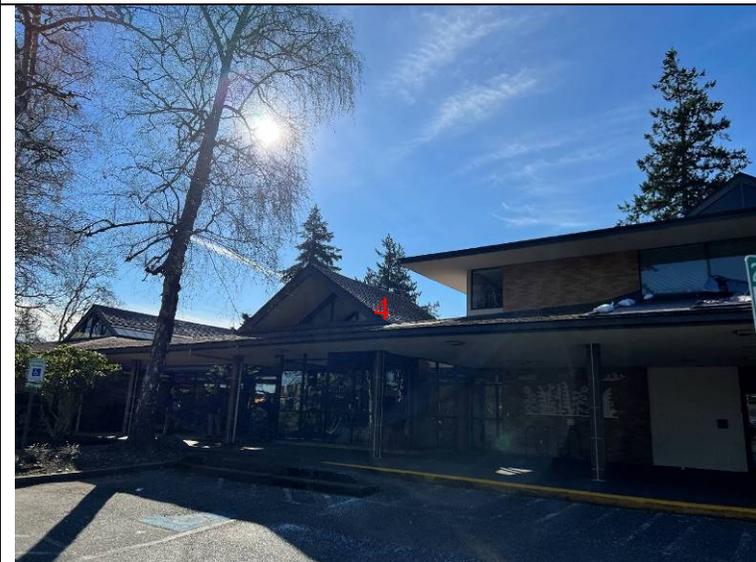
Photograph 3: Overview of the area where test opening 4 was made by Wayne's Roofing personnel.

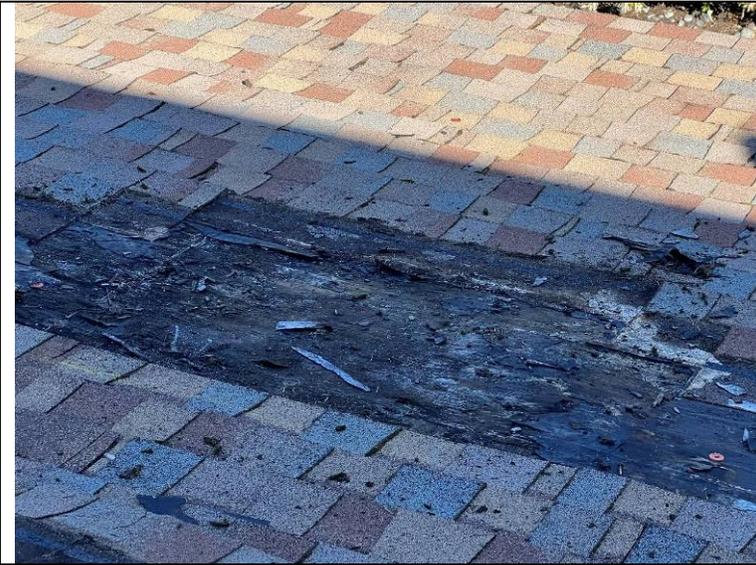
The plywood at this location which was exposed is deteriorated and black in color.

The underlayment was deteriorated.

Photograph 10: Closer view of the area shown in Photograph 9.

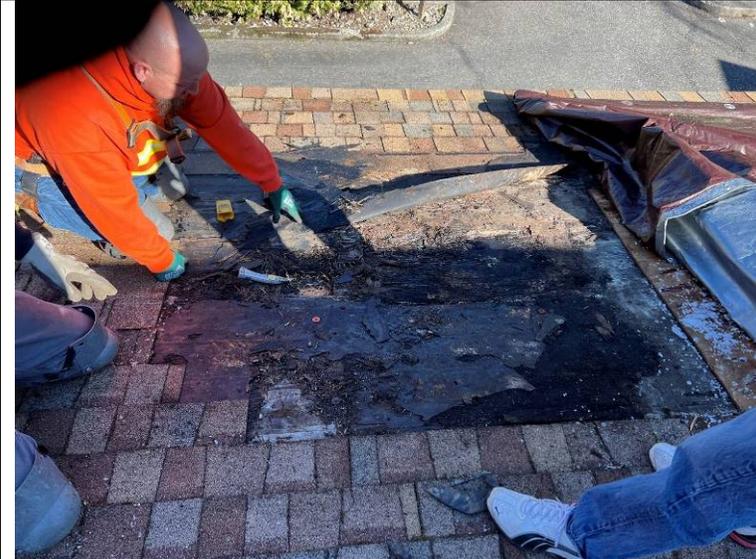
Photograph 11: Overview of opening location #3.

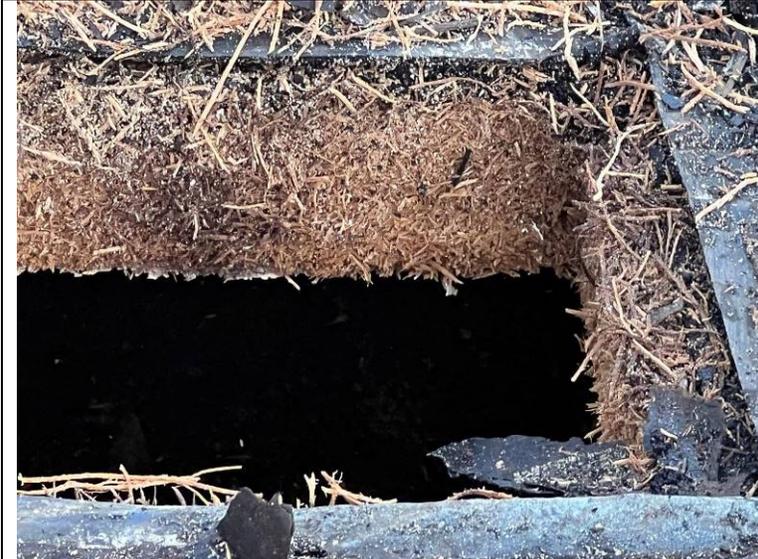
Note the cementitious wood fiber substrate board is deteriorated.

Photograph 14: Closer view of the cementitious wood fiber substrate board at the test opening.

The lower roof areas to the north and west of the second story (west half of the building) are no longer serviceable. The existing roof system, plywood, and cementitious wood fiber substrate board should be removed to expose the steel structure. Any needed repairs to the steel structure should be performed once exposed. This scope of work will create a condition where the interior under the roof areas noted will be exposed to weather.

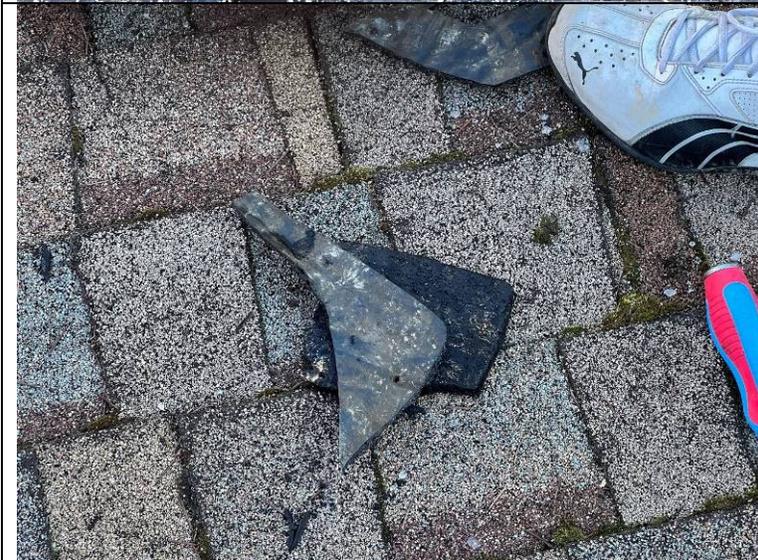
Photograph 15: Asphaltic membrane with a polyethylene surfacing.

The asphaltic membrane was situated over the cementitious wood fiber substrate board.

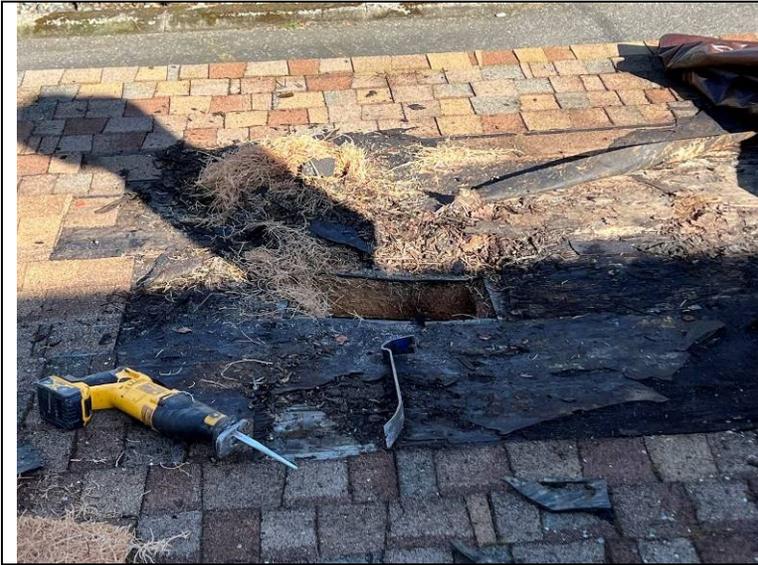
Photograph 16: Alternate view of test opening #3.

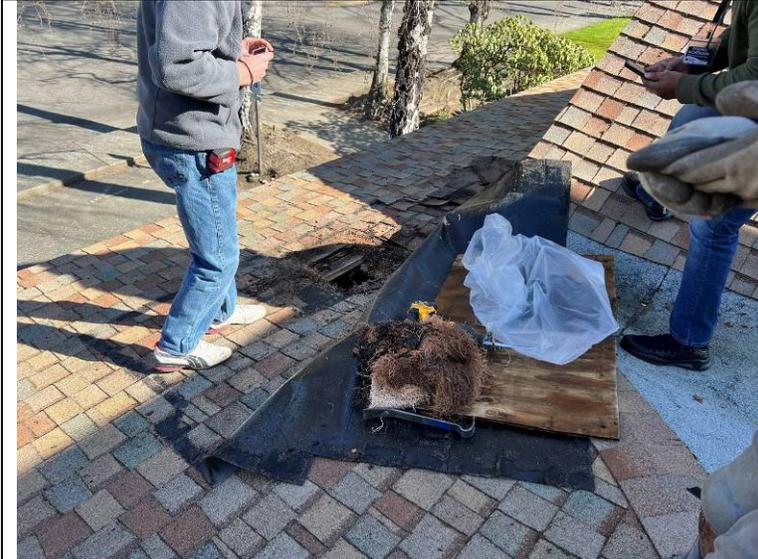
Photograph 17: Overview of test opening #4.

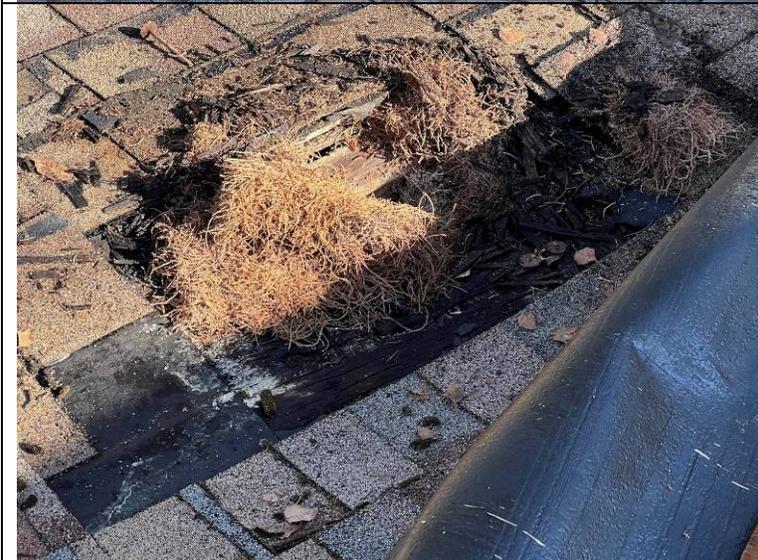
Photograph 18: Cementitious wood fiber substrate board removed at test opening #4.

Similar to test opening #3 the cementitious binder has washed away and only the wood fibers remained.

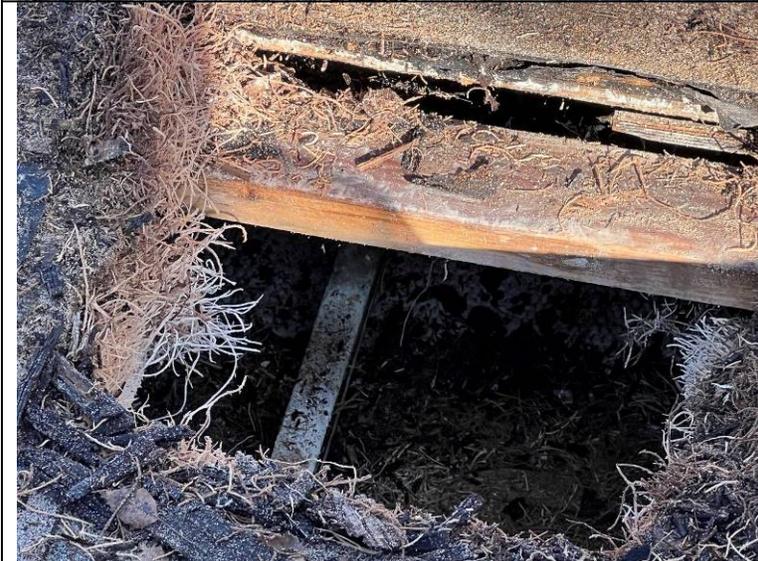
Photograph 20: Alternate view of the area shown in Photograph 19.

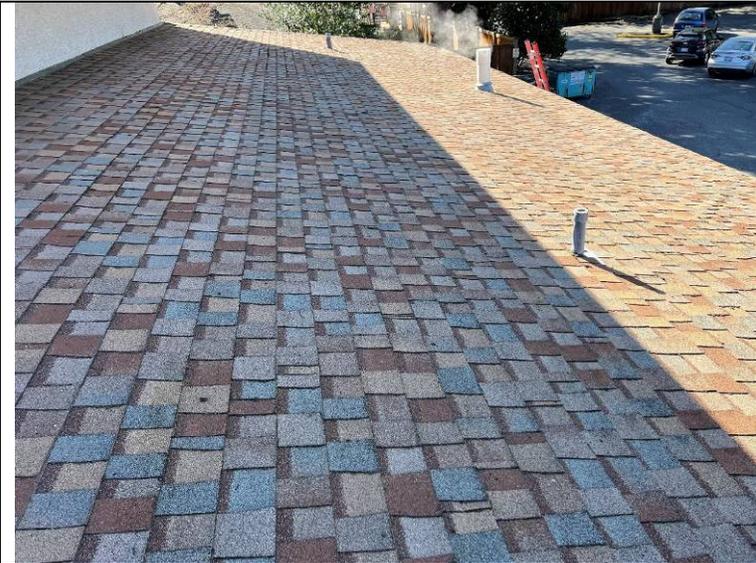
Photograph 22: Looking laterally across the Tamko architectural laminate shingles.

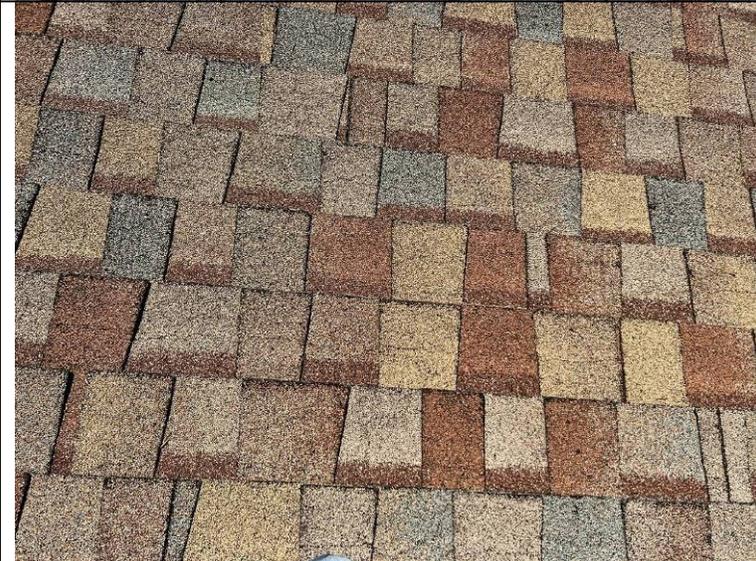
Photograph 23: Closer view of the Tamko architectural laminate shingles.

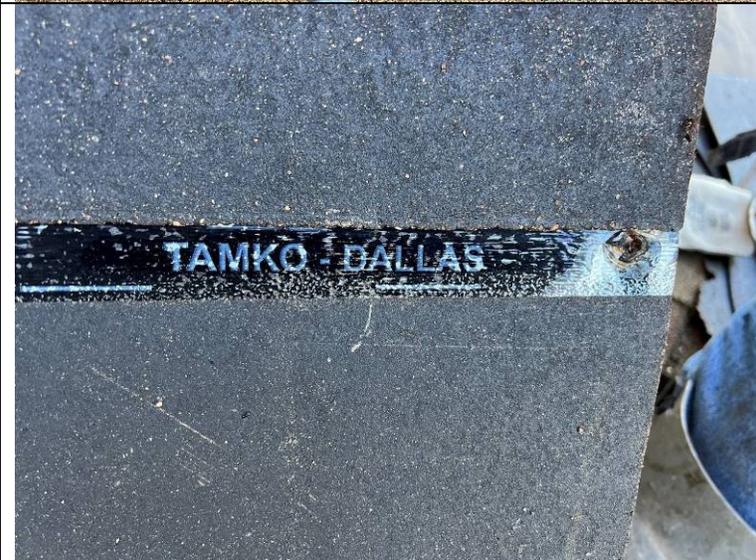
Photograph 24: Tamko label on the backside of one of the removed shingles.

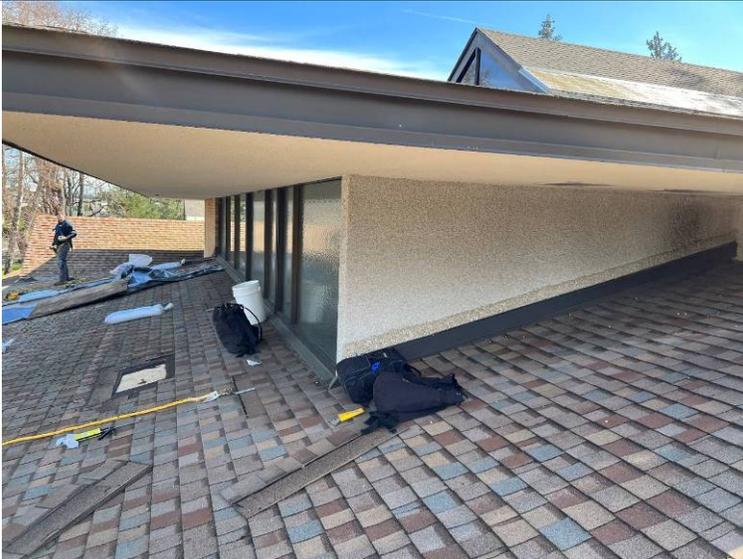
Photograph 26: Looking east along the rising window wall at the north sloping roof area.

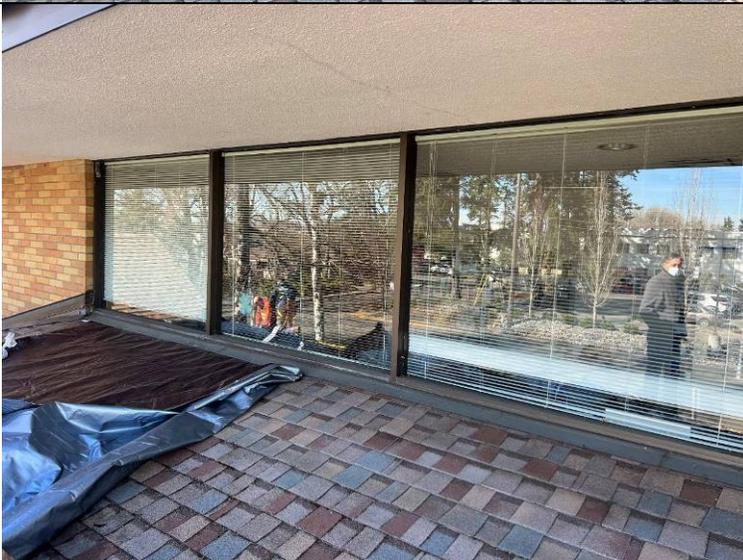
Photograph 27: Windows at the upslope edge of the north sloping roof area.
The windows sit less than 5-inches above the surface of the roof.

To accommodate the thickness of the new roof system, the single pane aluminum windows at the rising wall above the lower roof should be removed and replaced with new. The marblecrete should be removed and replaced with new architectural sheet metal or fiber cement board cladding. The skylights should be replaced with new sloped aluminum framed skylights integrated into the roof system. The clerestory glazing at the ends of the skylights will need to be replaced with new smaller framed windows to accommodate the thickness of the new roof system. The new windows at the rising walls, and at the clerestories should be configured a minimum of 8-inches above the finished roof surface and properly flashed into the roof and openings.

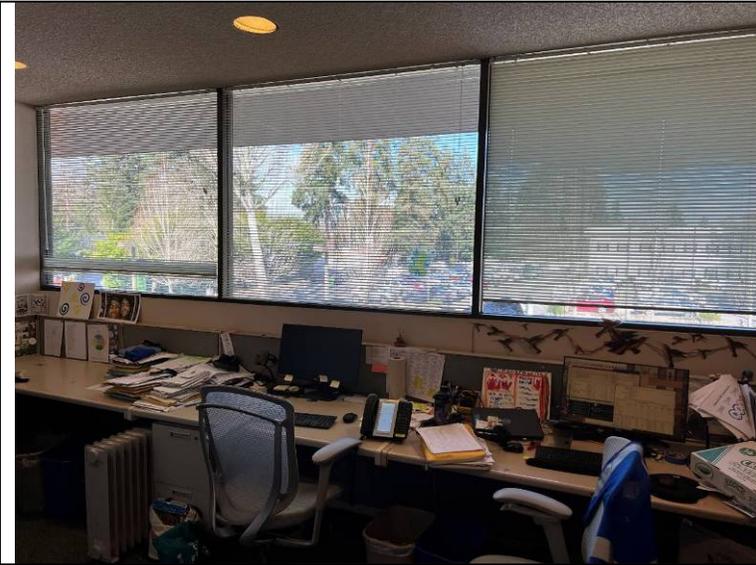
Photograph 28: Windows shown in Photograph 27 as seen from the interior.

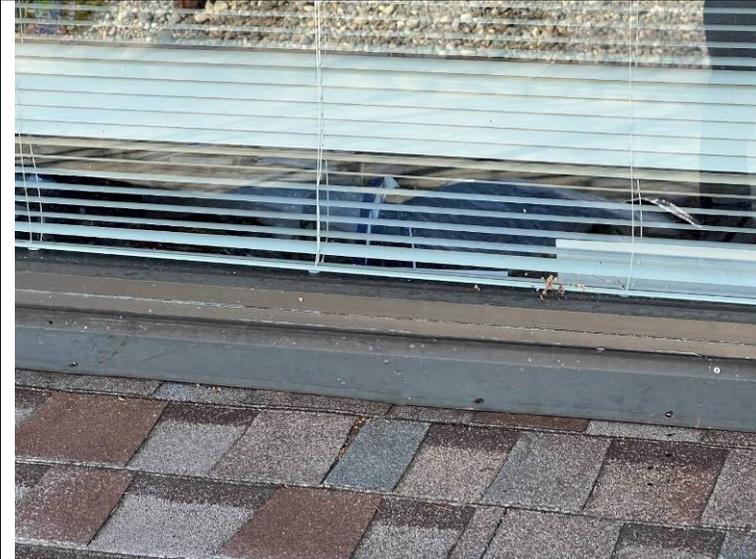
Photograph 29: Closer view of the base of the windows shown in Photograph 27.

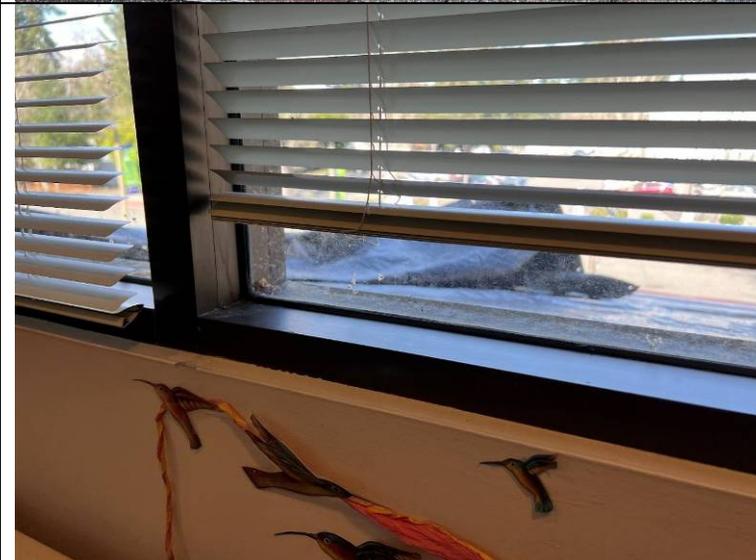
Photograph 30: Closer view of the bottom of the windows shown in Photograph 27 as seen from the interior.

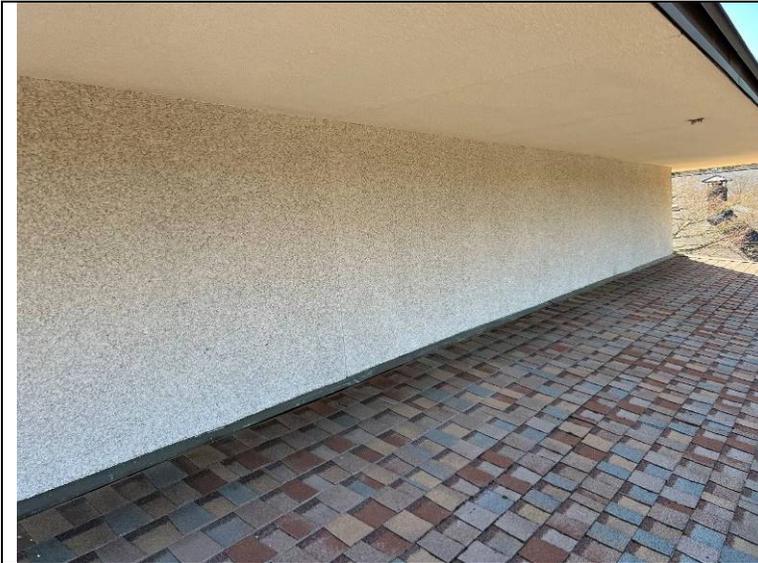
Photograph 31: Typical marblecrete clad rising wall above the lower roof.

The marblecrete comes down to the surface of the roof and transitions to the roofing with sheet metal flashing.

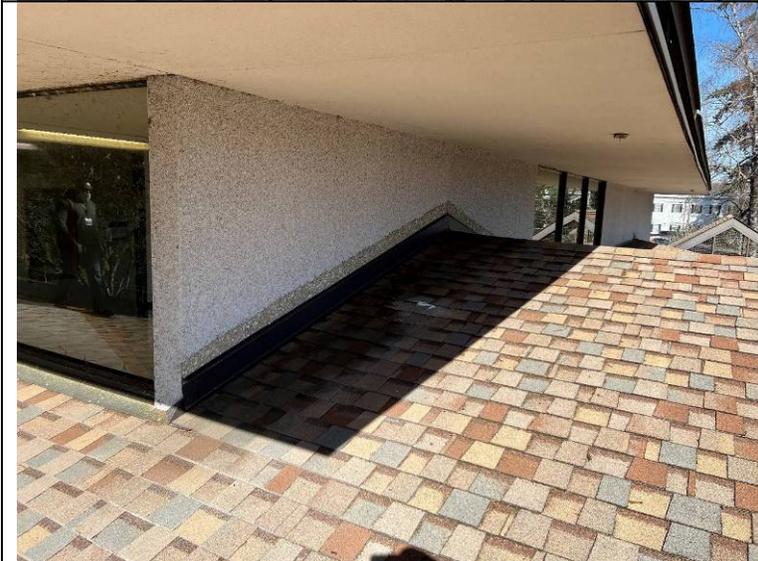
Photograph 32: Roof to wall transition along a rake wall.

The apparent different color in the marblecrete indicates that the marblecrete was reworked. The flashing height at this location differs from areas where the marblecrete was not reworked.

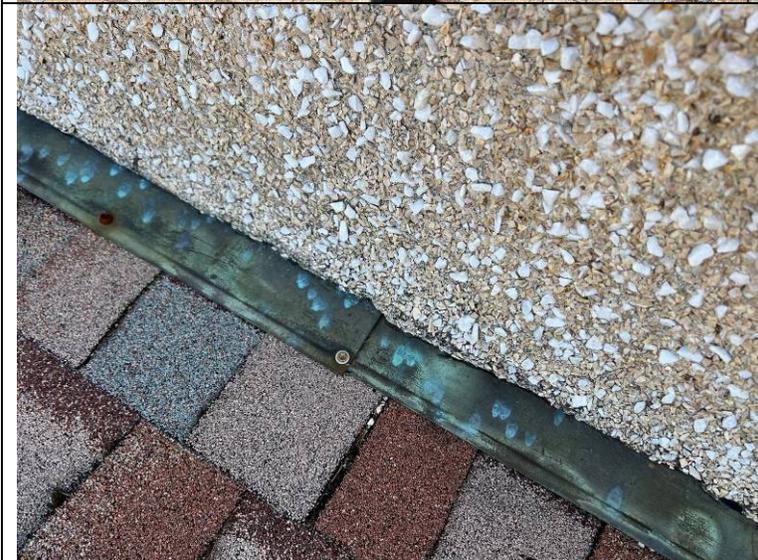
Photograph 33: Closer view of the headwall flashing.

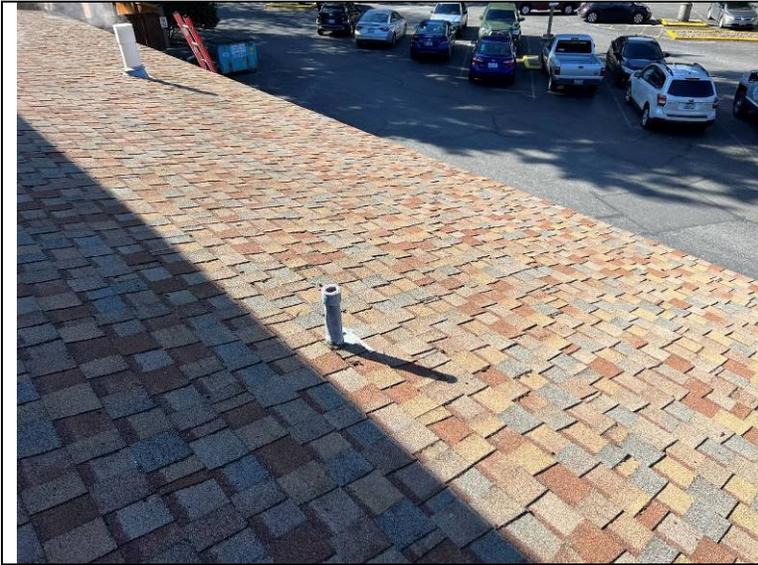
Photograph 34: Typical pipe penetration flashed with a lead penetration flashing.

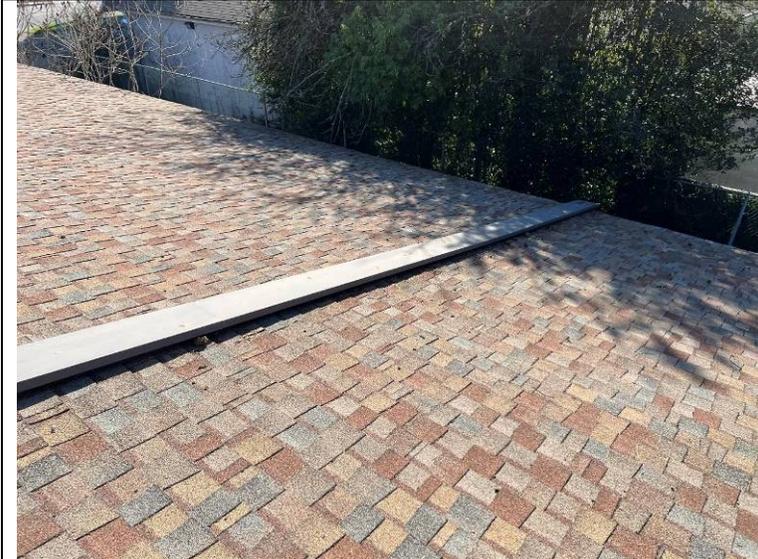
Photograph 38: Sheet metal cover over an area dividing wall.

This is situated at the transition between the original building and the 1974 expansion.

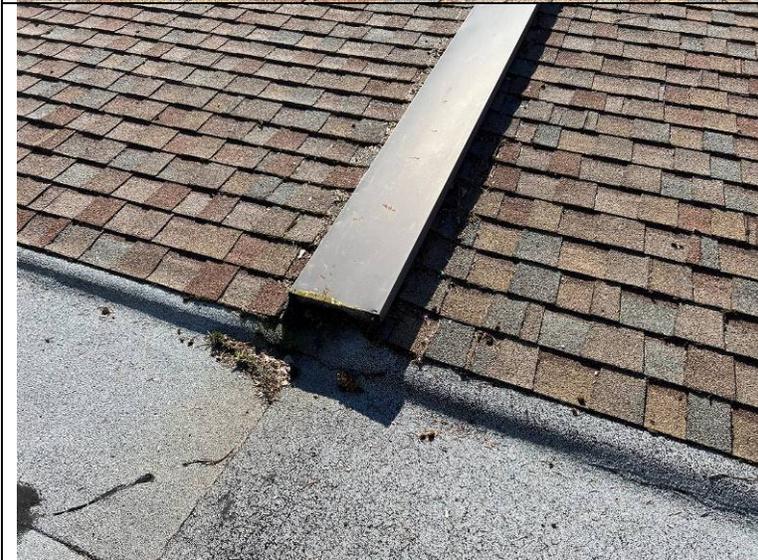
Photograph 39: Closer view of the sheet metal cover shown in Photograph 38.

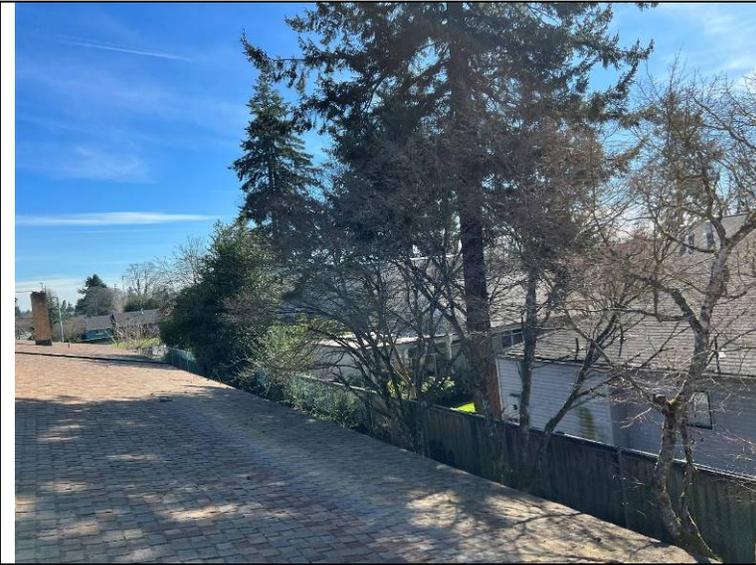
Photograph 40: Overview of the south sloping roof and trees within close proximity of the roof.

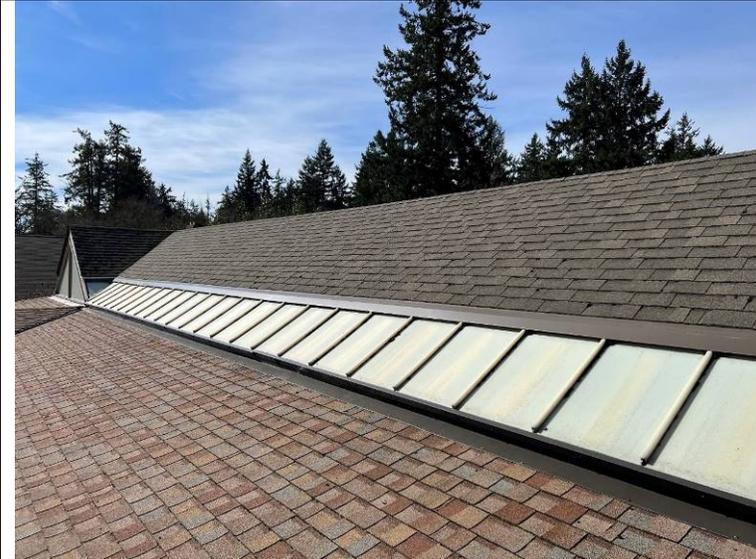
Photograph 41: Low roof to high roof transition at the translucent skylight panels.

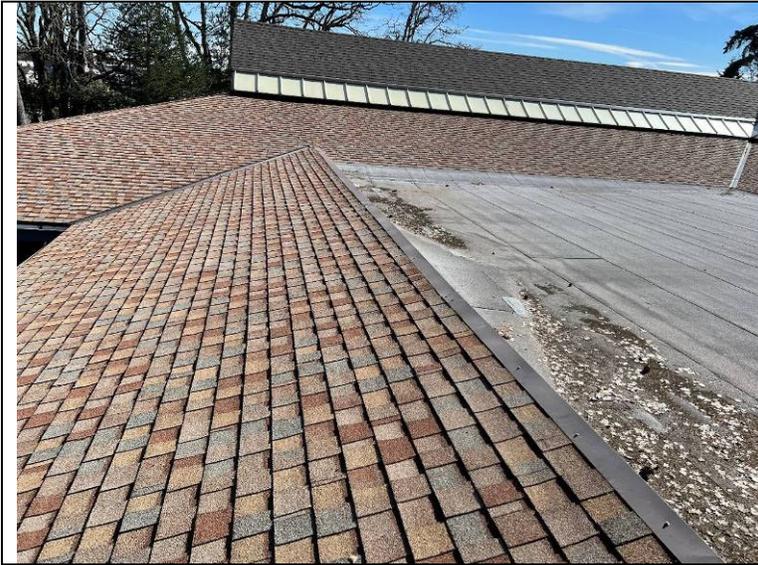
Photograph 43: Steep slope to low slope roof transition.

The leading edge of the shingle roof is terminated with sheet metal flashing.

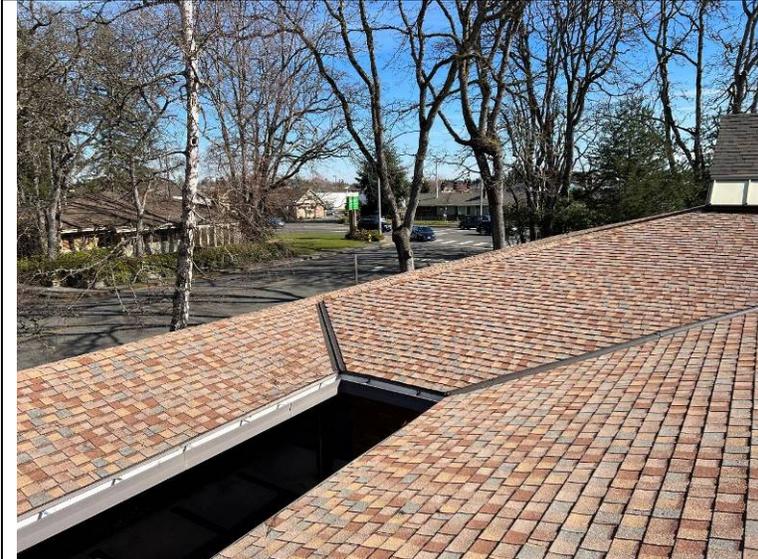
Photograph 44: Opening in the roof at the north central side of the roof.

The roof slopes to the draining edge and exterior hung gutter.

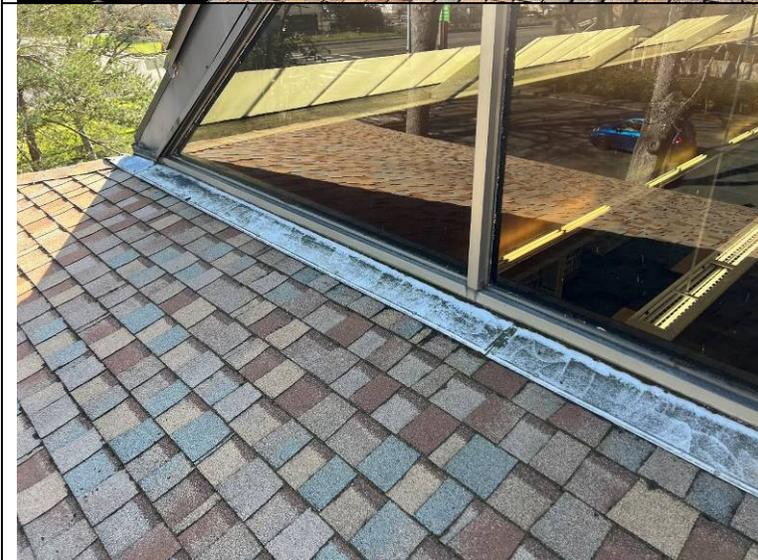
Photograph 45: Roof to clerestory transition.

Sheet metal flashing appears to be integrated under the clerestory windows.

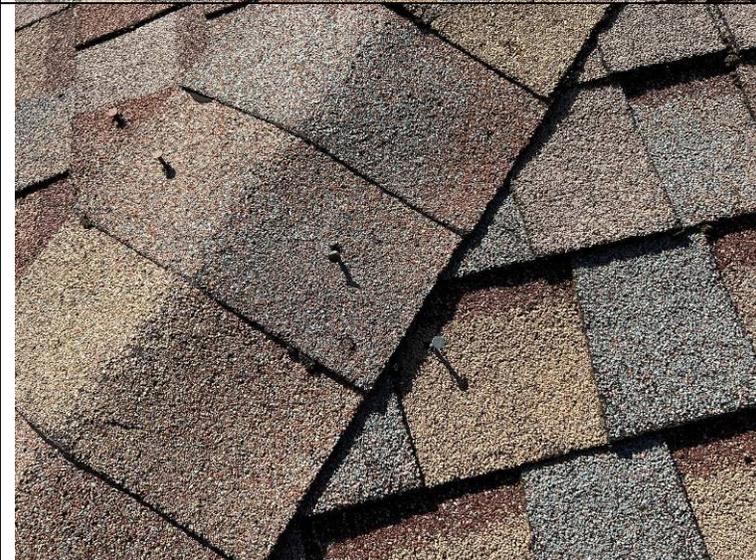
Photograph 48: Closer-up view of the backed-out nails.

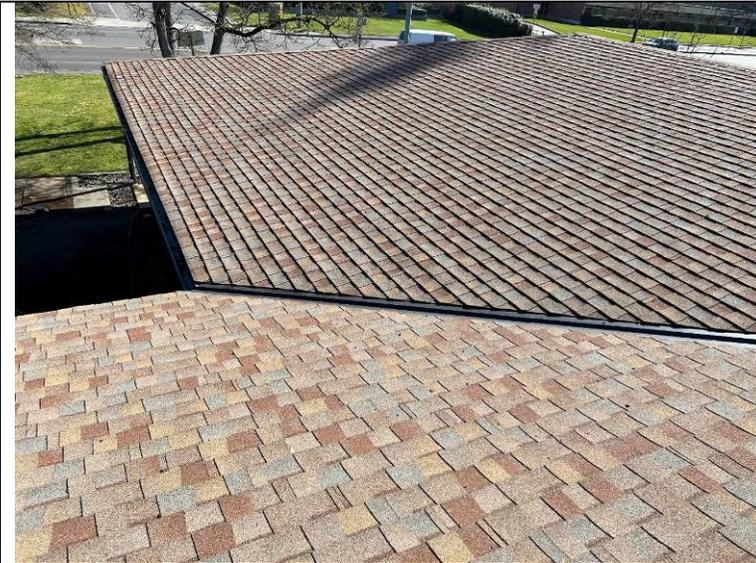
Photograph 49: Typical valley at the lower roofs configured with a sheet metal valley flashing.

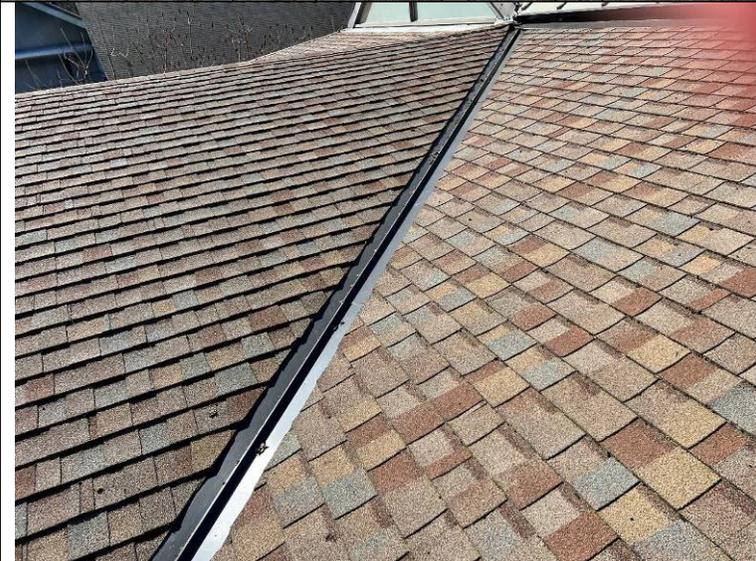
Photograph 50: Closer view of the sheet metal valley flashing.

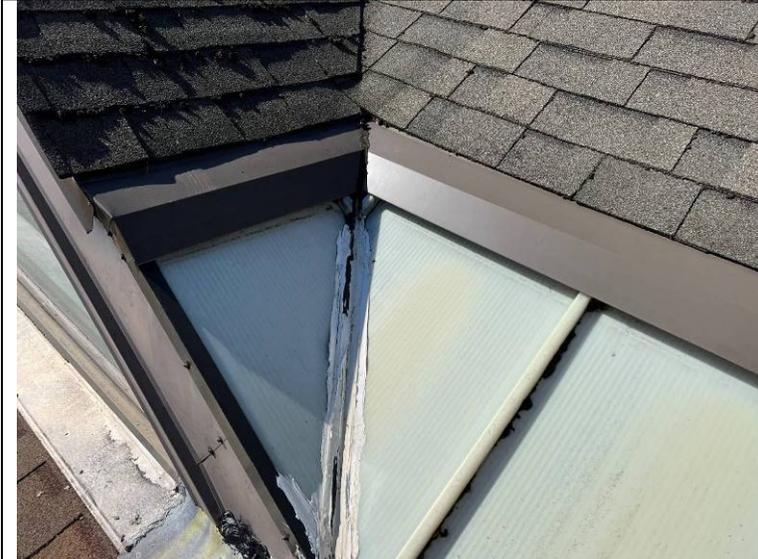
A leak (marked with a 2) was reported in an area below the transition between the skylight and steep slope roof. Application of sealant at the skylight appears to be aged indicating that water entry in this location has likely occurred multiple times. A new application of roof cement at the bottom of the skylight by Wayne's Roofing prior to this writer's site visit has reportedly stopped the water entry. The skylight panels and area below can be cleaned and prepped and an application of Alsan RS can be applied over the area as a long-term patch.

Photograph 53: Sealant at this location is older and was likely applied in response to previous water entry.

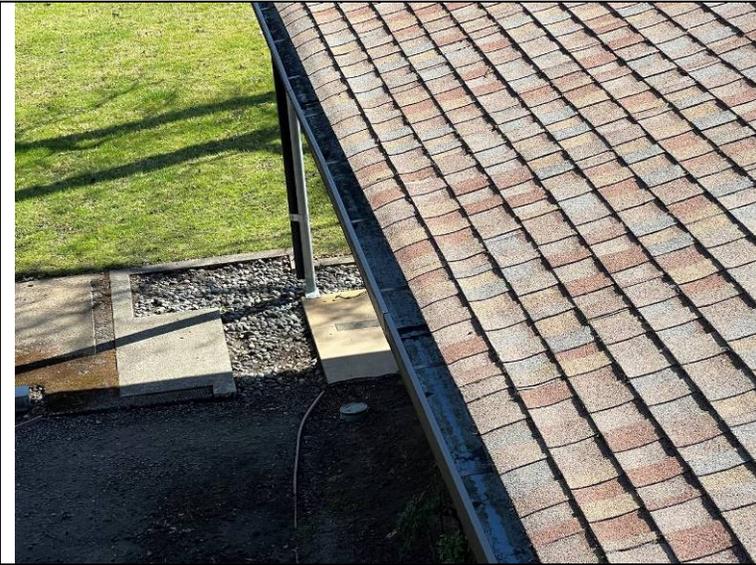
Photograph 55: Typical drainage detail with external hung gutter.

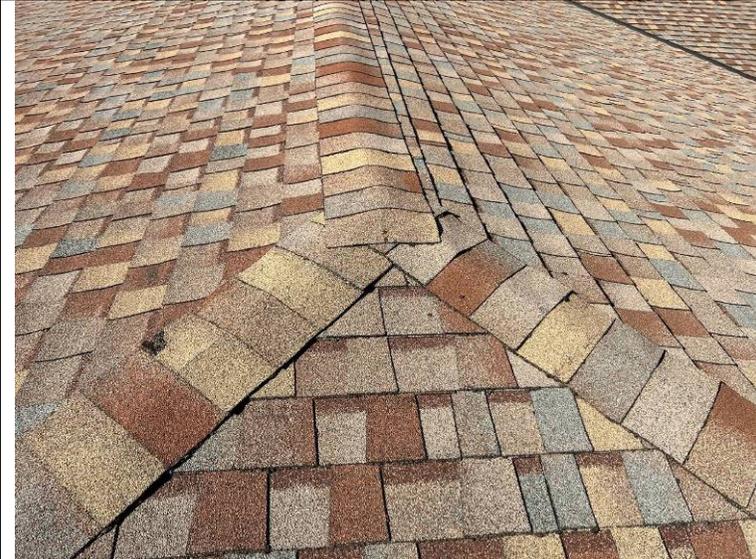
Photograph 56: Ridge to hip transition.

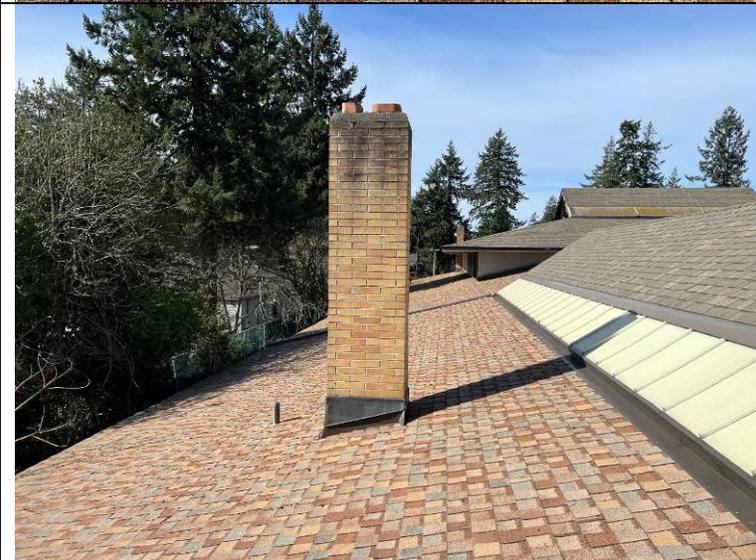
Photograph 57: Chimney penetration flashed with sheet metal flashing.

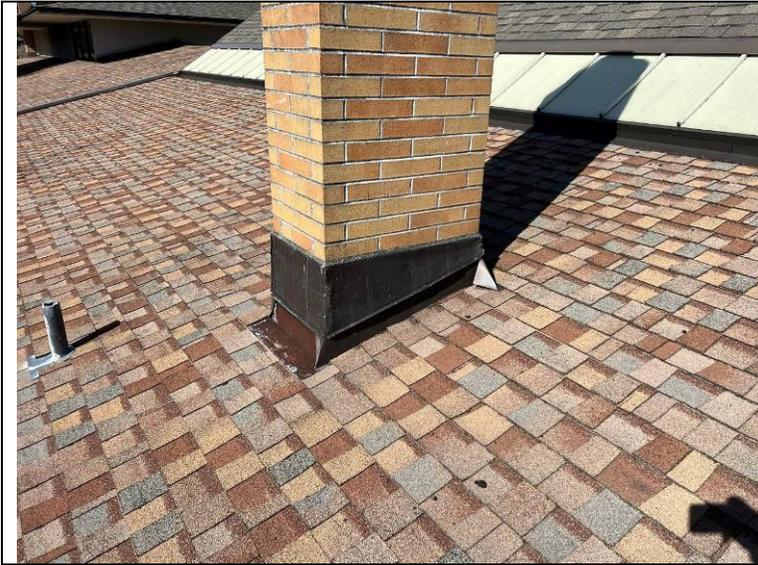
Photograph 58: Closer view of the chimney penetration shown in Photograph 57.

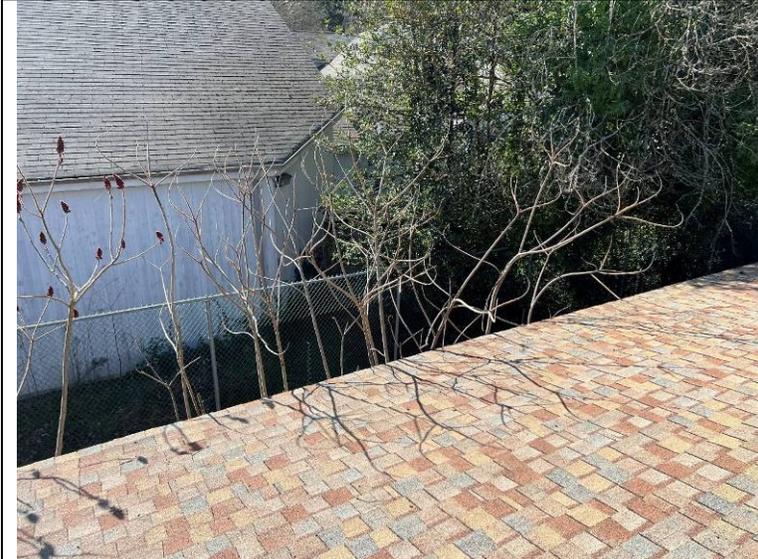
Photograph 59: Trees in close proximity to the roof along the south side of the roof.

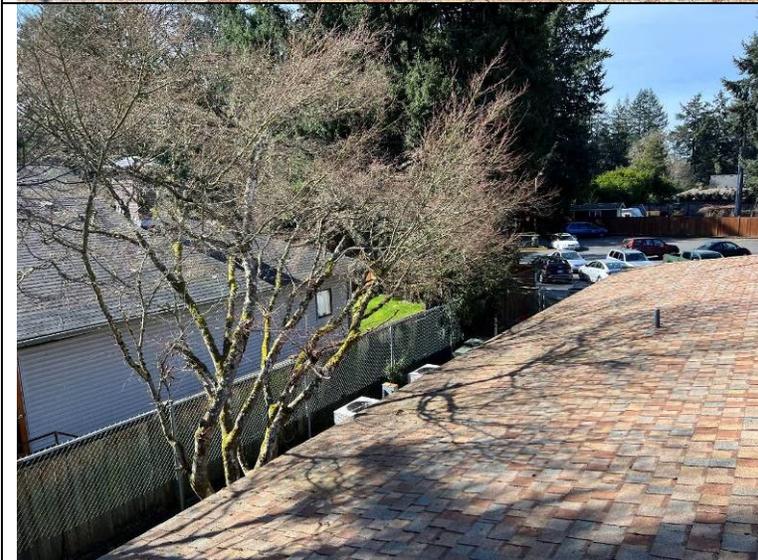
Photograph 60: Trees in close proximity to the roof along the south side of the roof.

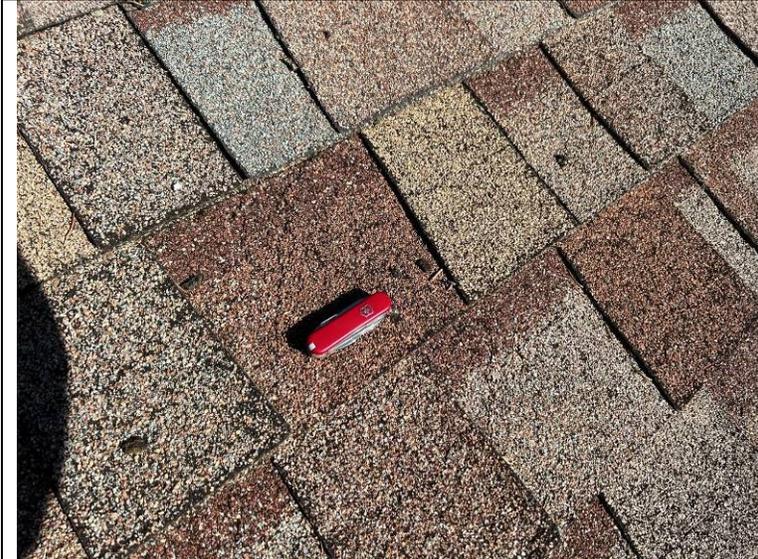
Photograph 62: Closer view of the surface of the shingles.

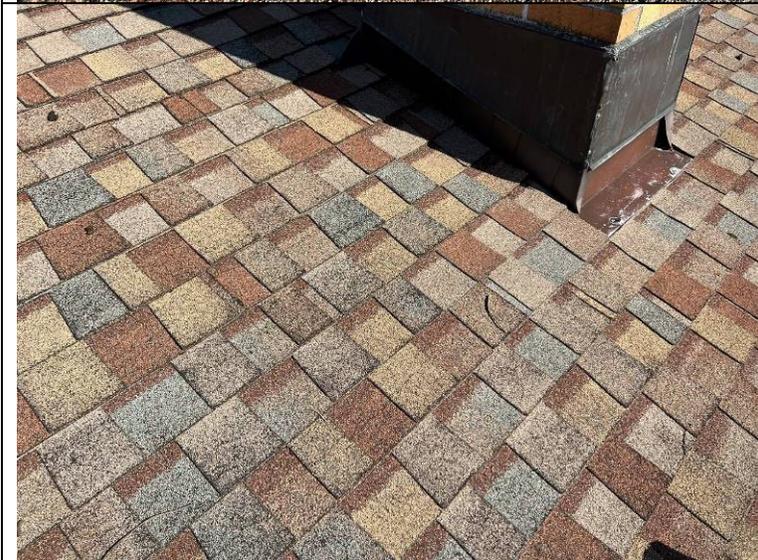
Photograph 63: Alternate view of an area with displaced mineral granules.

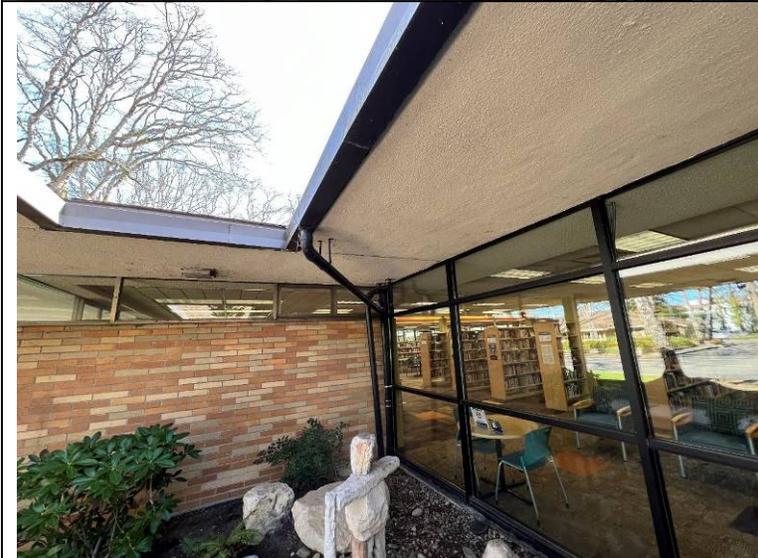
Photograph 69: Gutter downspout.

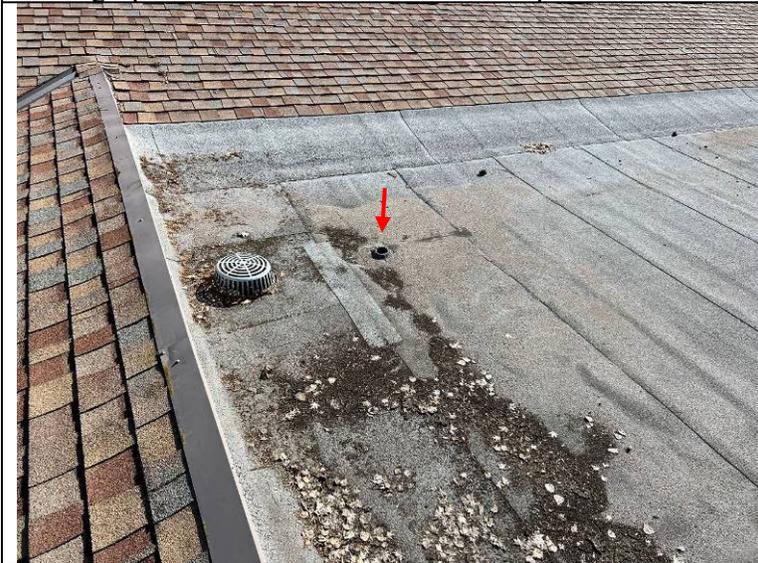
Photograph 74: Typical cast iron roof drain and adjacent contractor style overflow (arrow).

Contractor style overflows consist of a pipe stubbed above the roof flashed into the roof with a lead flashing.

Organic debris is collecting on the surface of the roof.

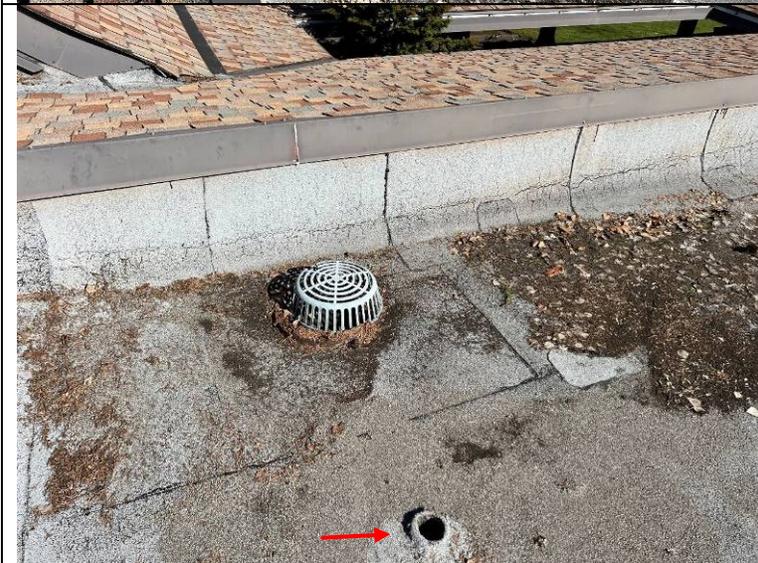
Photograph 75: Closer view of a cast iron roof drain and contractor style overflow (arrow).

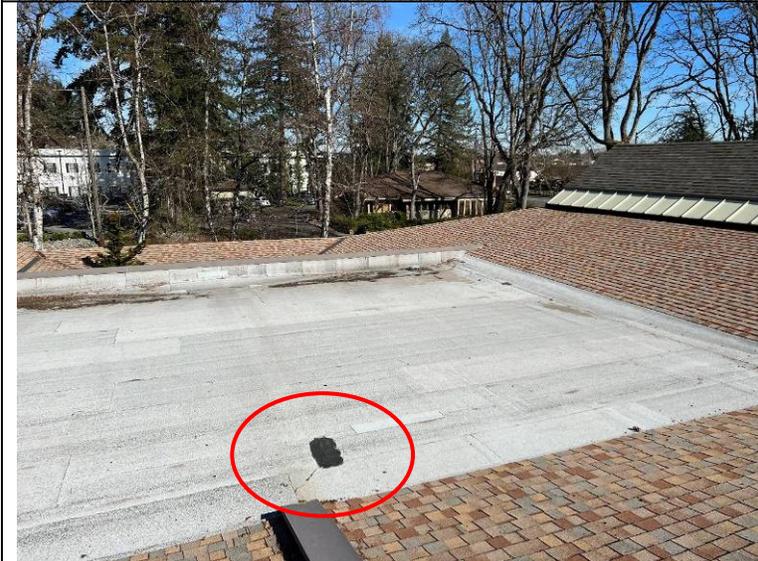
Photograph 77: Roof cement patch over an apparent location of damage.

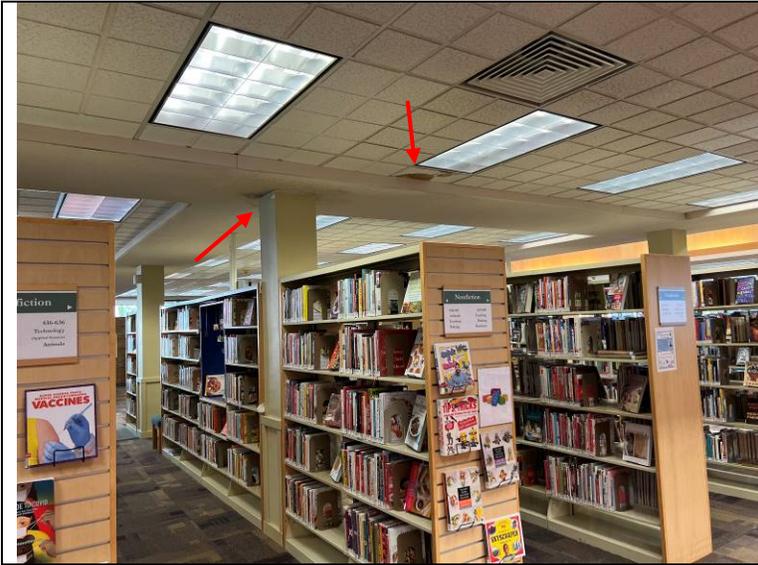
Photograph 79: Approximate area beneath the roof cement patch shown in Photographs 77 and 78.
