**Lakewood Pierce
County Library building
condition assessment,
roof evaluation, and
structural engineering
reports**

LWD Building Analysis – Executive Summary

Condition Assessment Report for Lakewood Library and Tillicum Library

**LAKESWOOD LIBRARY
ROOF EVALUATION
MARCH 10, 2022**

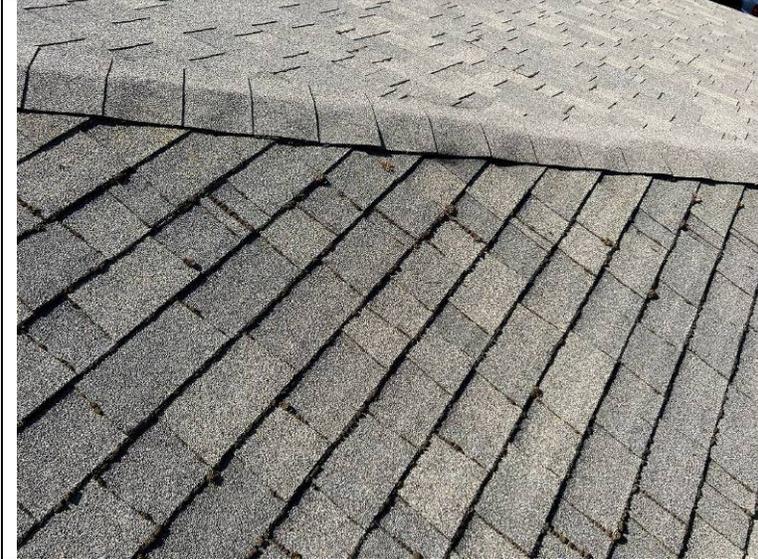
Photograph 89: Moss growth along the perimeter of the shingles.

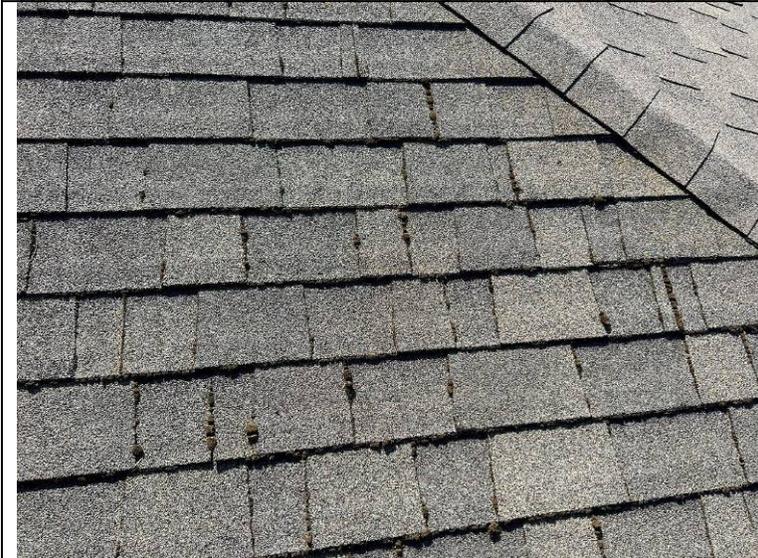
Photograph 90: Alternate view of the moss growth at the upper roof.

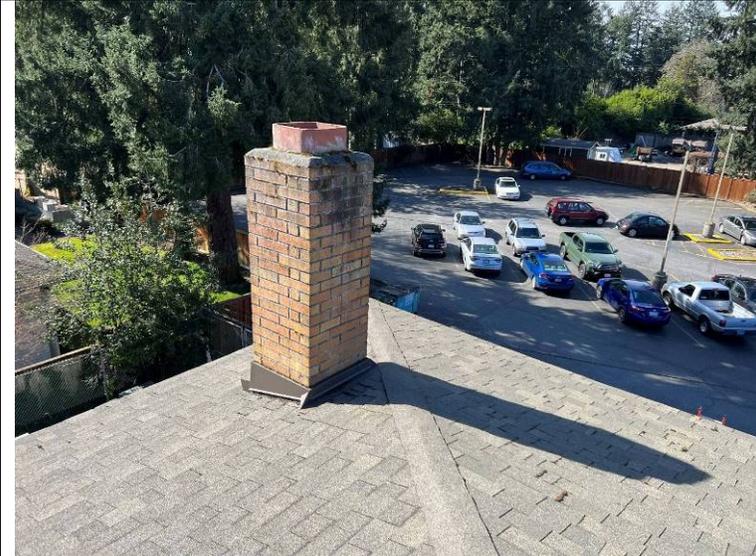
Photograph 92: Chimney penetration at the upper roof.

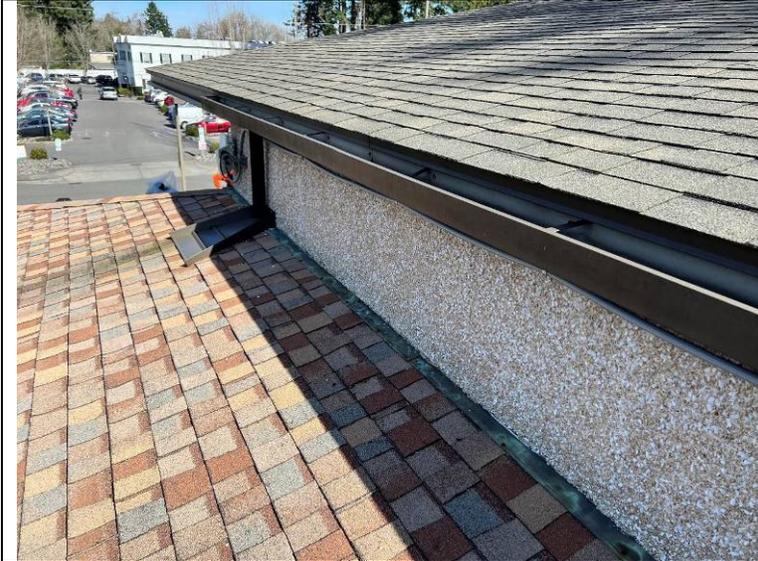
Photograph 98: Draining edge and gutter at the upper roof.

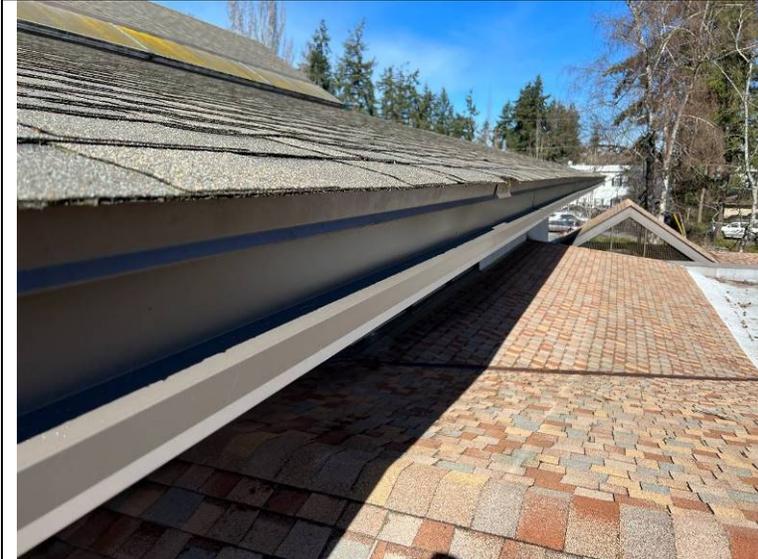
Photograph 101: Eave edge without a gutter.

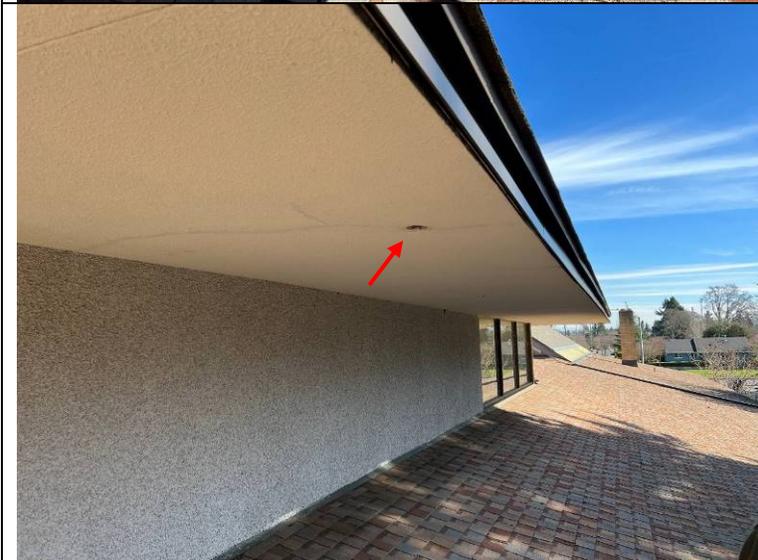
Photograph 102: Soffit above the low roof.

Arrow indicates a hole in the soffit.

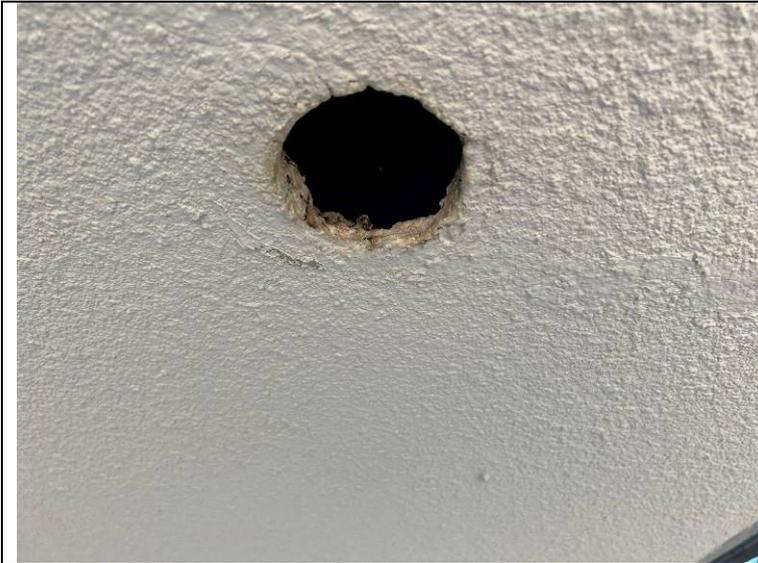
Photograph 103: Closer view of the hole indicated by the arrow in Photograph 102.

Holes in the soffit should be covered to prevent rodent or insects from entering into the building.

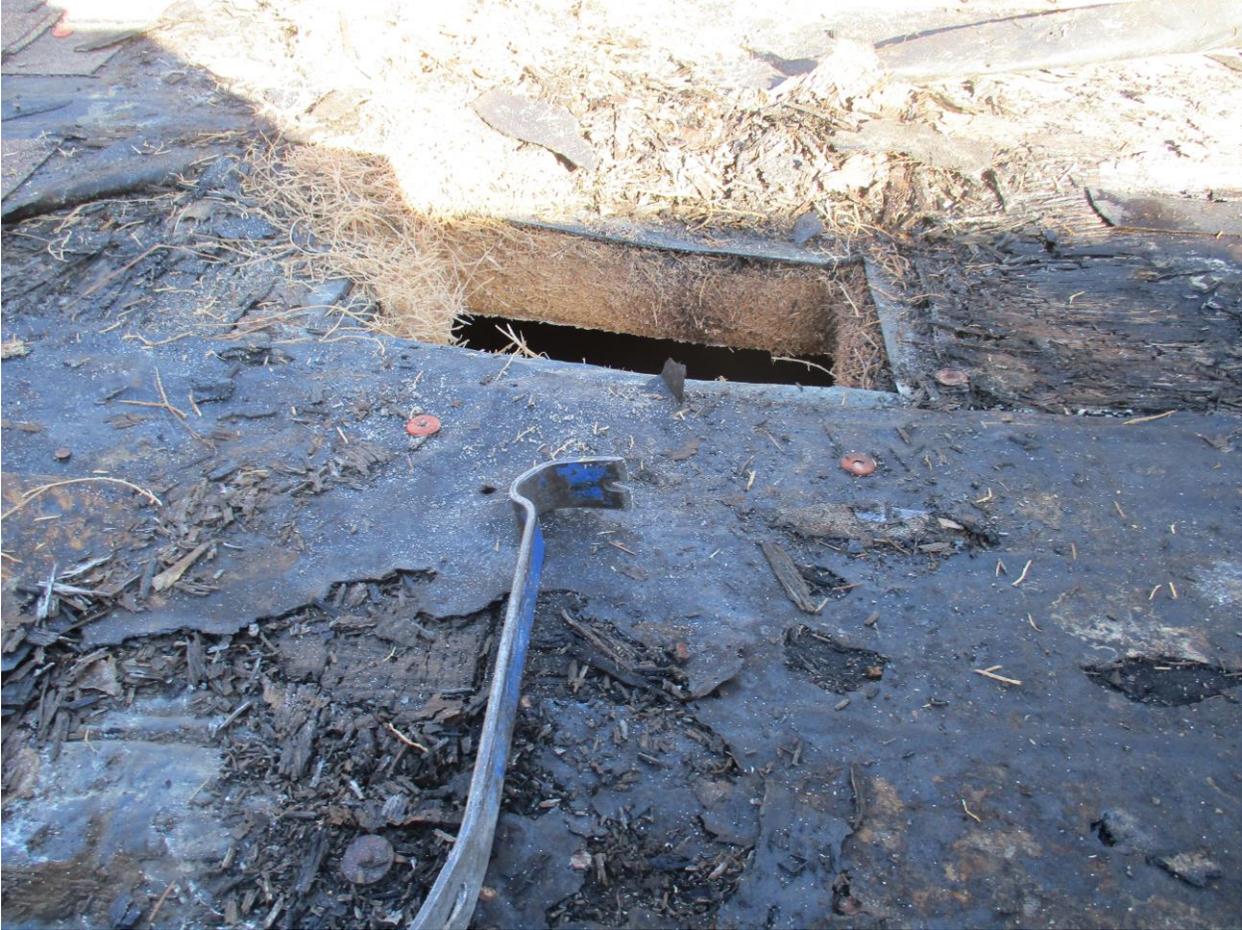
Photo 2 – Tectum Structural Panel Section

1. Roof System Exposed at North side of Building – The roof in this area consisted of asphalt shingles over underlayment, plywood sheathing over the cementitious wood fiber substrate board commonly called Tectum. As the roof was removed from the areas of investigation the plywood was significantly deteriorated. See photo #1 which shows the underlayment and what is left of the plywood sheathing. The wood fiber could also be observed in this photo. We had the contractor cut through the whole roof system to view the sub structure. Photo #2 shows the Tectum approximately 4” thick with some water damage. The Tectum panels support the roof structure by spanning between the roof beams. Photo #3 shows how deteriorated the Tectum is in another test location. Once the roof gets wet the plywood and Tectum loose strength and start to deflect causing more water damage. The deflection noticed in some roof areas will likely be areas where water damage has occurred. This lower roof system investigated has extensive damage in some locations. We recommend that this area of the roof be replaced with a new decking system supported by the existing structural steel roof system.

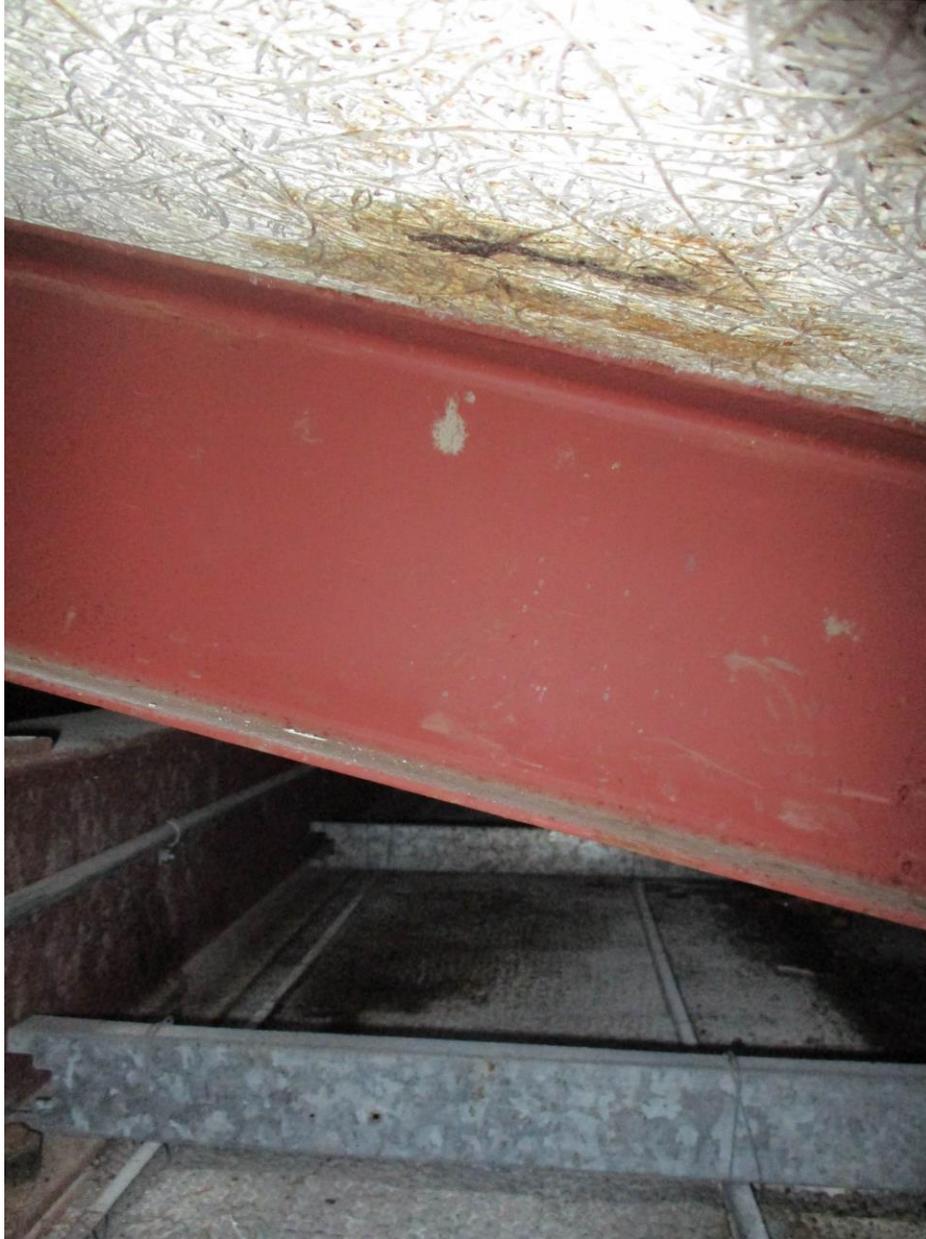
Photo 4 - Structural Steel Beams & Soffit Framing

2. Steel Beam Roof Supports – We were able to observe the structural steel beam that supports the Tectum roof panel system by looking through one of the holes cut into the roof. It appears in the areas investigated that the tectum spans between steel roof beams with a spacing of approximately 6-7 feet. Photo #4 shows the red primed steel beam support in good condition. We did not observe corrosion of the steel beam in this one section investigated. When the roofing system is removed for a re-roof and corrosion is discovered simple grinding and recoating of the structural steel with primer could be easily accomplished. Should a decision to replace the roof system in this area be made, reconstruction could occur by taking out the Tectum system and using a metal deck system to span between the steel beam roof structure.
