W E T H E R H O L T   A N D   A S S O C I A T E S ,   I N C .

**LAKWOOD LIBRARY  
ROOF EVALUATION  
MARCH 10, 2022**

Pierce County Library System  
3005 112<sup>th</sup> Street E  
Tacoma, WA 98446

April 1, 2022

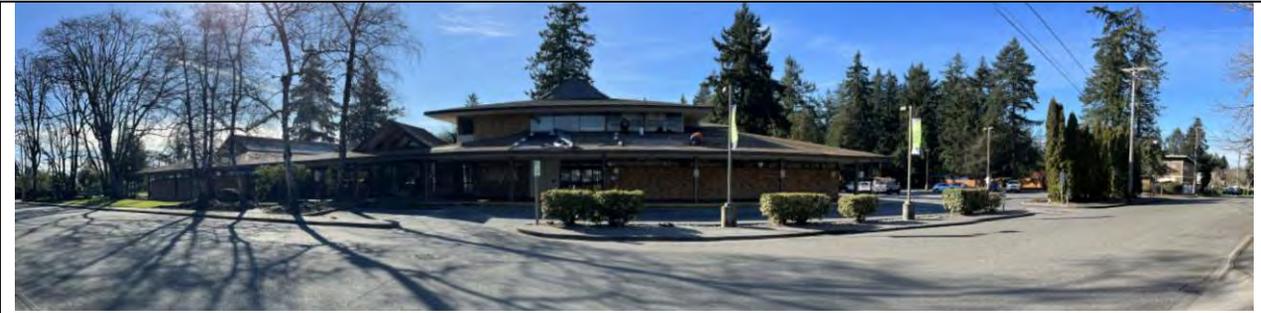
Photograph 1: Overview of the north elevation of the Lakewood Library.

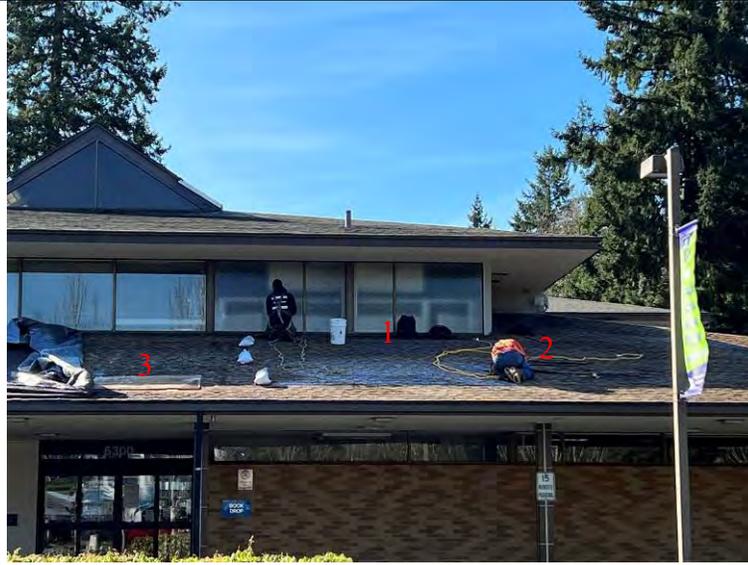
Photograph 2: Overview of the area where test openings 1-3 were made by Wayne's Roofing personnel.

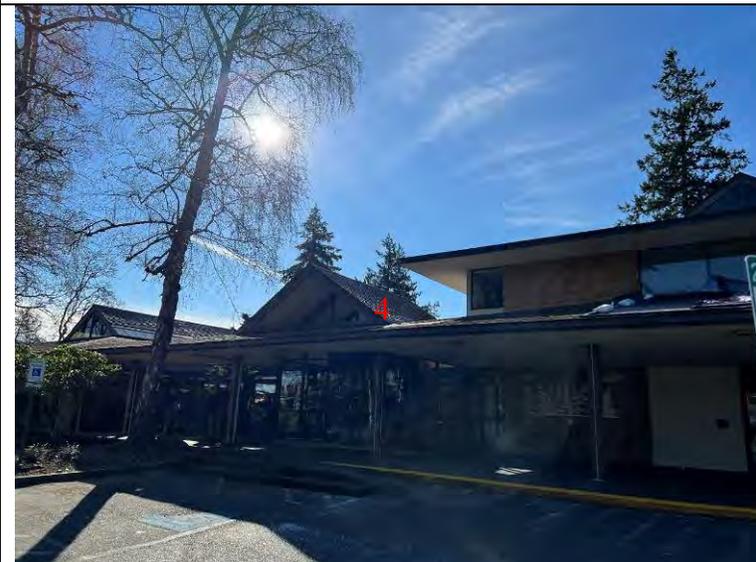
Photograph 3: Overview of the area where test opening 4 was made by Wayne's Roofing personnel.

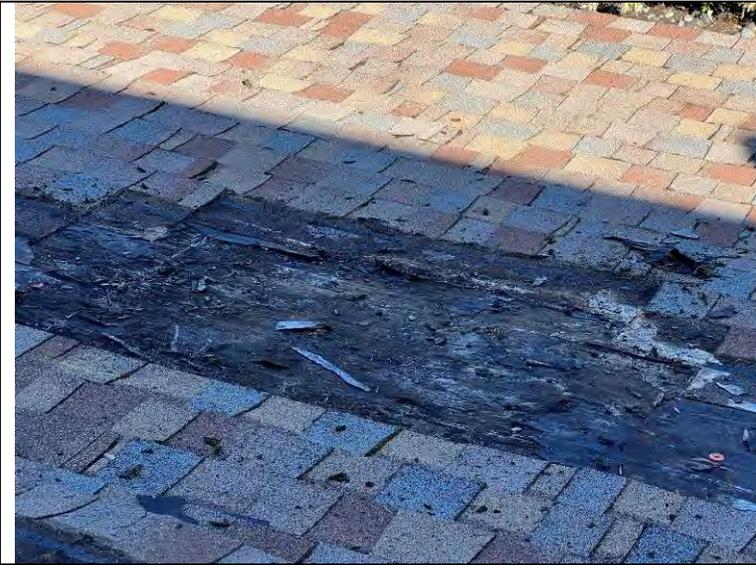
The plywood at this location which was exposed is deteriorated and black in color.

The underlayment was deteriorated.

Photograph 10: Closer view of the area shown in Photograph 9.

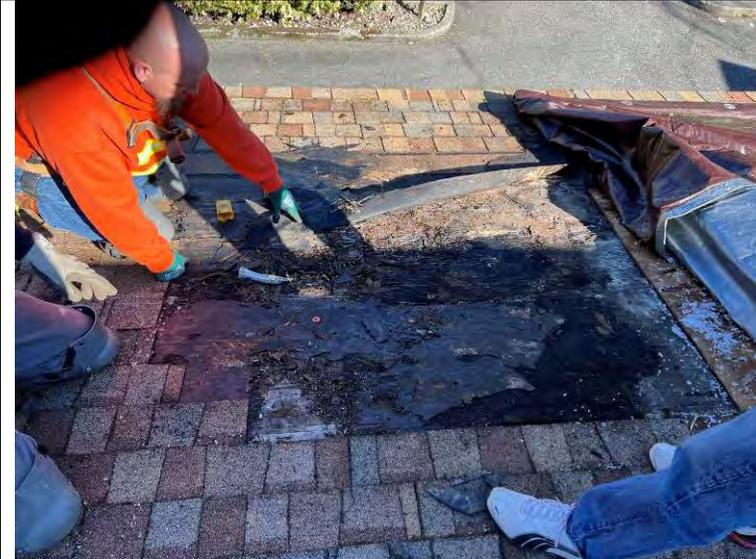
Photograph 11: Overview of opening location #3.

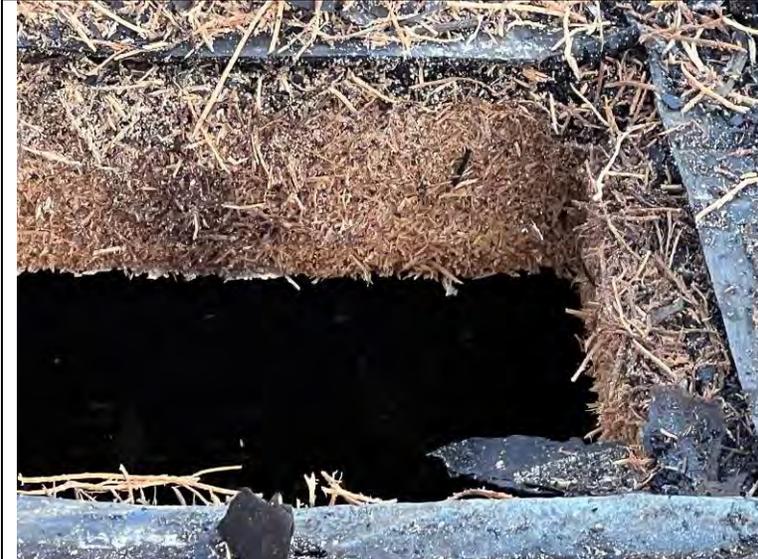
The cementitious wood fiber substrate board is deteriorated in many areas, and likely not serviceable to maintain a solid substrate for a new roof system. Where observed cementitious binder was washed away leaving only the wood fibers. The lack of binder has caused the cementitious wood fiber substrate board to weaken and deflect. The deflecting substrate boards cause the shingles to deflect, further exacerbating water entry as water can travel laterally creating further water entry and damage.

Photograph 14: Closer view of the cementitious wood fiber substrate board at the test opening.

The lower roof areas to the north and west of the second story (west half of the building) are no longer serviceable. The existing roof system, plywood, and cementitious wood fiber substrate board should be removed to expose the steel structure. Any needed repairs to the steel structure should be performed once exposed. This scope of work will create a condition where the interior under the roof areas noted will be exposed to weather.

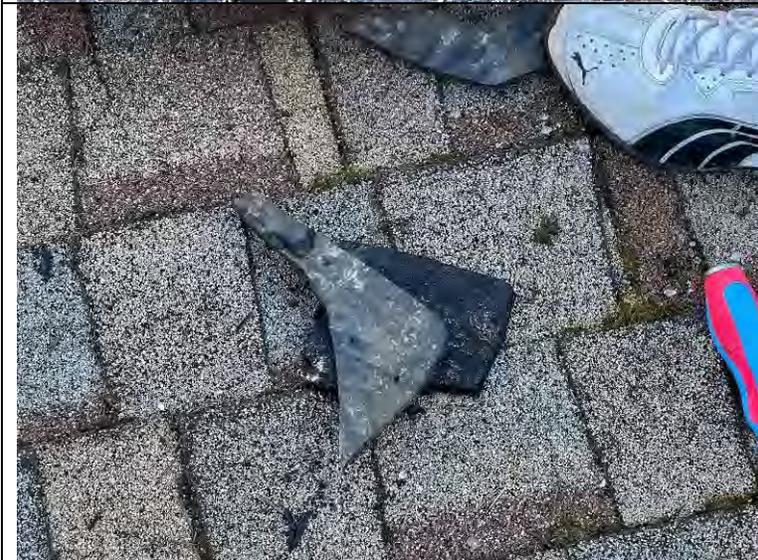
Photograph 15: Asphaltic membrane with a polyethylene surfacing.

The asphaltic membrane was situated over the cementitious wood fiber substrate board.

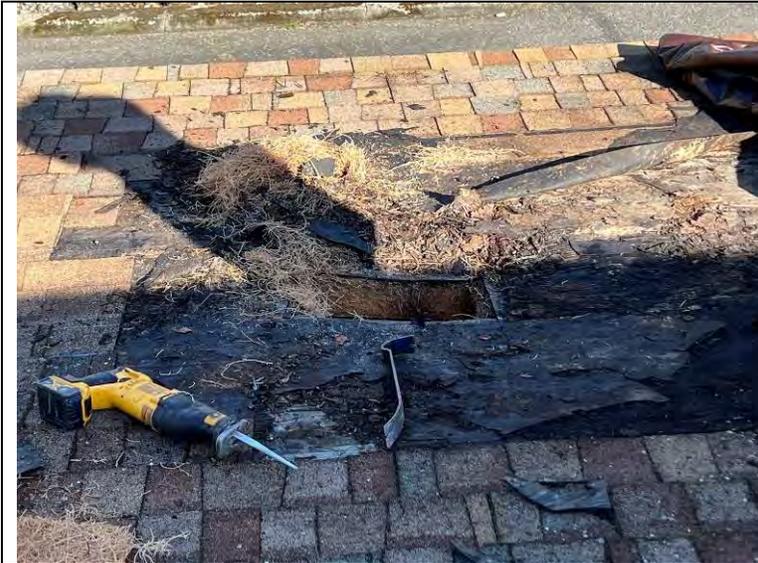
Photograph 16: Alternate view of test opening #3.

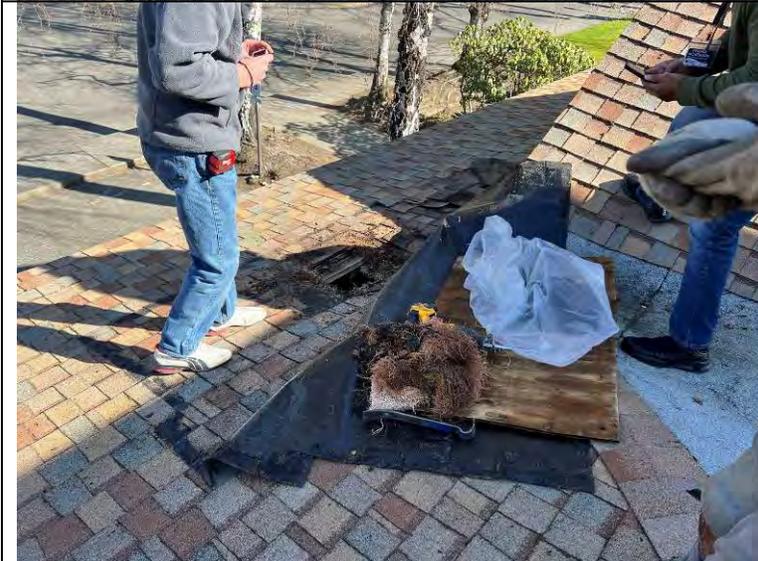
Photograph 17: Overview of test opening #4.

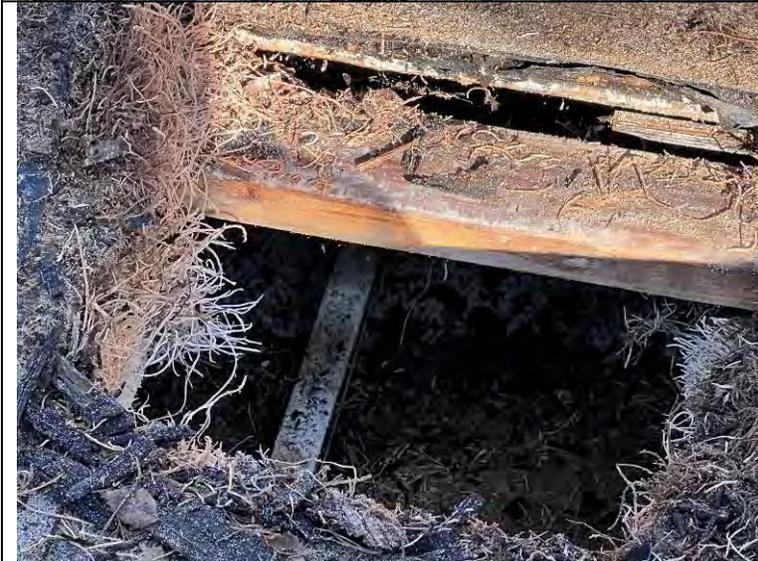
Photograph 20: Alternate view of the area shown in Photograph 19.

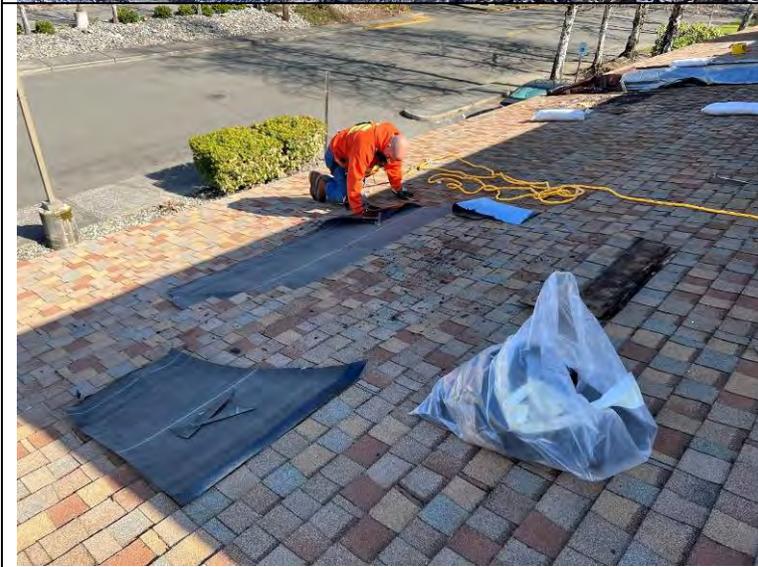
Photograph 21: Temporary roof repairs were made with self-adhered membrane integrated into the shingles in a water shedding manner.

In locations where the plywood sheathing and cementitious wood fiber substrate board were deteriorated and could not support weight new plywood was placed over the opening prior to placing the patch.

Where previously installed the tarp was repositioned.

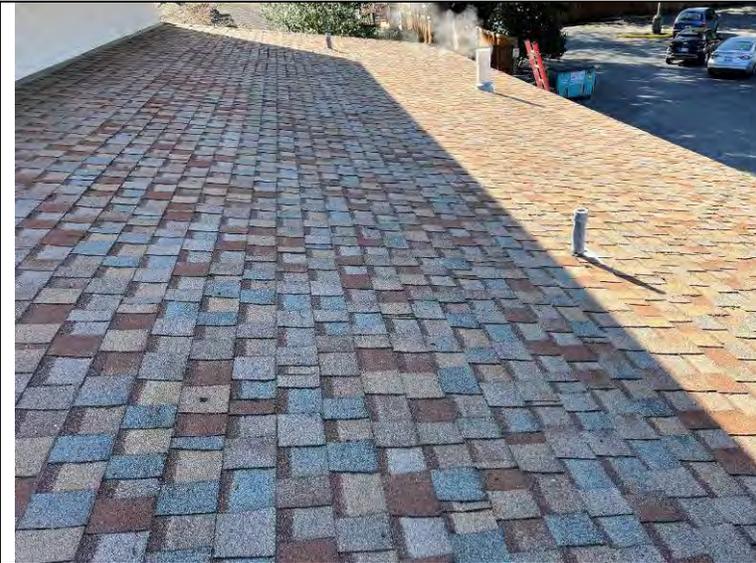
Photograph 22: Looking laterally across the Tamko architectural laminate shingles.

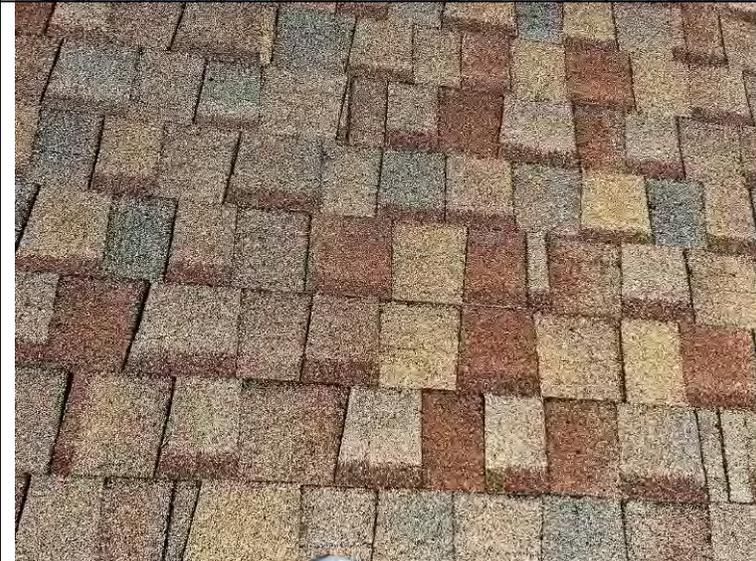
Photograph 23: Closer view of the Tamko architectural laminate shingles.

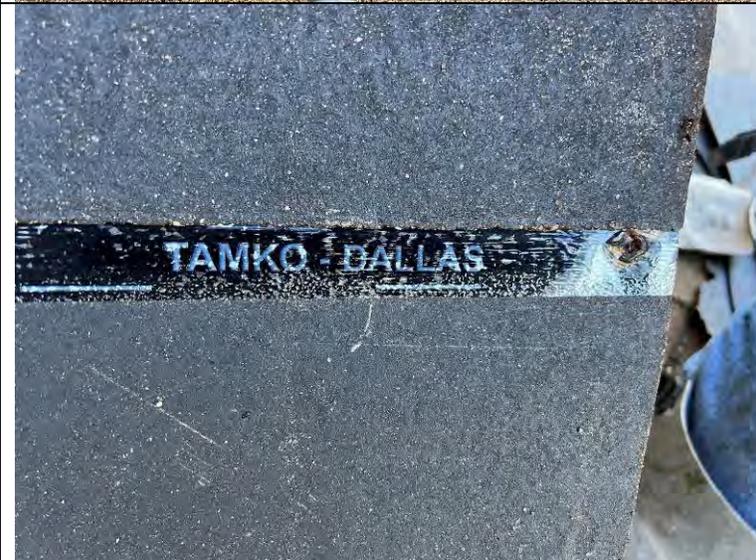
Photograph 24: Tamko label on the backside of one of the removed shingles.

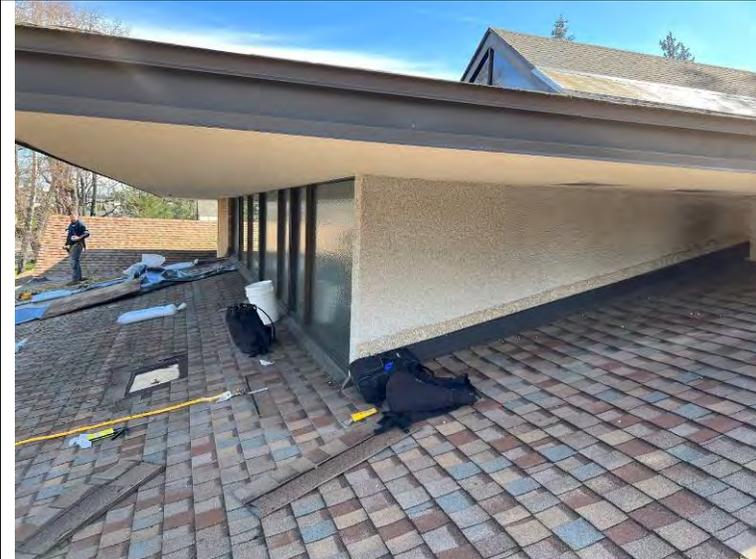
Photograph 26: Looking east along the rising window wall at the north sloping roof area.

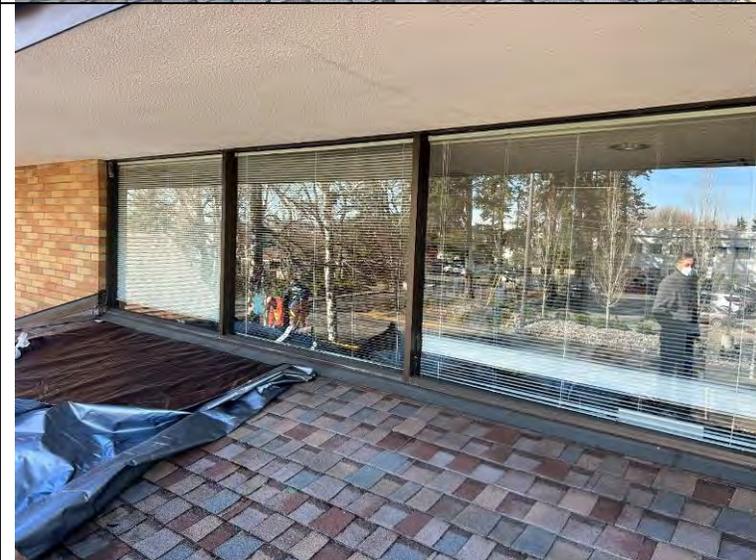
Photograph 27: Windows at the upslope edge of the north sloping roof area.  
The windows sit less than 5-inches above the surface of the roof.

To accommodate the thickness of the new roof system, the single pane aluminum windows at the rising wall above the lower roof should be removed and replaced with new. The marblecrete should be removed and replaced with new architectural sheet metal or fiber cement board cladding. The skylights should be replaced with new sloped aluminum framed skylights integrated into the roof system. The clerestory glazing at the ends of the skylights will need to be replaced with new smaller framed windows to accommodate the thickness of the new roof system. The new windows at the rising walls, and at the clerestories should be configured a minimum of 8-inches above the finished roof surface and properly flashed into the roof and openings.

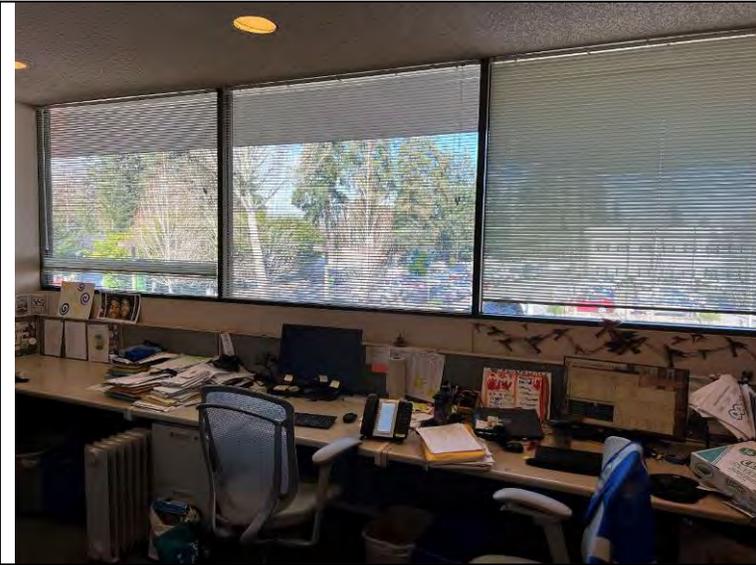
Photograph 28: Windows shown in Photograph 27 as seen from the interior.

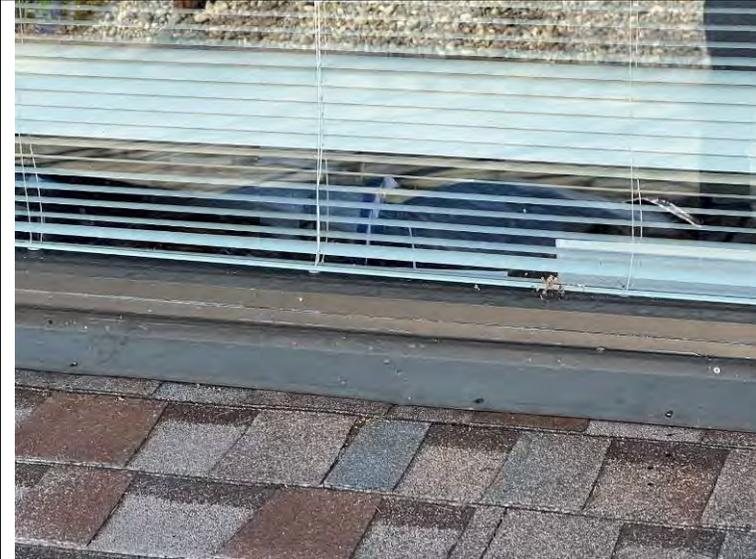
Photograph 29: Closer view of the base of the windows shown in Photograph 27.

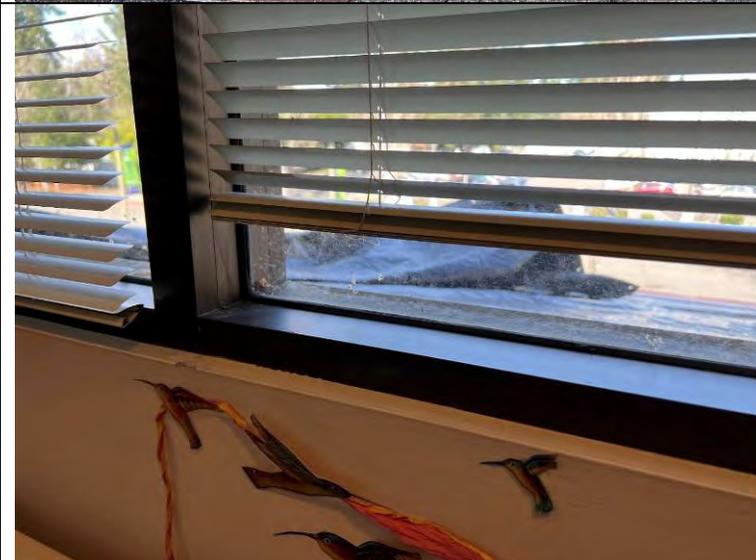
Photograph 30: Closer view of the bottom of the windows shown in Photograph 27 as seen from the interior.

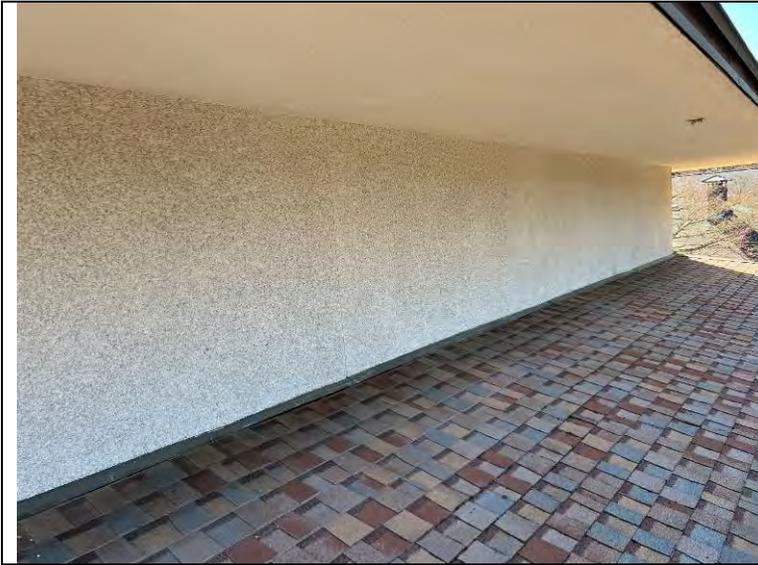
Photograph 31: Typical marblecrete clad rising wall above the lower roof.

The marblecrete comes down to the surface of the roof and transitions to the roofing with sheet metal flashing.

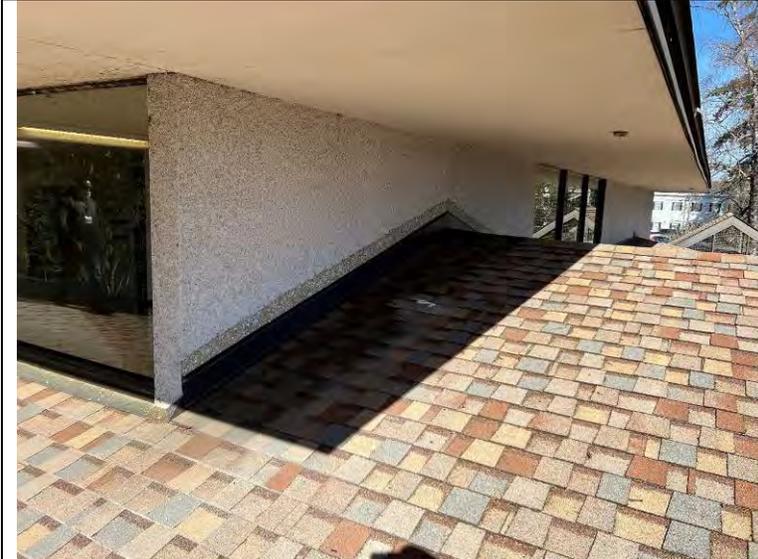
Photograph 32: Roof to wall transition along a rake wall.

The apparent different color in the marblecrete indicates that the marblecrete was reworked. The flashing height at this location differs from areas where the marblecrete was not reworked.

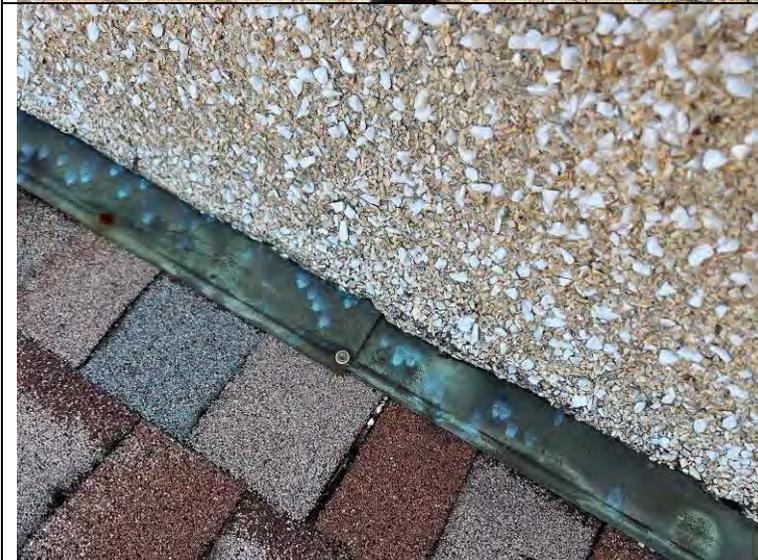
Photograph 33: Closer view of the headwall flashing.

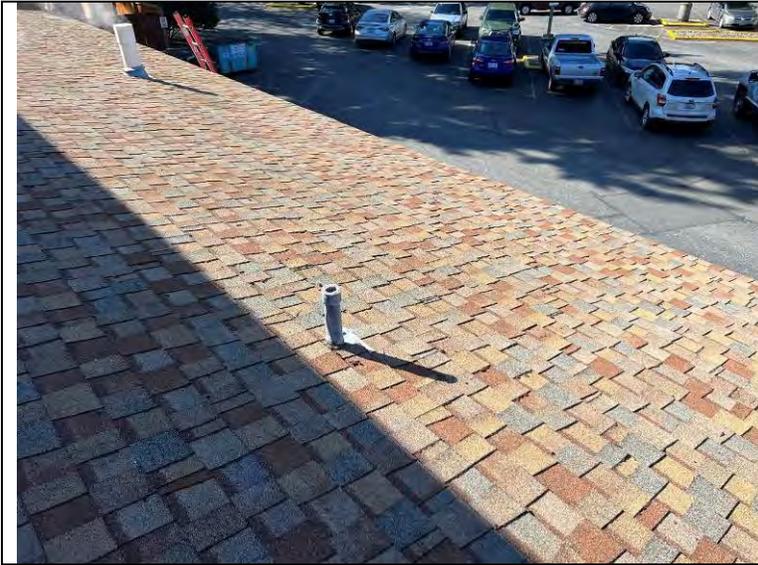
Photograph 34: Typical pipe penetration flashed with a lead penetration flashing.

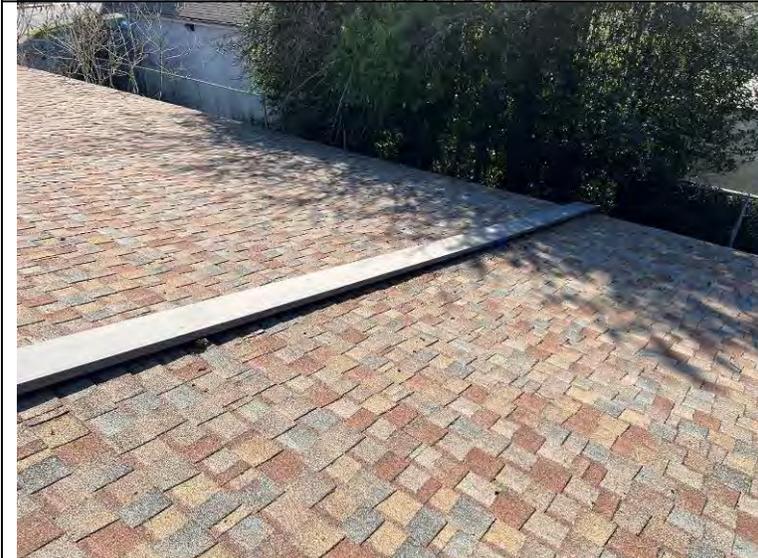
Photograph 38: Sheet metal cover over an area dividing wall.

This is situated at the transition between the original building and the 1974 expansion.

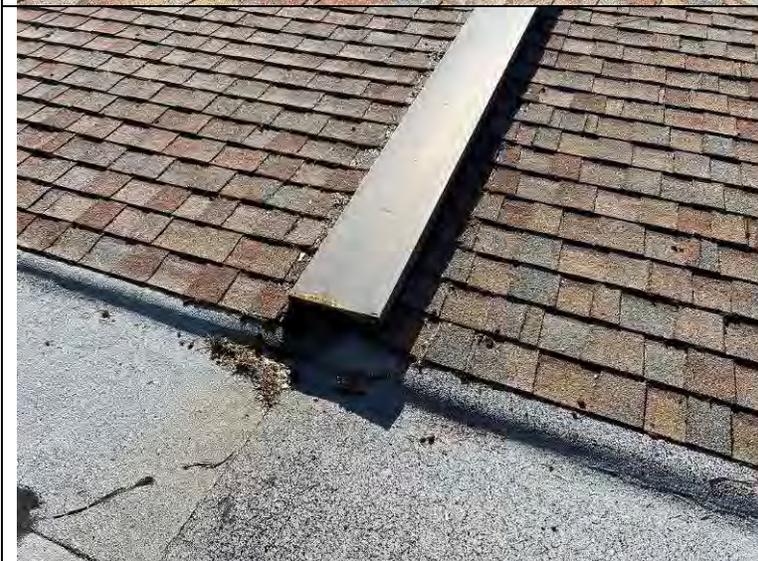
Photograph 39: Closer view of the sheet metal cover shown in Photograph 38.

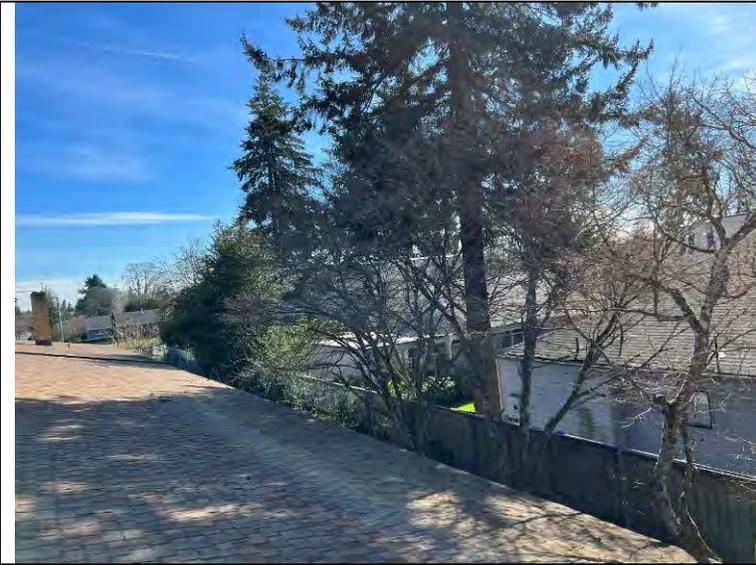
Photograph 40: Overview of the south sloping roof and trees within close proximity of the roof.

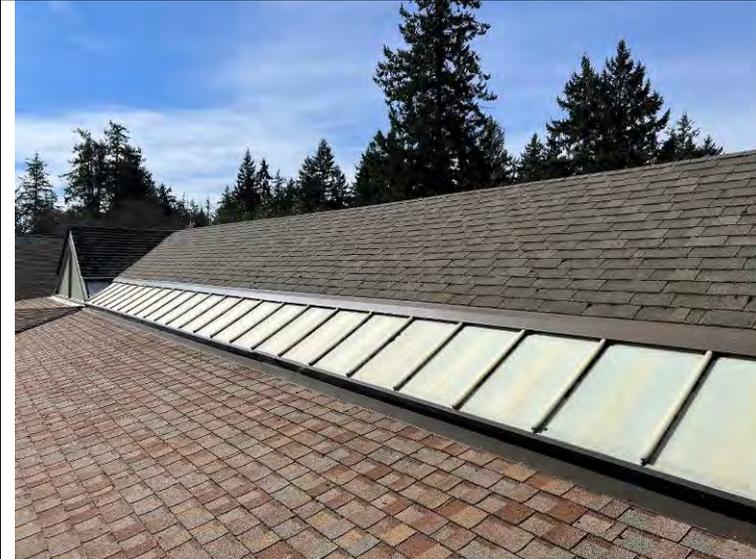
Photograph 41: Low roof to high roof transition at the translucent skylight panels.

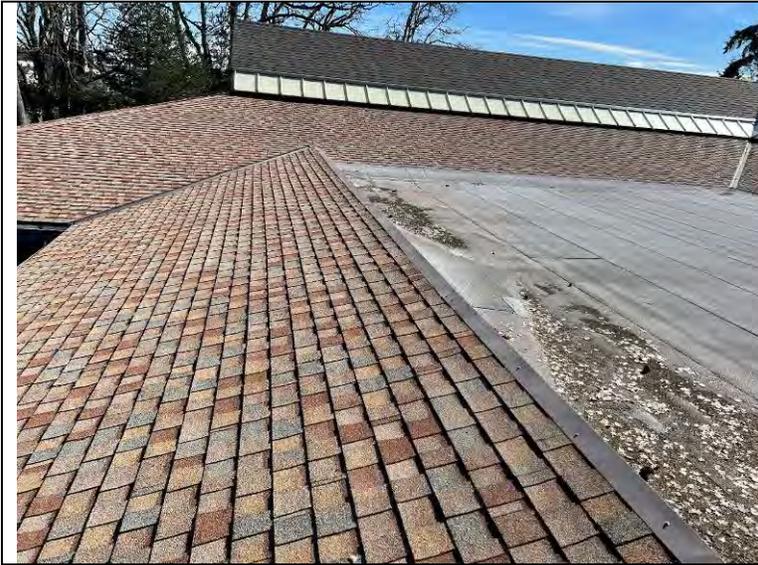
Photograph 43: Steep slope to low slope roof transition.

The leading edge of the shingle roof is terminated with sheet metal flashing.

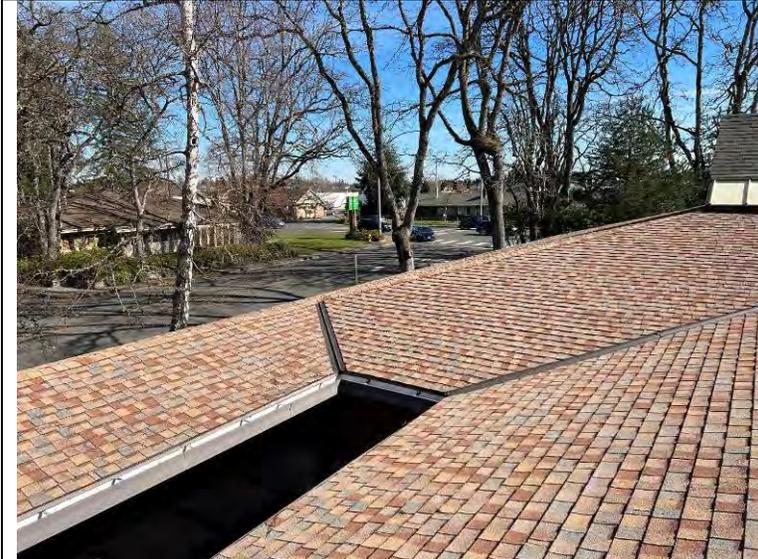
Photograph 44: Opening in the roof at the north central side of the roof.

The roof slopes to the draining edge and exterior hung gutter.

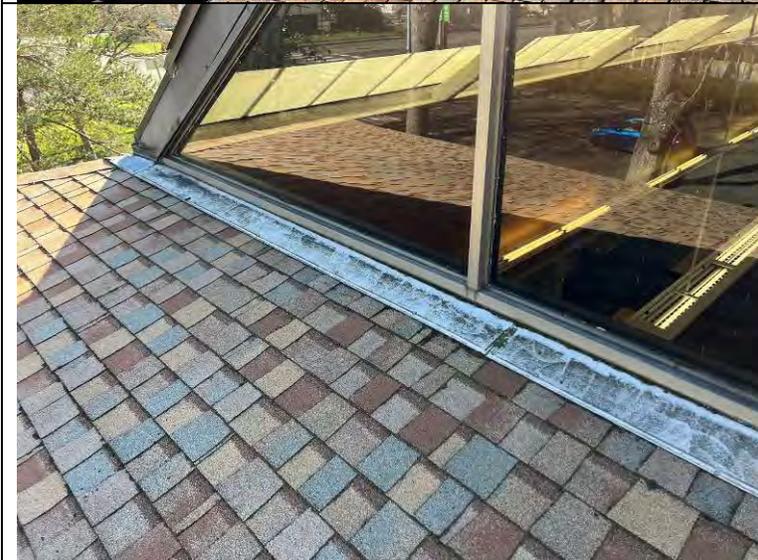
Photograph 45: Roof to clerestory transition.

Sheet metal flashing appears to be integrated under the clerestory windows.

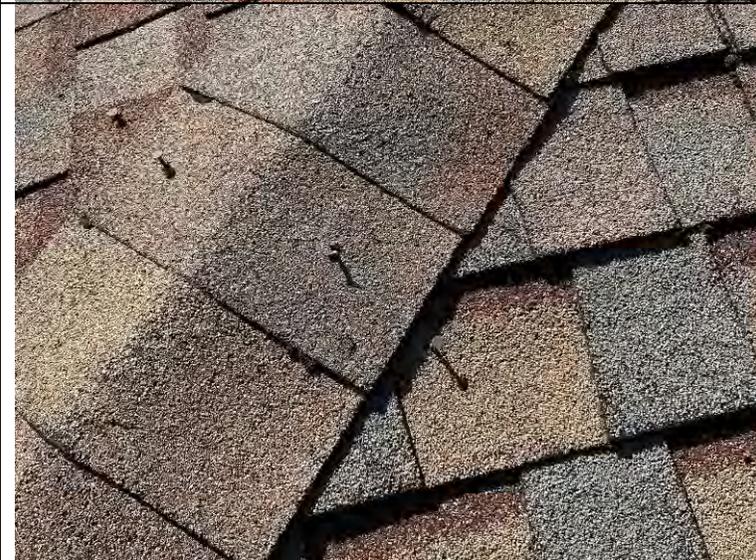
Photograph 48: Closer-up view of the backed-out nails.

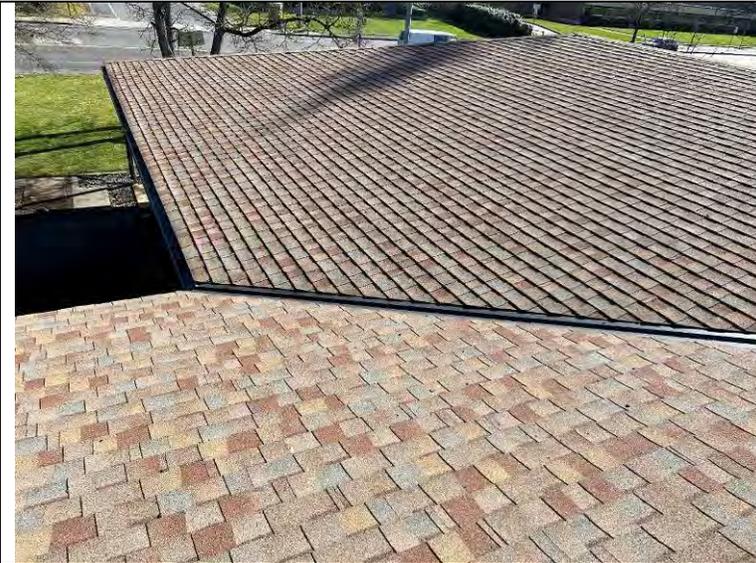
Photograph 49: Typical valley at the lower roofs configured with a sheet metal valley flashing.

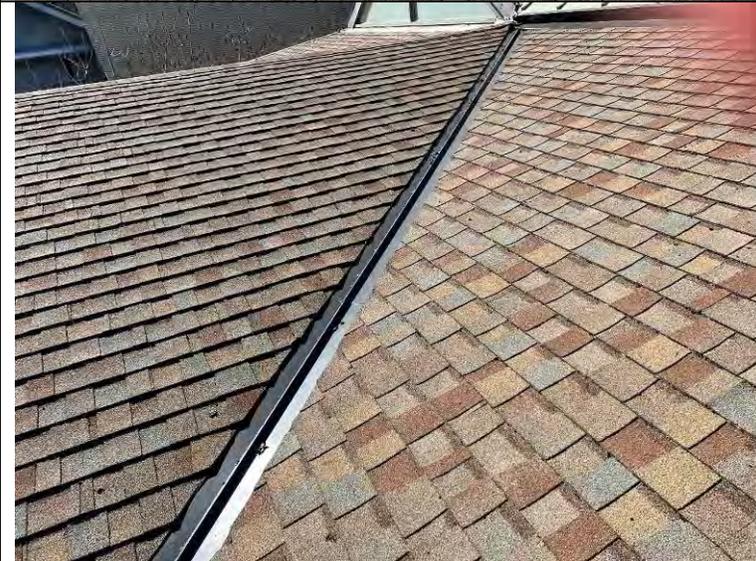
Photograph 50: Closer view of the sheet metal valley flashing.

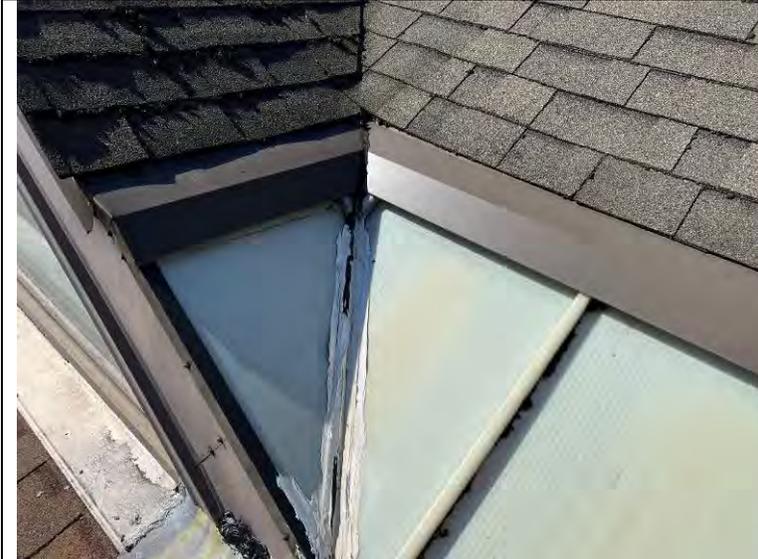
A leak (marked with a 2) was reported in an area below the transition between the skylight and steep slope roof. Application of sealant at the skylight appears to be aged indicating that water entry in this location has likely occurred multiple times. A new application of roof cement at the bottom of the skylight by Wayne's Roofing prior to this writer's site visit has reportedly stopped the water entry. The skylight panels and area below can be cleaned and prepped and an application of Alsan RS can be applied over the area as a long-term patch.

Photograph 53: Sealant at this location is older and was likely applied in response to previous water entry.

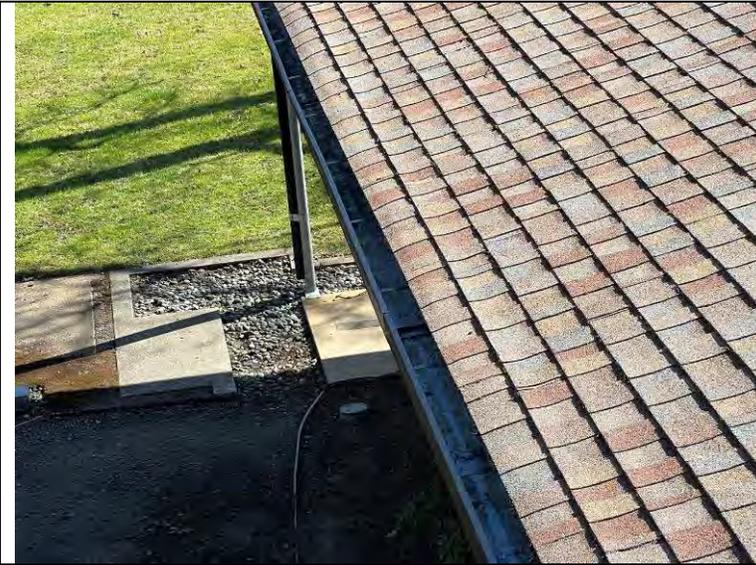
Photograph 55: Typical drainage detail with external hung gutter.

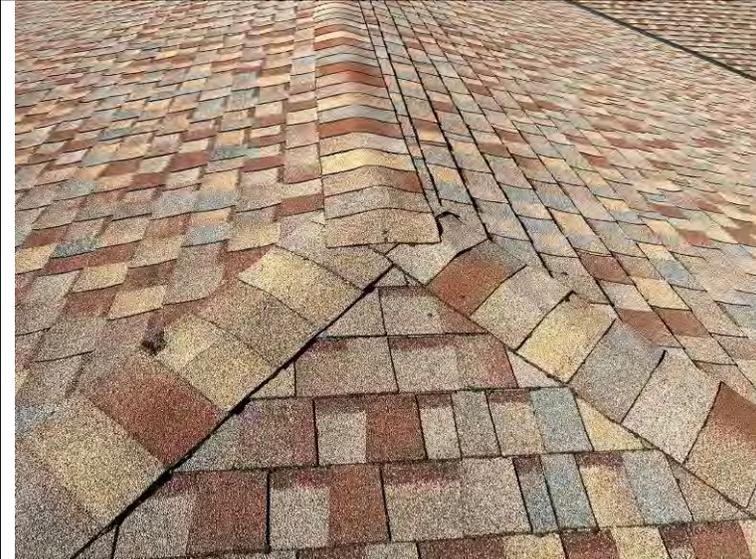
Photograph 56: Ridge to hip transition.

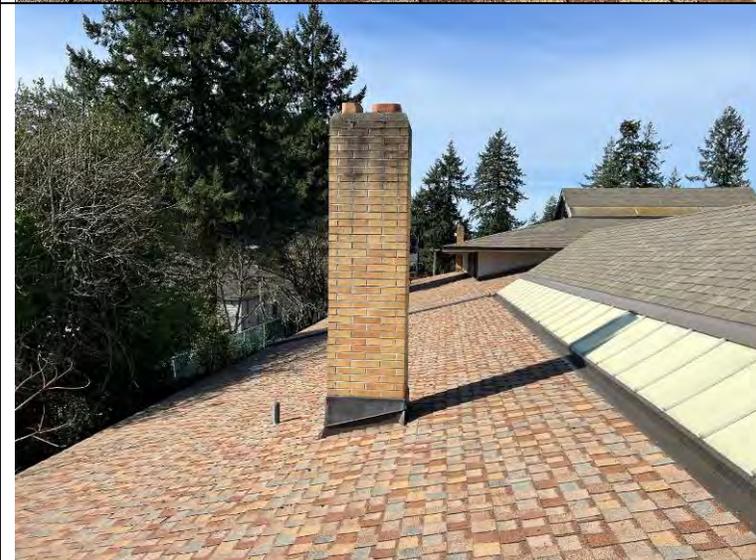
Photograph 57: Chimney penetration flashed with sheet metal flashing.

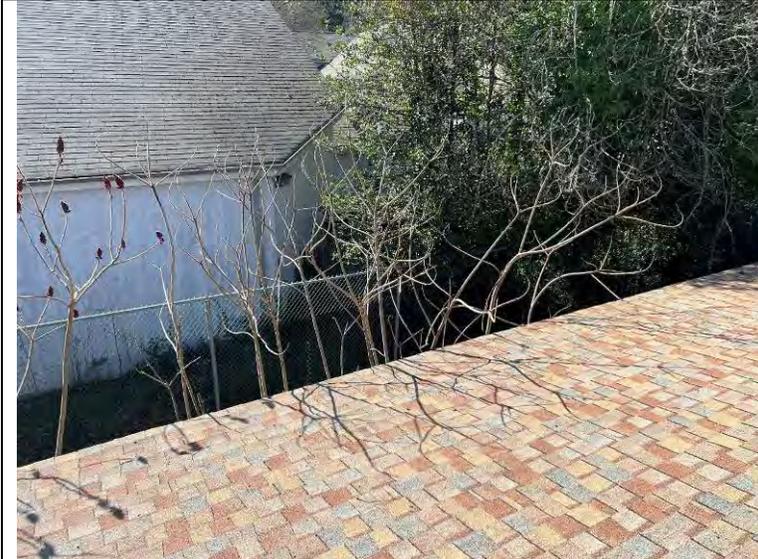
Photograph 59: Trees in close proximity to the roof along the south side of the roof.

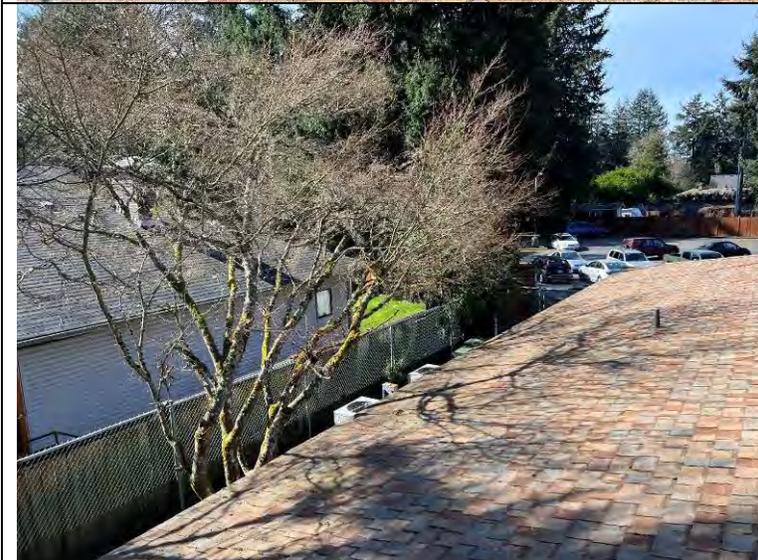
Photograph 60: Trees in close proximity to the roof along the south side of the roof.

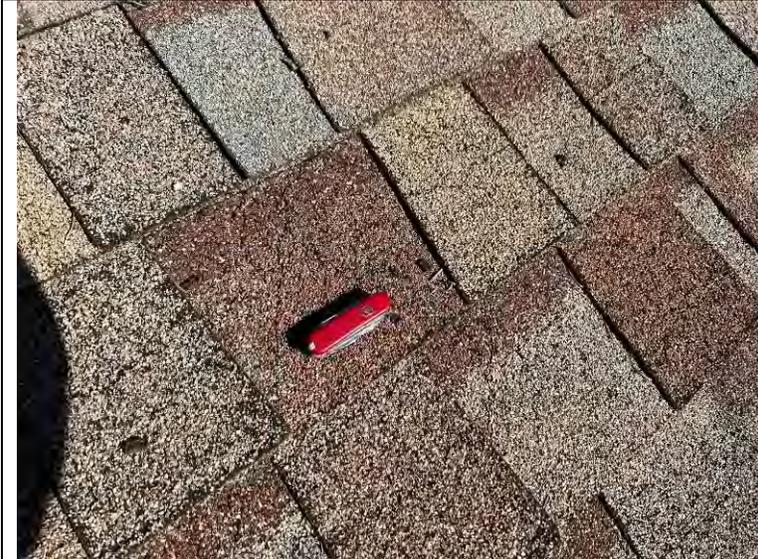
Photograph 62: Closer view of the surface of the shingles.

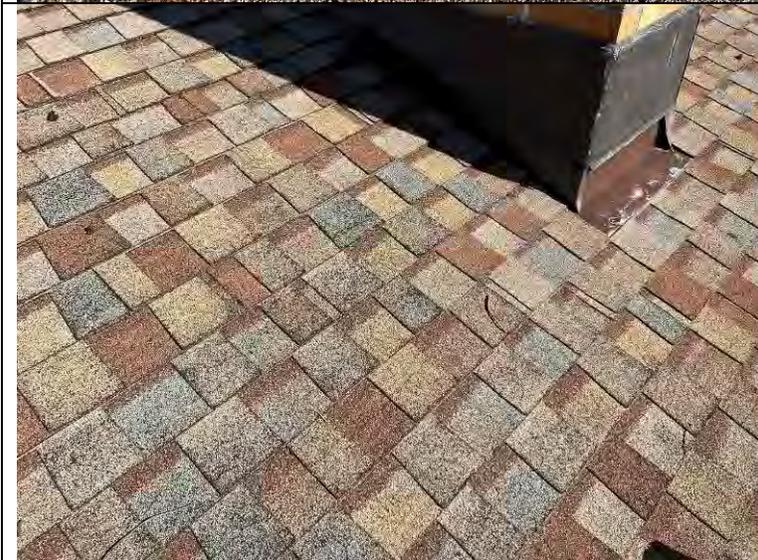
Photograph 63: Alternate view of an area with displaced mineral granules.

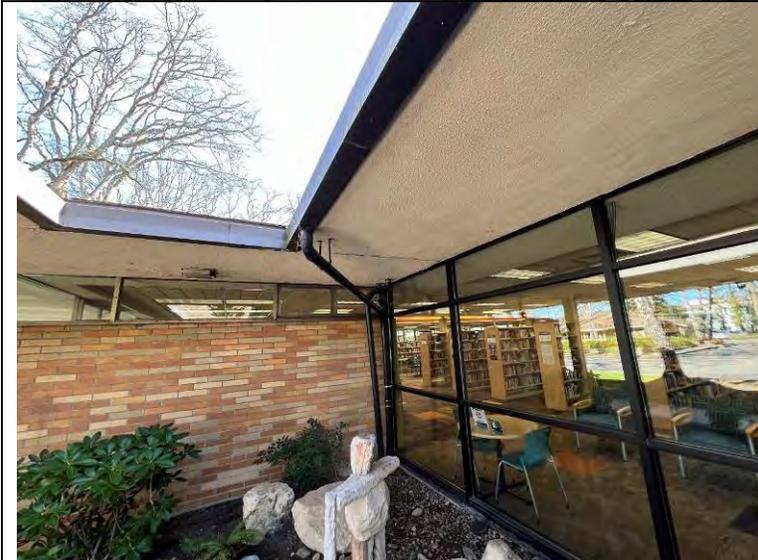
Photograph 69: Gutter downspout.

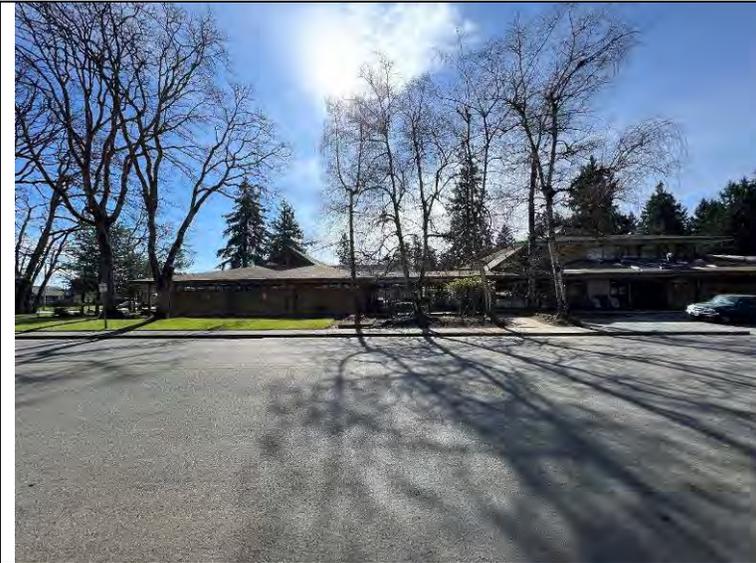
Photograph 70: Overview of the east end of the north elevation.

This area appears to be the 1974 addition.

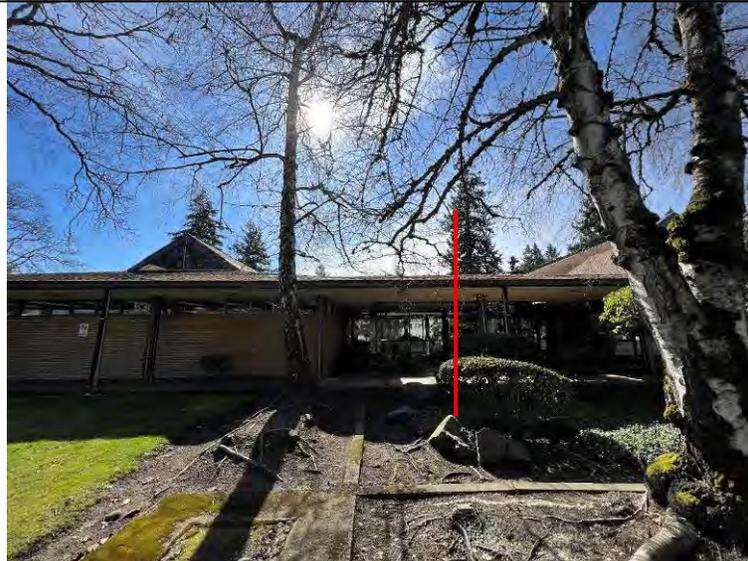
Photograph 71: Area to the left of the red line appears to be the 1974 addition.

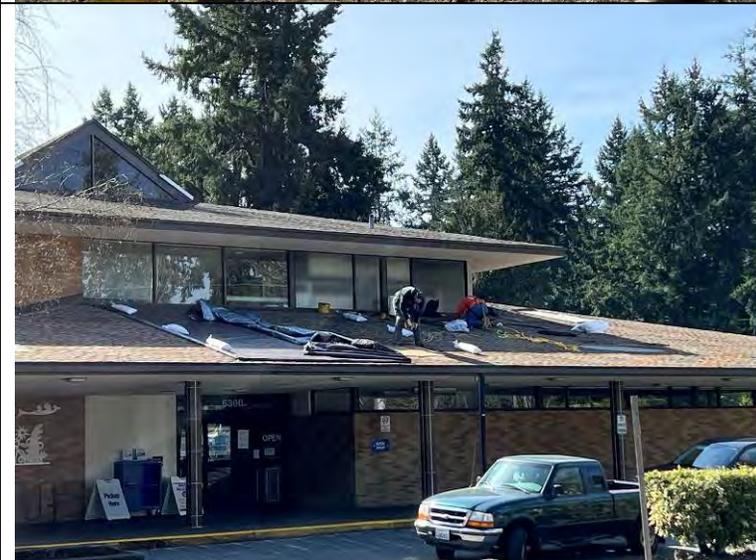
Photograph 72: Overview of the repairs at the test openings.

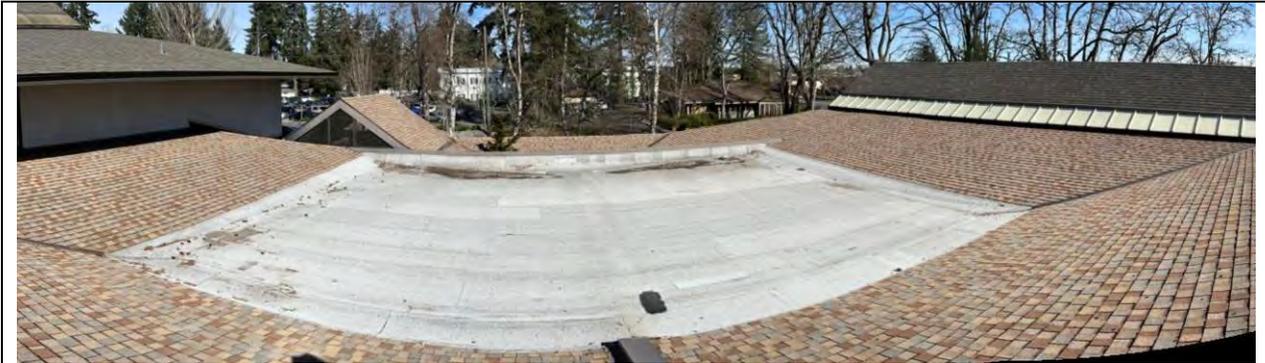
Photograph 73: Overview of the low slope roof.

The low slope roof should be removed and replaced with a new torch applied roof system. The system should be configured with a gypsum substrate board, self-adhered temporary roof/vapor retarder, R-38 (or local jurisdiction required insulation) polyisocyanurate insulation in a minimum of 2-layers, gypsum coverboard, a self-adhered basesheet, a torch applied midply, and a torch applied mineral surfaced capsheet. The overflow drains should be reworked and configured with a cast iron drain body integrated into the new roof assembly. Insulation below the roof deck should be removed.

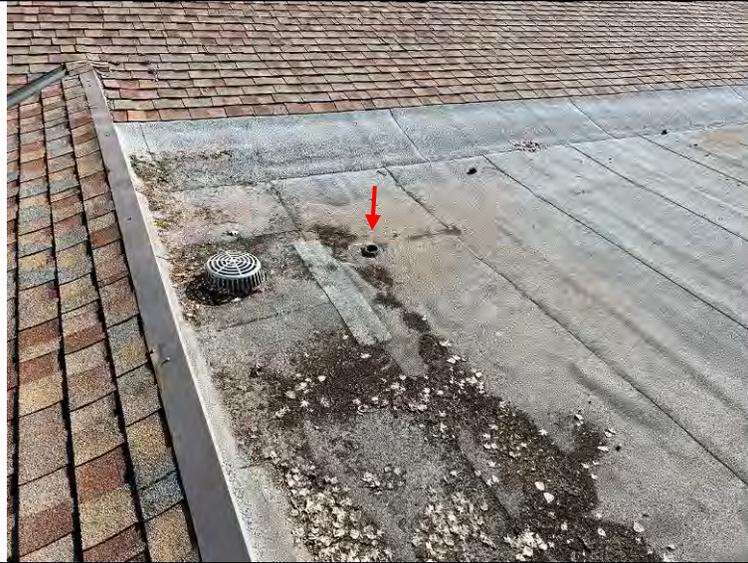
Photograph 74: Typical cast iron roof drain and adjacent contractor style overflow (arrow).

Contractor style overflows consist of a pipe stubbed above the roof flashed into the roof with a lead flashing.

Organic debris is collecting on the surface of the roof.

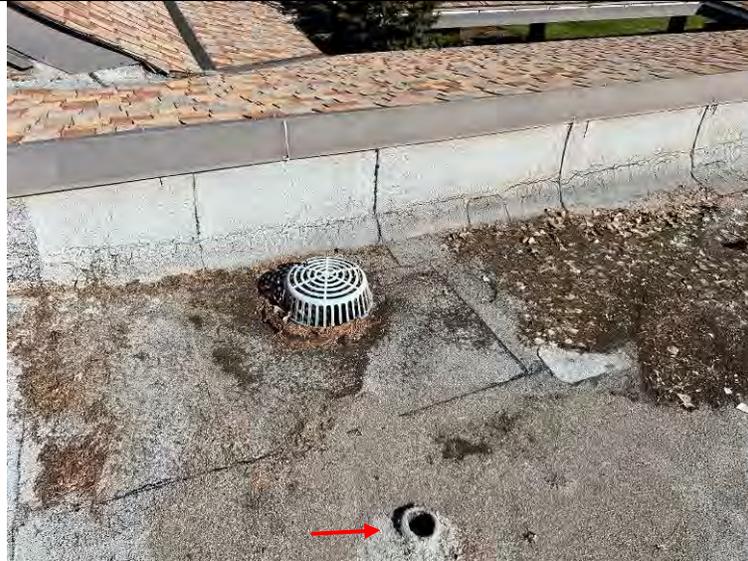
Photograph 75: Closer view of a cast iron roof drain and contractor style overflow (arrow).

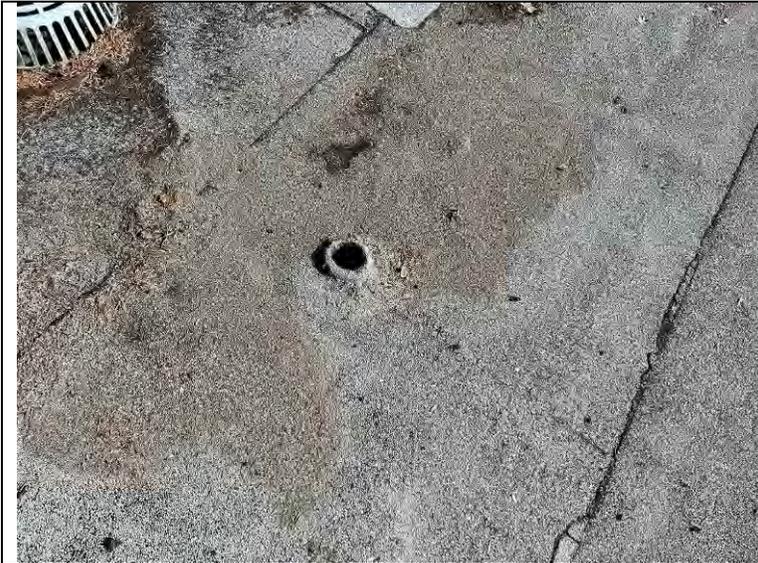
Photograph 76: Closer view of the contractor style overflow.
