W E T H E R H O L T   A N D   A S S O C I A T E S ,   I N C .

**LAKWOOD LIBRARY  
ROOF EVALUATION  
MARCH 10, 2022**

Pierce County Library System  
3005 112<sup>th</sup> Street E  
Tacoma, WA 98446

April 1, 2022

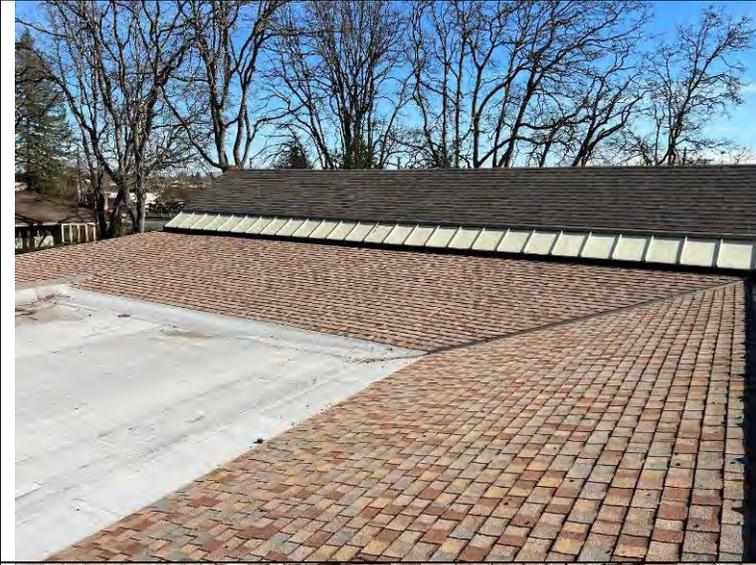
Photograph 82: Steep slope to low slope roof transition.

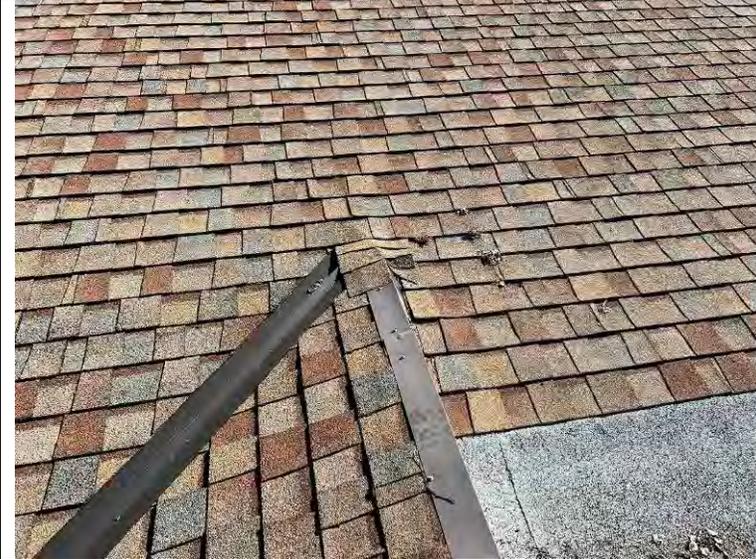
Photograph 83: Closer view of the steep slope to low slope transition.

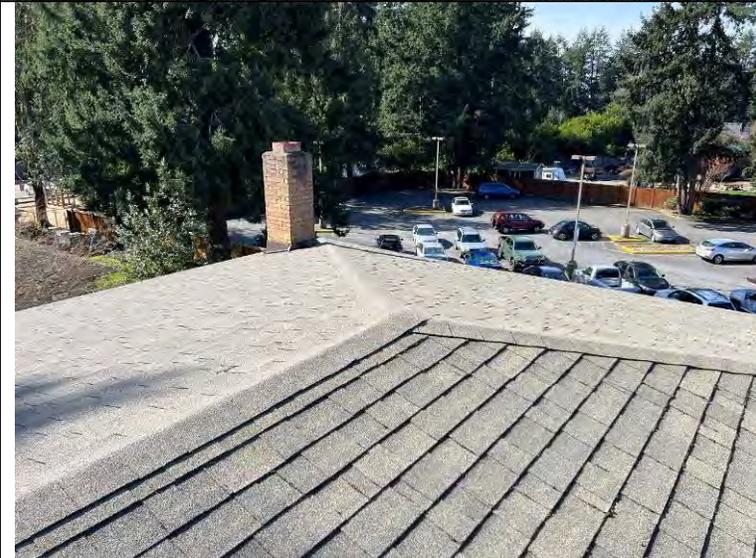
Photograph 84: Overview of the upper roof.

The upper roof area, the east roof areas, and the skylight roofs should be replaced with a new vented roof assembly. The existing shingles and underlayment should be removed to expose the plywood sheathing. Replace any deteriorated plywood sheathing that is found.

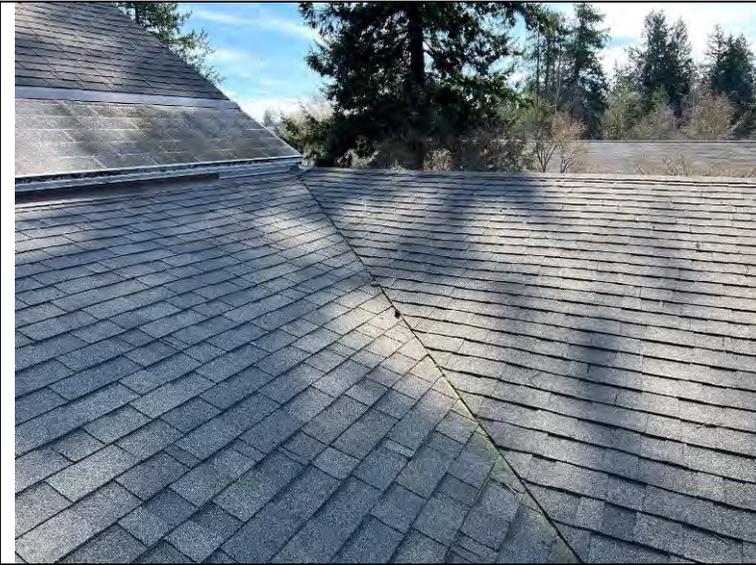
Photograph 85: Typical closed cut valley at the upper roof.

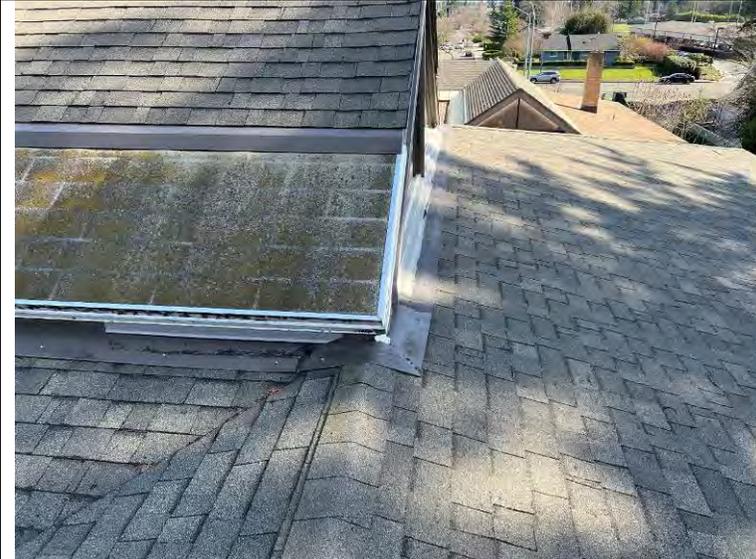
Photograph 86: Roof to skylight transition.

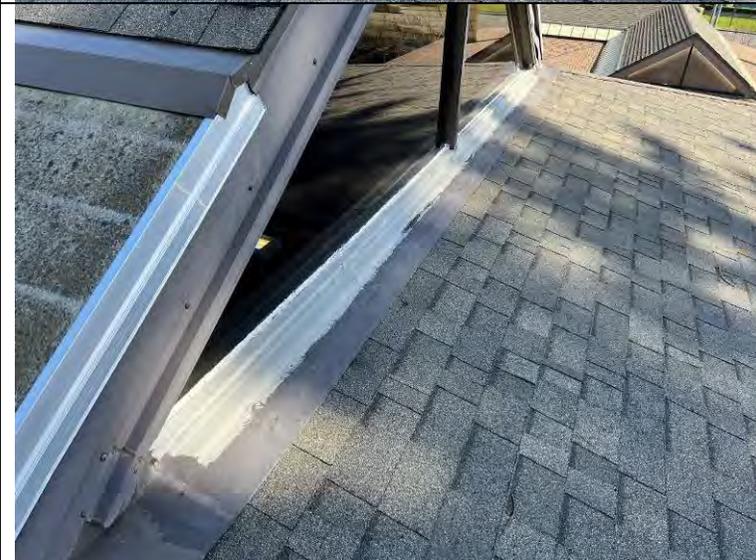
Photograph 87: Roof to clerestory transition.

Note the fluid applied flashing at the base of the window. It is likely the fluid applied flashing was applied in response to water entry.

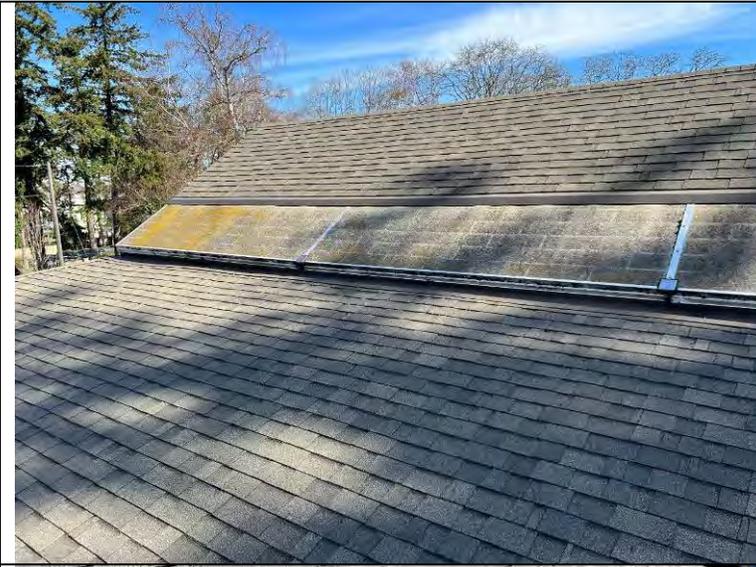
Photograph 88: Overview of the skylights at the upper roof.

Note the lichen growth on the surface of the skylight lenses.

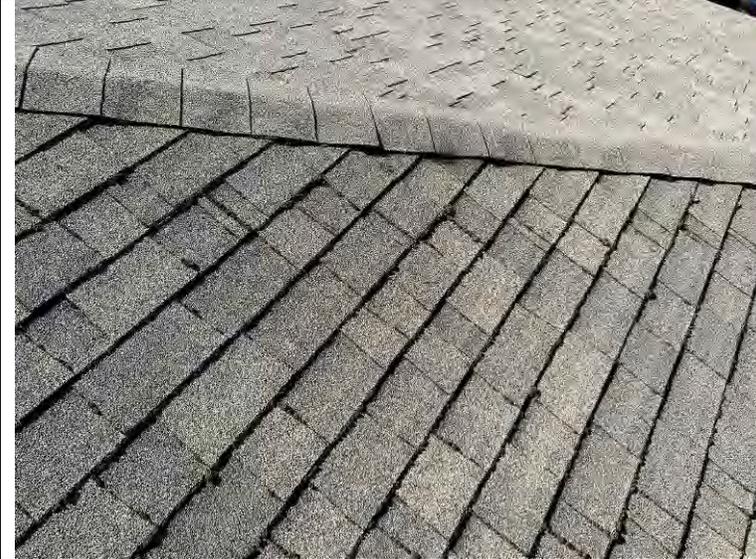
Photograph 89: Moss growth along the perimeter of the shingles.

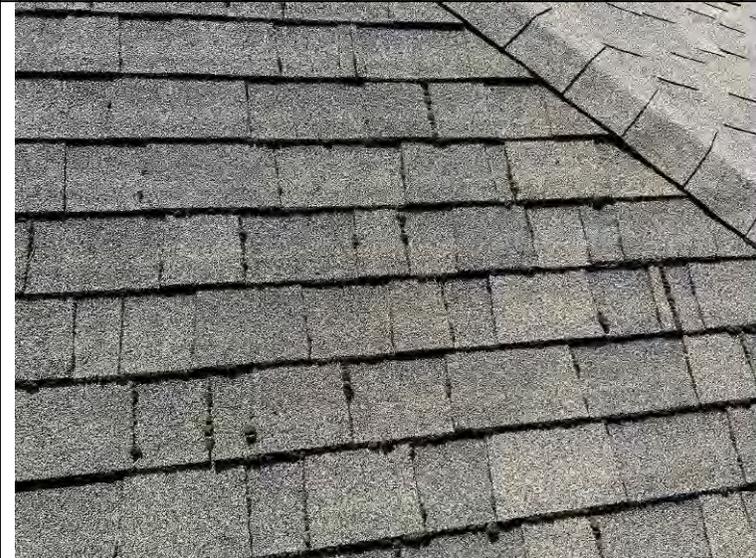
Photograph 90: Alternate view of the moss growth at the upper roof.

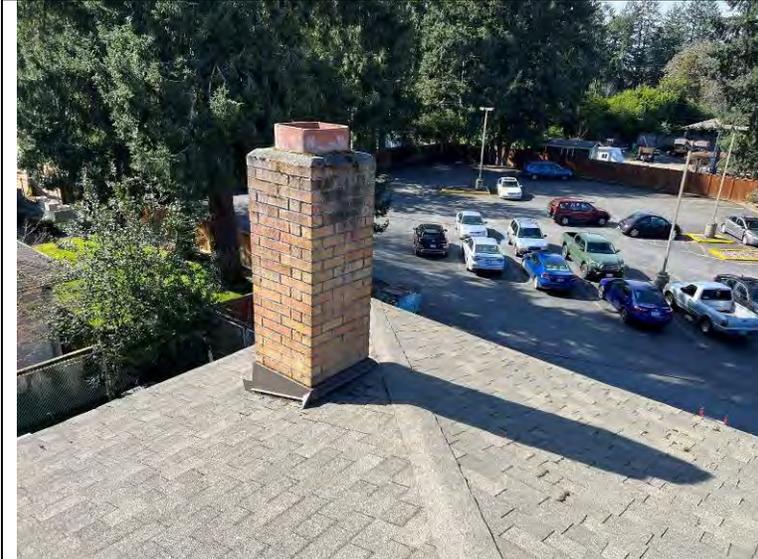
Photograph 92: Chimney penetration at the upper roof.

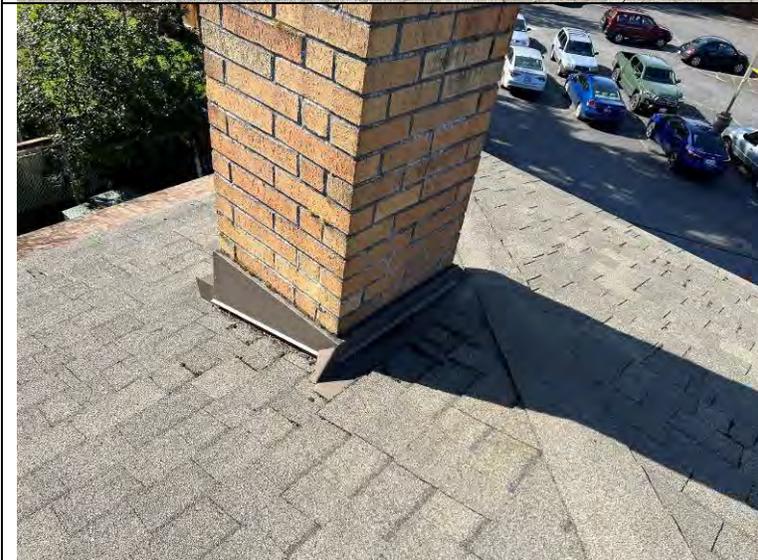
Photograph 93: Closer view of the sheet metal chimney flashing.

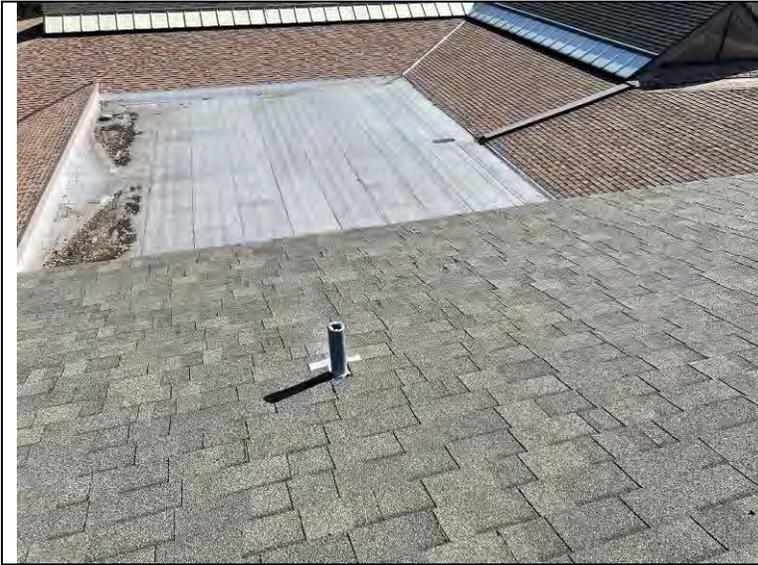
Photograph 94: Typical pipe penetration flashed with a lead.

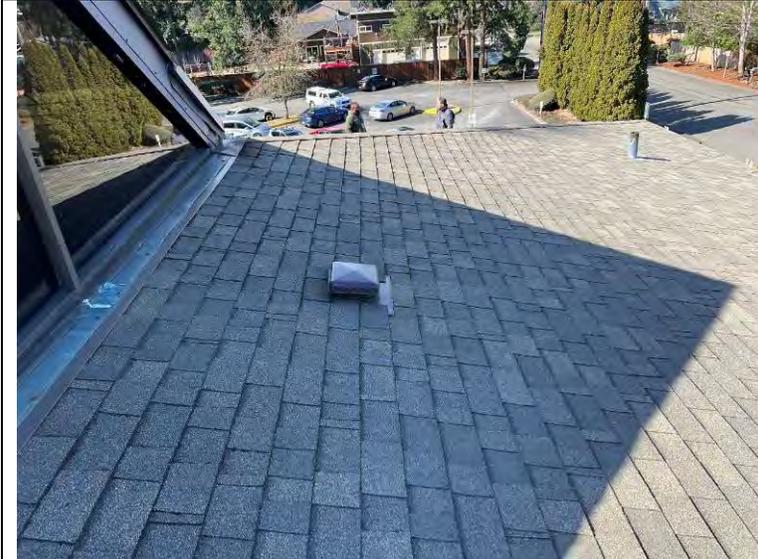
Photograph 95: Typical roof vent stripped into the shingle roof.

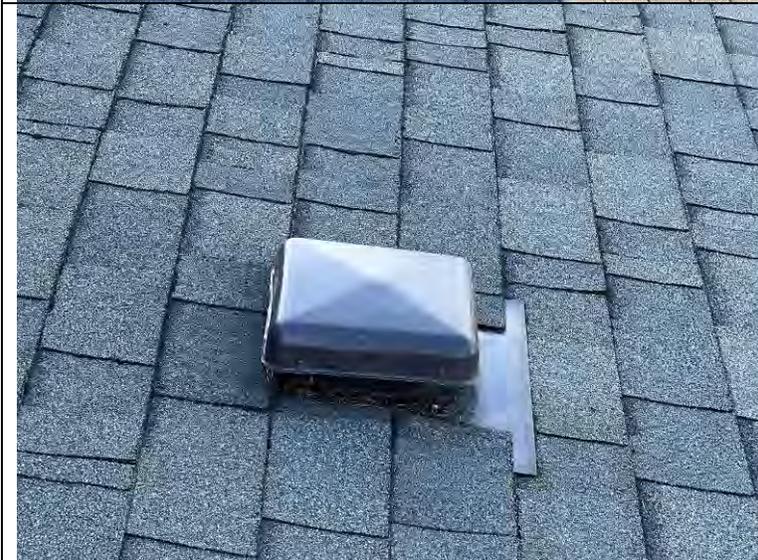
Photograph 96: Closer view of the roof vent shown in Photograph 95.

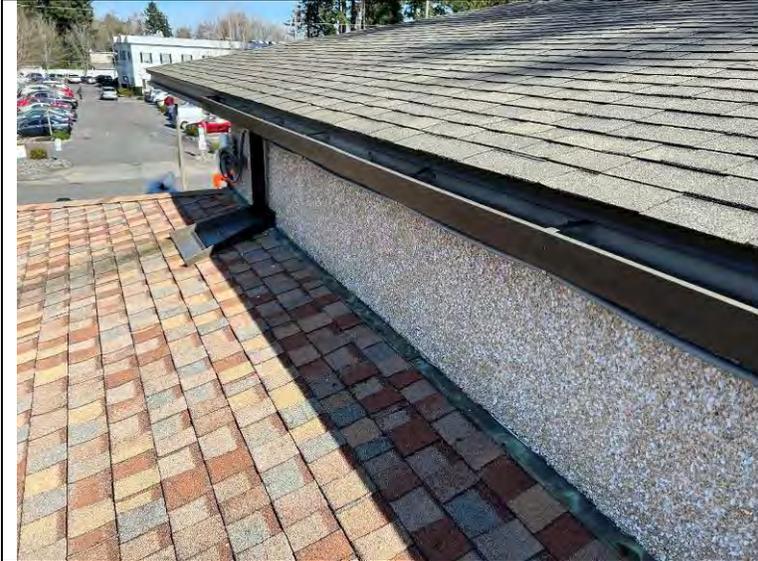
Photograph 98: Draining edge and gutter at the upper roof.

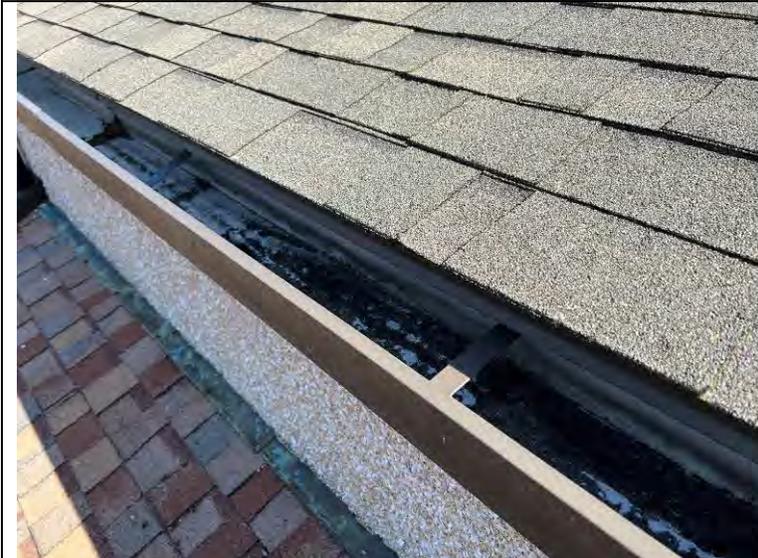
Photograph 99: Closer view of the gutter and draining edge shown in Photograph 98.

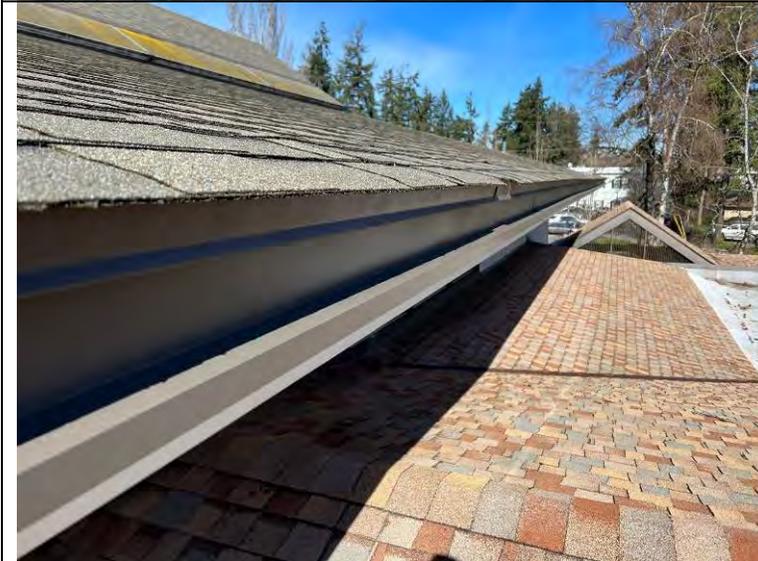
Photograph 101: Eave edge without a gutter.

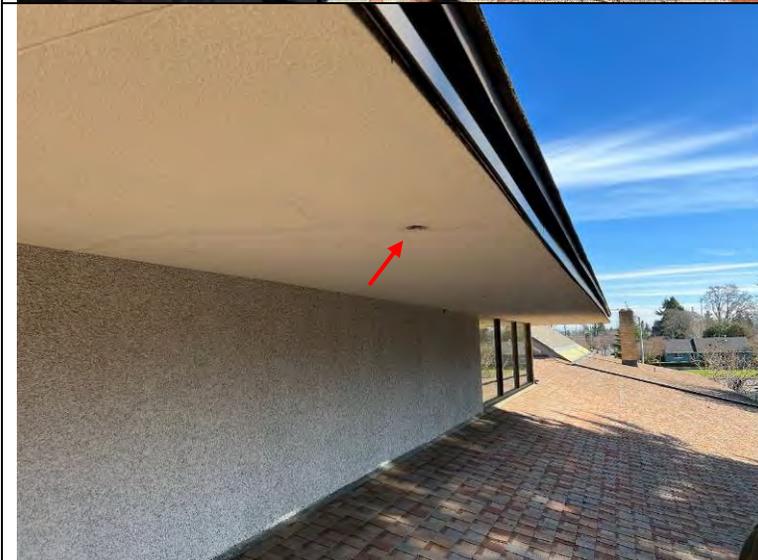
Photograph 102: Soffit above the low roof.

Arrow indicates a hole in the soffit.
